Mendocino County Museum  
Building Condition Assessment Report  
Prepared by: Stephen Farneth FAIA  
Final Report September 16, 2022

## **1. Introduction:**

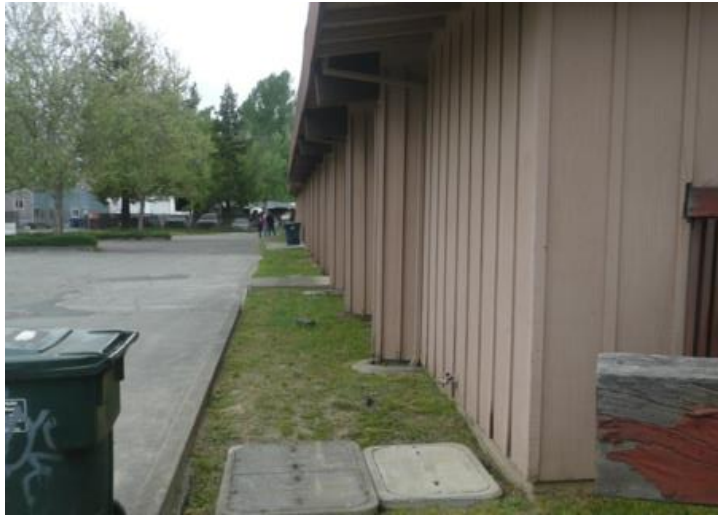
- e) Leaks along the base of the western walls of the Exhibits and Collection Storage Buildings. Past and present leaking along this wall is caused by the existing roof drain downspouts along this wall discharging to grade, and the fact that the grade in some areas slopes back to the building. Because of the size of the roof area, there is a very large amount of water being discharged along the base of these building walls. This problem has not been resolved, and is actually causing settlement at the Exhibits building at the staff lounge area. This problem needs to be resolved with an improved site drainage system, described later in this report.

- a) Site Drainage: Roof downspouts on all sides of the building simply drain onto the grade adjacent to the building wall. This is a major problem on the west side of the building, where the grade in some areas actually slopes back toward the building. This drainage water is causing foundation settlement along the west side (northern end), and is also responsible for past water leaks into the building along this wall. At a minimum, all downspouts along the west wall should be extended to drain onto the parking lot adjacent. The preferred solution would be to install a new storm drain pipe running along the west wall, connecting to all of the downspouts and discharging the storm water either to an existing storm drain in the parking lot, or to a low point away from the building. While the western façade drainage is the most critical to attend to, drainage along all of the facades should be extended away from the building and preferably into a new perimeter drainage pipe taking the water to adjacent storm drains. This work has already been done along the south facades of

*Figure 6. Drainage at West Elevation*

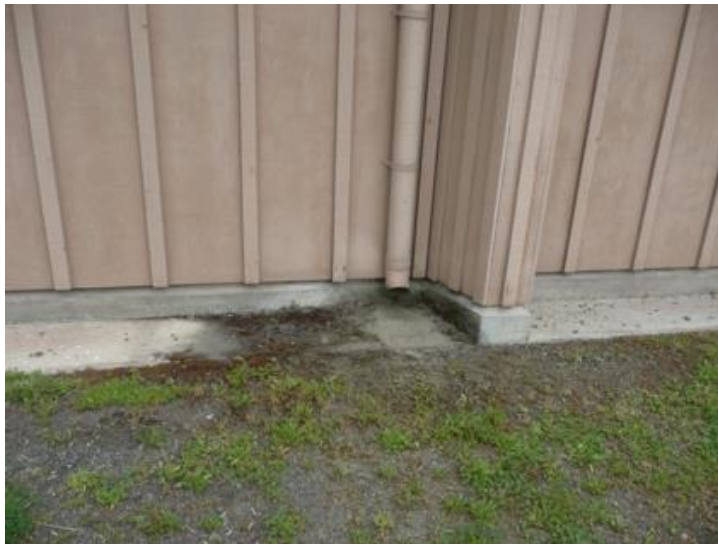
*Figure 7. Drainage Detail*

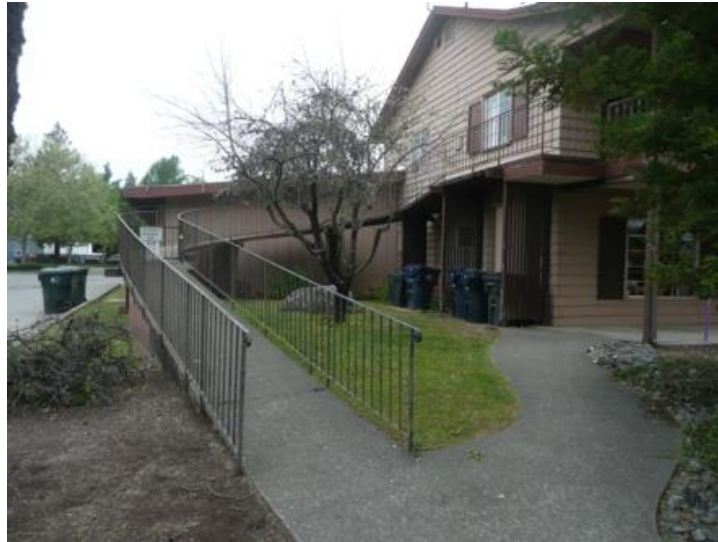
*Figure 8. Curved ramp at southwest corner of site*

Based on this rough code analysis, it appears that the existing second floor can be served by only one exit stairway connected to the building’s entry lobby. Therefore, the exterior curved ramp can be removed without adding another replacement exit stair. This issue should be reviewed with the County Fire Marshall for concurrence.

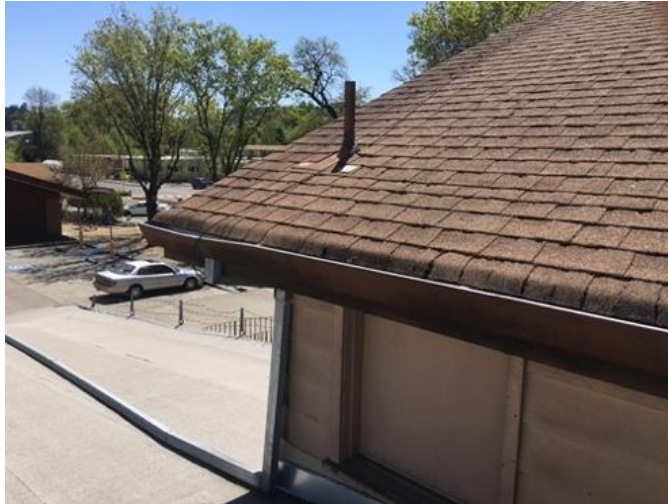
- Administration Building: The existing sloped gable roof is a composition shingle roofing system, in fair condition. It has a few more years of life, but replacement should be planned in the next 5 years or so. The gutter and

downspout system are painted steel gutters, in fair condition. The gutters and fascia have a few areas of damage from ladders or other causes. They should be repaired or replaced when the building façade is painted or when the roofing is replaced.

*Figure 11. Composition shingle roof at Administration Building*

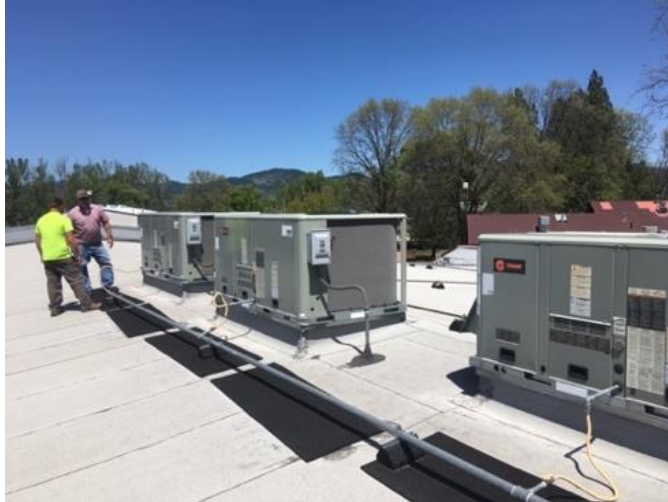
- Exhibits Building: The Exhibits Building roof is a shallow slope gable roof form sloping to integral gutters and drains on the west and east. The existing roof is a modified bitumen roof in very good condition, recently installed. There were no records on site of the installation details, especially as regards whether additional insulation was installed below the new roof. In the course of the roof work, the three HVAC units on this roof were also replaced. They appear to be well installed and watertight. Utility lines, electrical and gas are run across the roof, set off on blocks. In the course of the work, the north parapet wall with the Collections Storage Building, was reclad with metal siding and new flashings and copings. It is also in good condition.

Figure 12. New roof and new HVAC units at Exhibit Building Roof

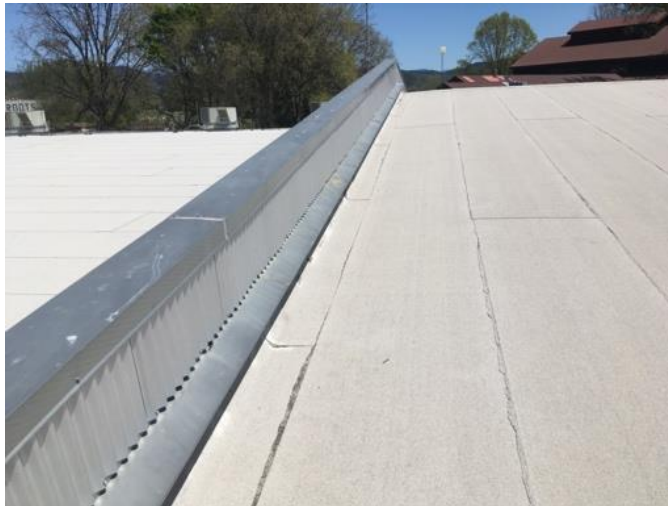
- b) Leaks along the seismic joint between the Exhibits Building and the Collections Storage Building. These leaks were also extensive and appear to have been caused by poorly designed waterproofing at the seismic joint connection between the structures. A series of reports from 2014-16 document the wide extent of damage to structure, sheathing, and gypsum board finishes. The high humidity from the leaks also caused mold conditions throughout the building. These conditions appear to have been resolved through removal of damaged and compromised materials, the recent re-roofing of both buildings and the reconstruction of the parapet and seismic joint between the buildings. There were no as-built drawings available to review the exact details of the re-roofing, so this conclusion is based on the observation that there does not appear to be any current or recent leaking. This line of the building should continue to be observed closely for any future leakage.

Figure 13. Parapet at seismic joint between Exhibit Building and Collections Storage Building

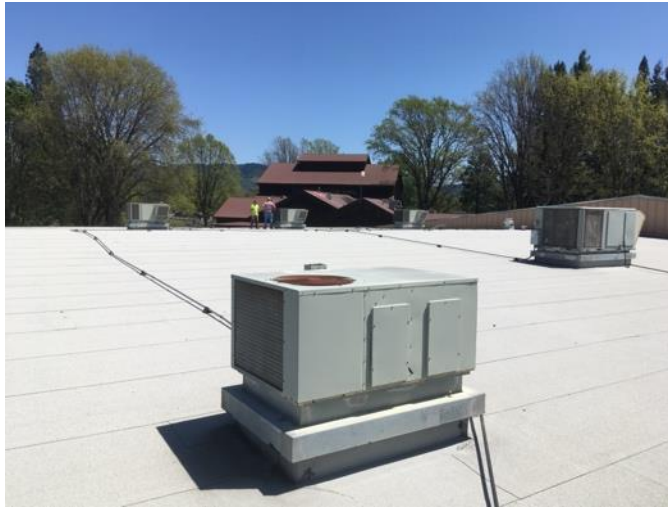
- Collections Storage Building: This structure has a near flat (1/4"/ft.) roof, sloping to roof drains along the west and east facades. It has also been reroofed recently with the same roofing system as the Exhibits Building. The roof is in very good condition. As with the Exhibits building roof, it is not known whether or how much rigid insulation was installed under the new roof. The rooftop HVAC units above the Collections Storage Building were not replaced. It appears that they were reinstalled in their original locations with new curbs and flashing. Roof drains drain to metal downspouts which discharge onto grade along the west and east walls of the building. They are in fair condition. The parapet wall and seismic joint with the Exhibits Building, has been re clad with plywood, and flashing replaced. It appears to be functioning adequately.

*Figure 14. New roof and old rooftop HVAC units at Collections Storage Building*

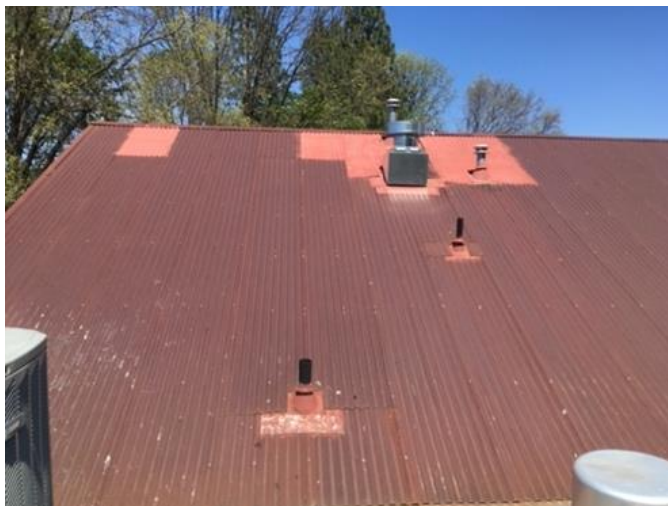
- **Classrooms Building:** The Classrooms Building (and adjacent Engine House), are primarily roofed with a collection of steeply pitched gable roofs, which conceal a central flat-roofed area, which houses a collection of mechanical units. The steeply sloped roofs are roofed with corrugated Corten steel. The steel roofing itself appears to be in good condition, but penetrations through the roofs have been altered in the past and may still be potential areas of leaks. Also, roof patches were not made with weathering steel to match the existing. Future alterations should take care to match the original weathering steel.

*Figure 15. Corten steel roof with patched roof areas*

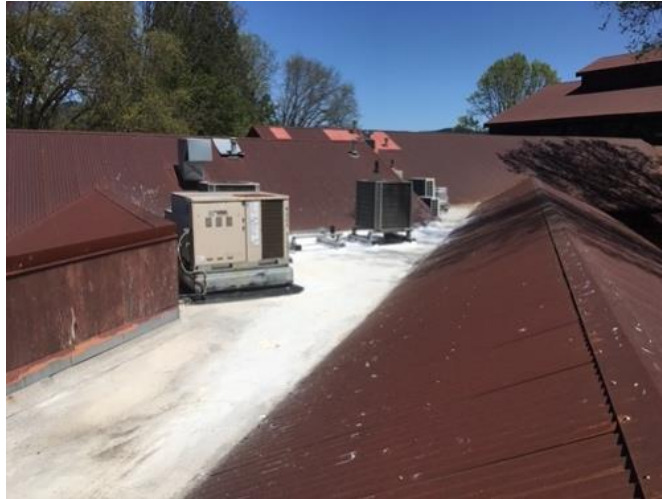
- f) Current leaks above the Roots Library space in the Classroom Building. This is an active leak, and it was not possible to pinpoint the exact source of the leak, (there may be several sources), but it is noted that the flat roof above this area was not replaced during the recent roof projects. This flat roof area has numerous flashing and HVAC penetrations and is near the end of its life. Recent efforts with elastomeric coatings have failed. The flat roof of the Classroom building needs to be replaced.

The central flat-roofed “well” still has its original built up roof, which is in poor condition, with a recent elastomeric coating, attempting to seal ongoing leaks. Multiple mechanical units and penetrations exist in this flat roofed area. There are current and ongoing leaks into the Roots Library

below. The exact source for these leaks is not possible to determine, but could be from any number of penetrations or roof transition areas. The roof is at the end of its life and should be replaced in a comprehensive manner, incorporating new or re-installed HVAC units, addressing penetrations and all flashing conditions to the surrounding steep metal roofs. In addition, the plywood sided parapet wall along the north edge of the flat roofed area, is in poor condition, and needs repair and replacement at the same time as the re-roofing project.

Figure 16. Classroom Building Flat-roofed "well"

- Investigate the as-built construction of the new roofs over the Exhibits Building and Classroom Storage Building.
- Replace the flat roof over the Classroom wing. This work should include all flashings to the existing corrugated sloped roofs, as well as repair and replacement of deteriorated plywood parapet walls. Remove and reset existing mechanical units. (note some of these units are at the end of their lives and could be replaced at the same time, depending on budget). If this roof replacement work cannot be implemented immediately, temporary measures should be implemented to locate and seal existing leaks.

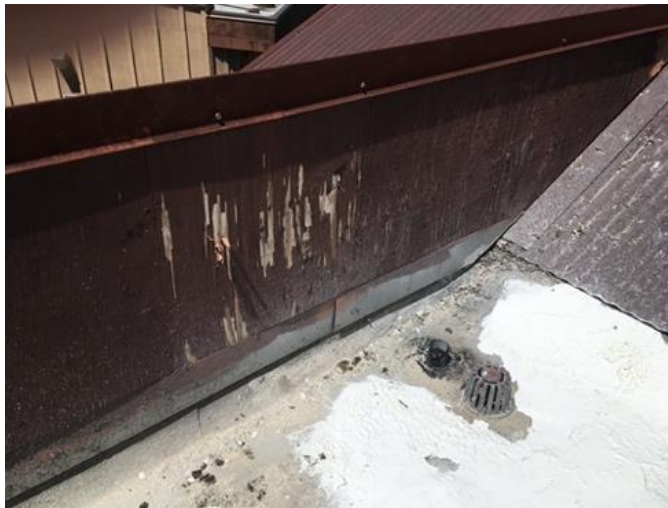
Figure 17. Detail, plywood deterioration and failed past roof patching

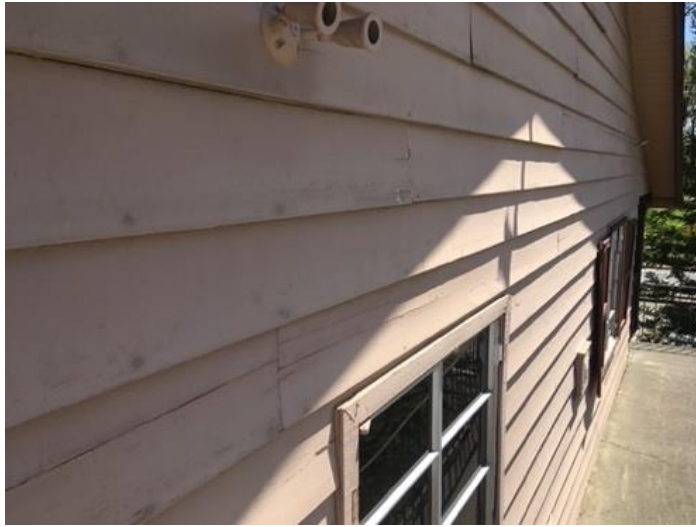
- b) Walls/Siding/Trim: The exterior walls of the Museum vary by building age and type, but all are wood or plywood surfaces, and all are in need of limited repair and painting.
- Administration Building: The Administration Building is sided with 8" beveled wood horizontal siding. There are a number of split or damaged boards, but in general the siding is in fair condition. Flat 1x wall trim exist at

openings and corners. Trim damage was noted at a number of locations and should be repaired when the entire building is painted.

Figure 18. Detail, split siding boards at Administration Building

- Repair siding and trim and repaint all structures, (Natural finished wood of the Classroom wing should be treated with clear sealer).
  - Improve signage, parking, and path of travel to the rear classroom entry. (Until south façade access plan is created).

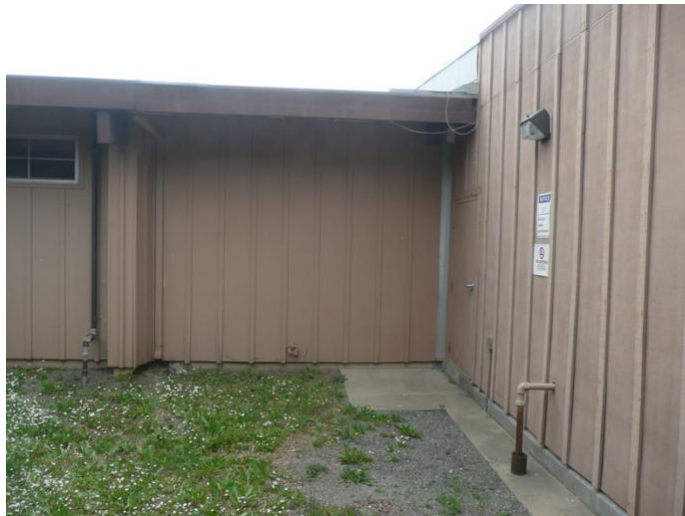
- Exhibits Building: The Exhibits Building is sided with plywood siding, with vertical wood battens applied at 16" centers. The plywood and trim is in serviceable condition, in need of maintenance and painting.
- Collections Storage Building: The Collections Storage Building is sided with plywood siding and wood battens to match the Exhibits building. As with that building, the walls are in need of maintenance and painting.

Figure 19. Plywood with batten siding at Exhibit and Collection Storage Buildings

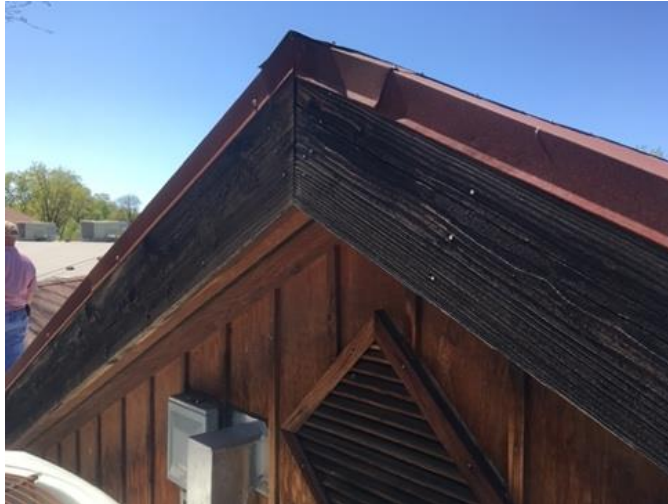
- Classrooms Building: The Classroom Building is sided with vertical 1x redwood boards and redwood battens, unpainted. Flat trim and roof fascia are also all unpainted redwood. These surfaces are generally in good condition, but are weathering. In conjunction with repair and repainting the

wood surfaces of the adjacent buildings, the Classroom Building should be evaluated in greater detail, and treated with a clear sealer or other appropriate surface coating to extend the life of the wood surfaces.

*Figure 20. Untreated and weathered redwood siding and trim at Classroom Building*

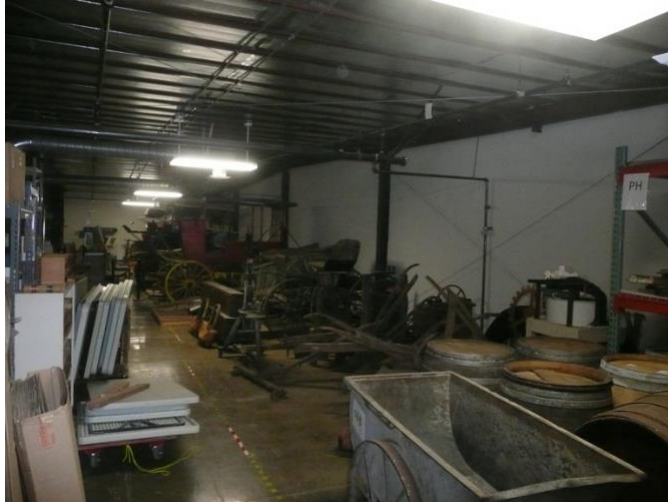
- a) The open areas of the Collections Storage Building have an unfinished (exposed foil-faced insulation). Once the question of the roof insulation and condensation has been resolved, the open storage areas would greatly benefit from fully insulating the roof cavities and installing gypsum board ceiling with improved lighting.

*Figure 21. Interior Collections Storage area*

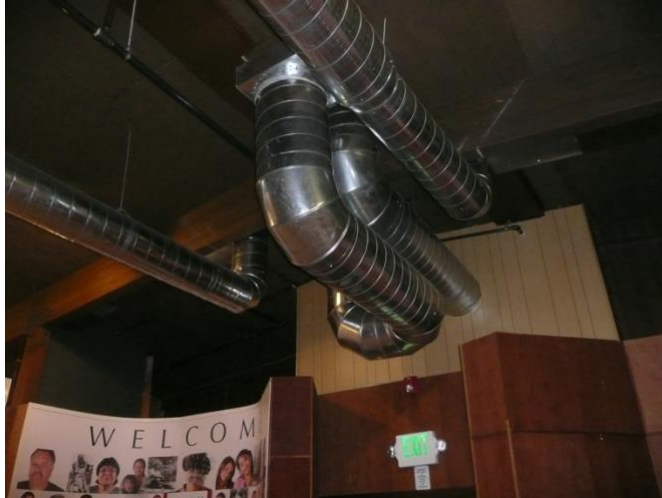
- c) In the Exhibit Building, the recently-installed exposed metal ductwork was installed unpainted. It has a very sculptural appearance, but takes some focus away from the exhibits. Consideration should be given to painting the ductwork to be less distracting.

Figure 23. New ductwork at Exhibit Building

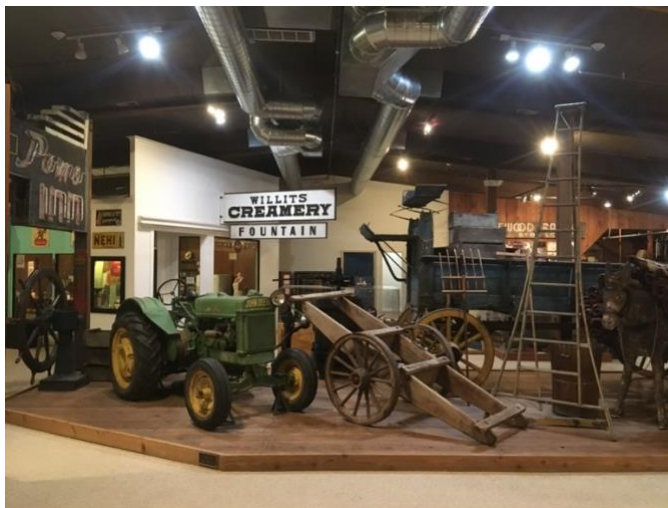
- 150 amp panel serving the Classroom Building
  - The display and general lighting of the Exhibits area are a mixture of incandescent and halogen lights, with a few replacement LED lamps. These older lighting systems are all due to be replaced with more energy efficient LED systems. In addition to energy savings, this replacement will also provide an opportunity to rethink lighting levels and intensities throughout the displays. Rather than reinstating the current overall bright level of lighting, consider a lower overall ambient lighting with stronger accent lighting at appropriate locations in the various exhibits. Implementation of this improvement should involve an exhibit designer and lighting engineer. Lighting control systems should be included and upgraded at the same time, with appropriate dimmer systems, and occupancy sensitive switching.

Figure 24. Main Gallery displays at Exhibit Building

- Replace and upgrade display lighting to LED in the Exhibits Building to improve energy efficiency and to enhance the presentation of the exhibits. This may require a lighting designer to size and direct lighting requirements.
