# Hazardous Building Materials Survey Report

County of Mendocino  
Pre-Demo PA# 21-188

131 Whitmore Lane,  
Ukiah, California

FACS Project #PJ69282

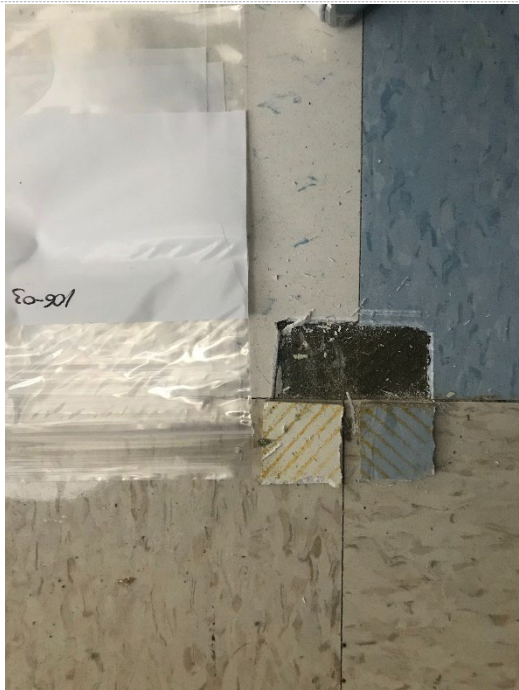
Photo #5: Black and yellow mastic; Blue, off white and beige 12"x12" vinyl floor tile

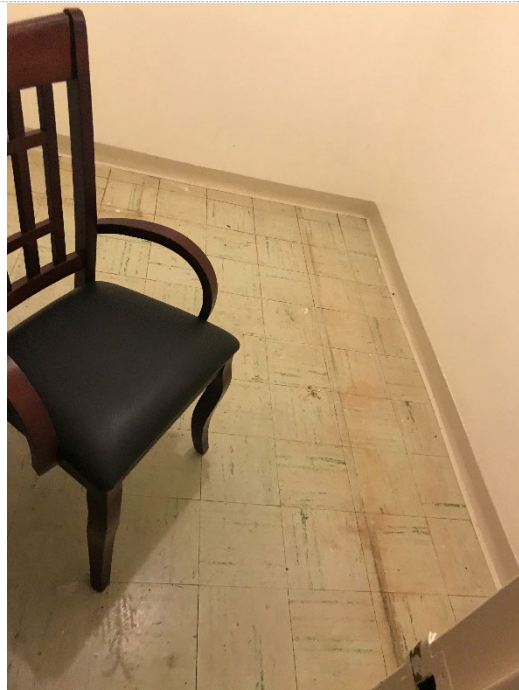
Photo #6: 9"x9" floor tile

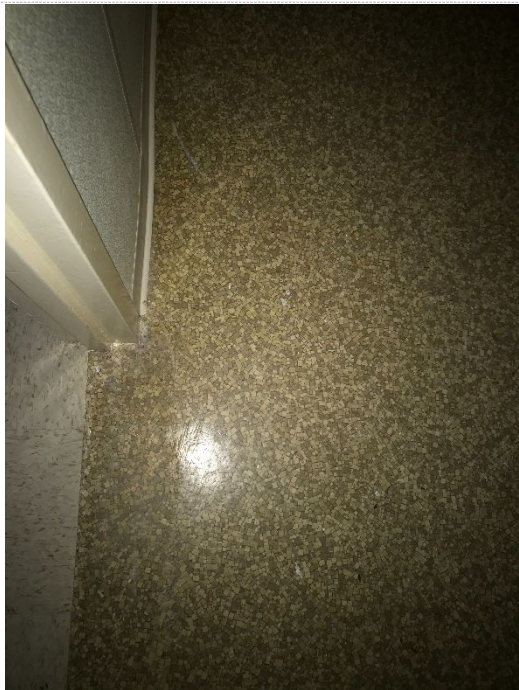
Photo #7: Box pattern vinyl sheet flooring

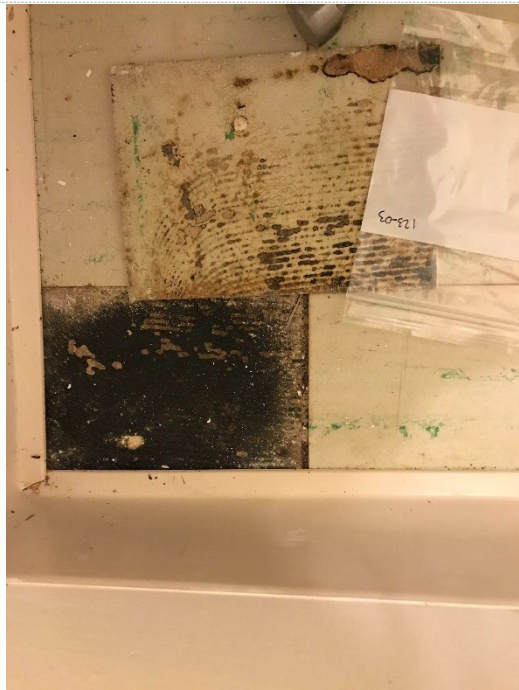
Photo #8: Off white vinyl floor tile with black mastic

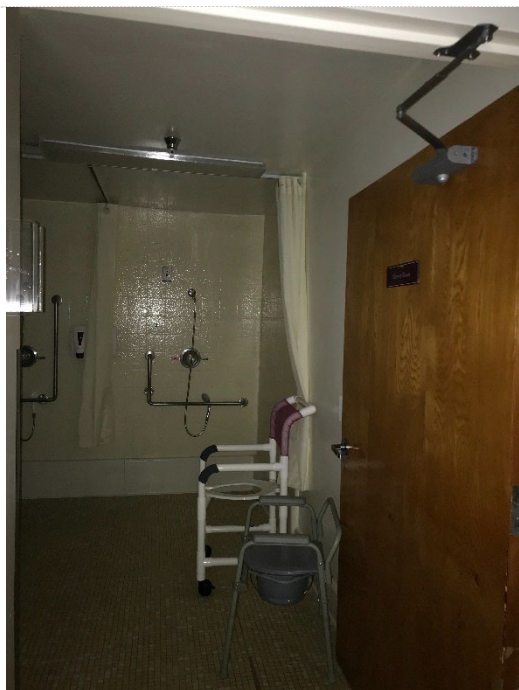
Photo #9: Shower room - ceramic tile floor, baseboard and walls

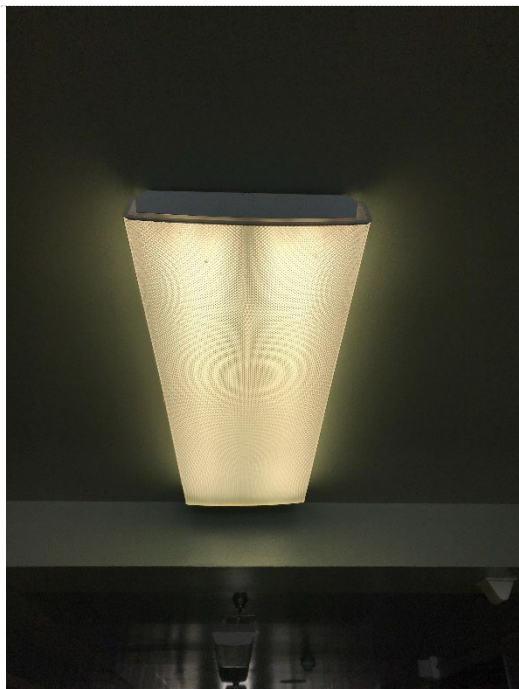
Photo #15: Light fixture – Lithonia Lighting  
Model: LB 32 MVOLT ¼ MVIS

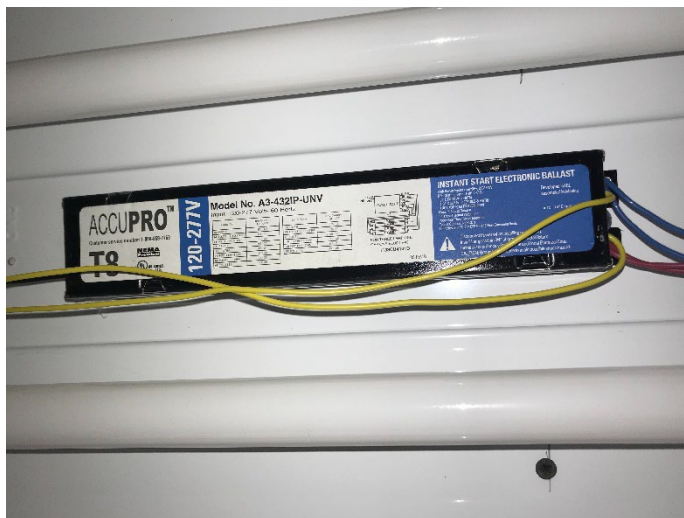
Photo #16: Ballast  
Model No. A3-432IP-UNV  
Type 1 Outdoor, No PCB's

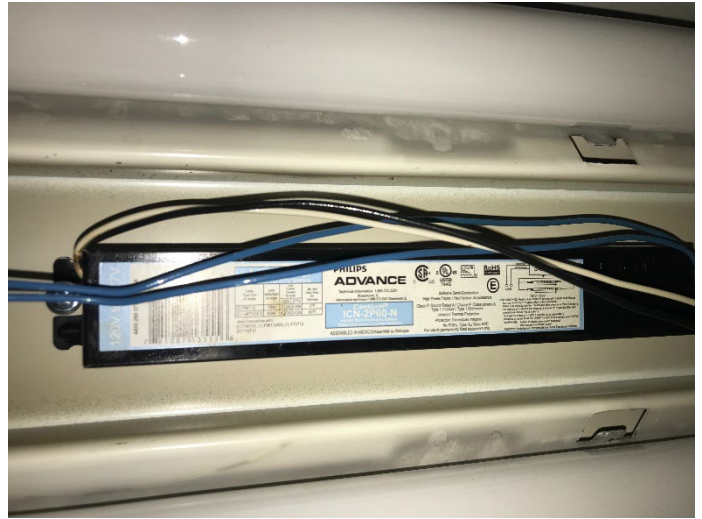
Photo #18: Ballast ICN-2P60-N  
No PCB's

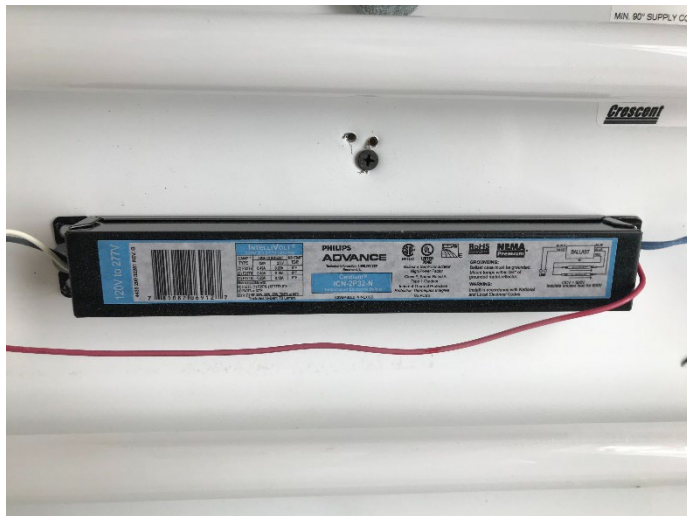
Photo #22: Ballast – ICN-2P32N  
No PCB's

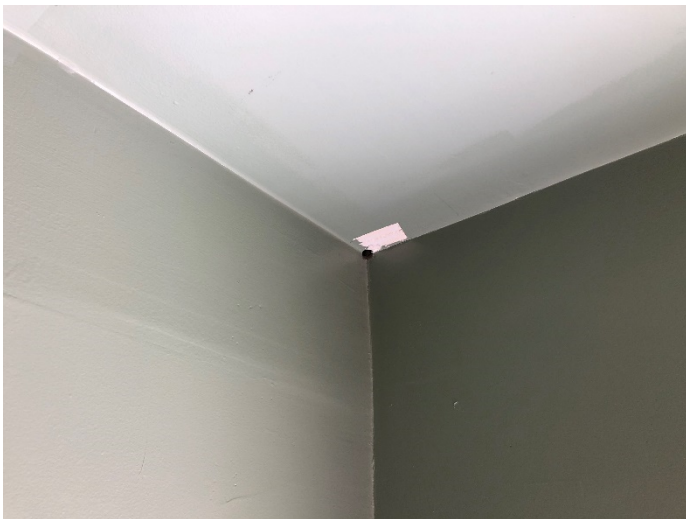
Photo #3: Interior paint sampled (Pb01)

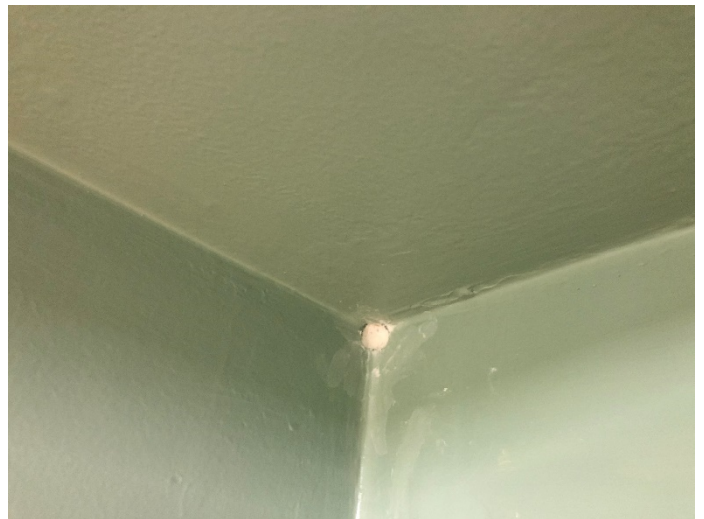
Photo #4: Interior drywall with joint compound sampled (63797-101-01 to 03)

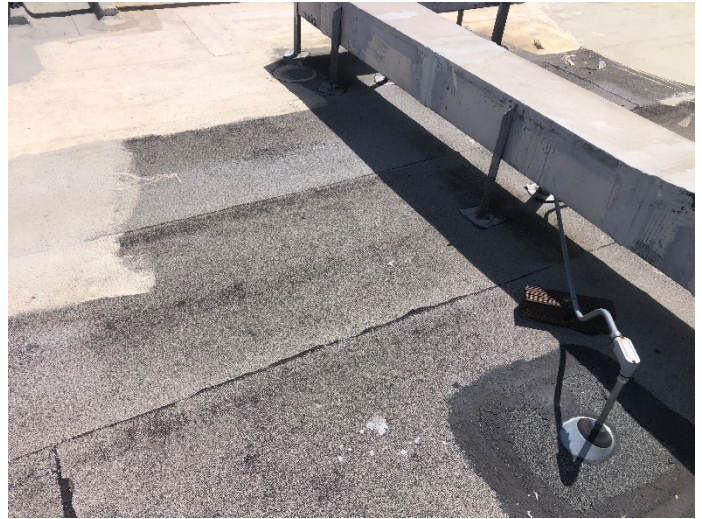
Photo #6: Roof Patch

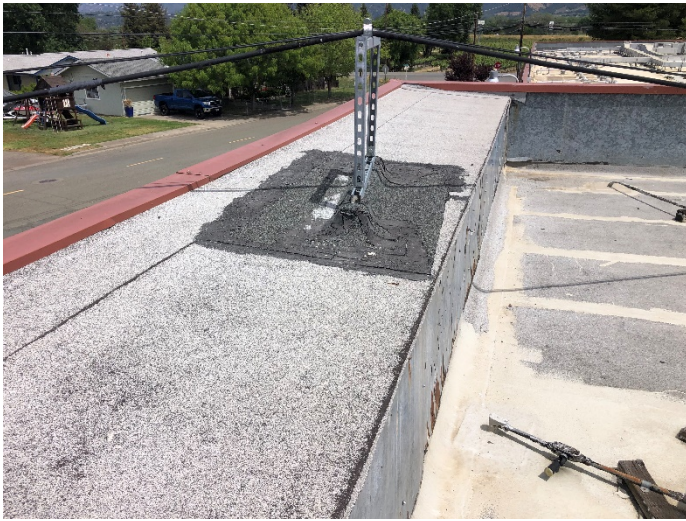
Photo #13: Roof patch

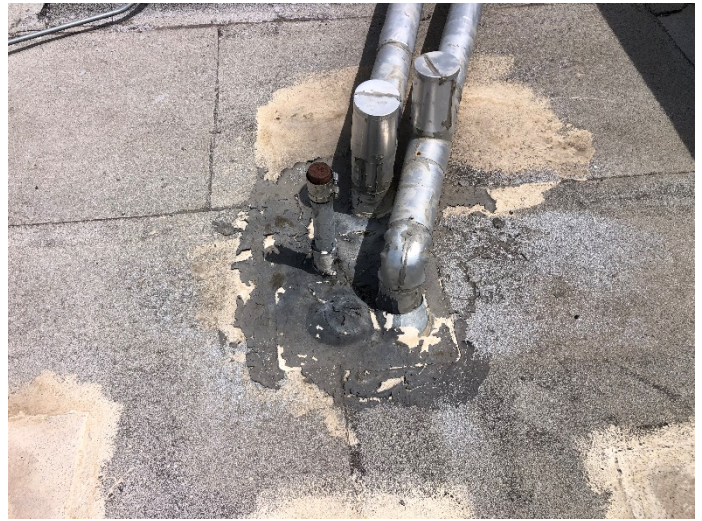
Photo #14: Roof patch

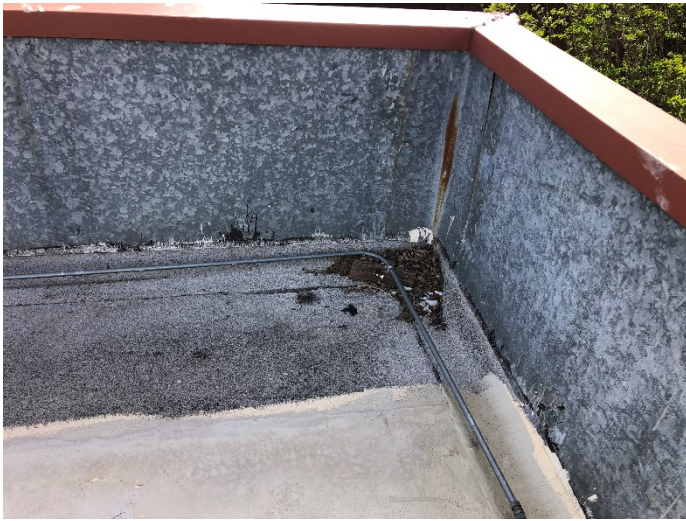
Photo #15: Roof Cap (Sample Pb02)

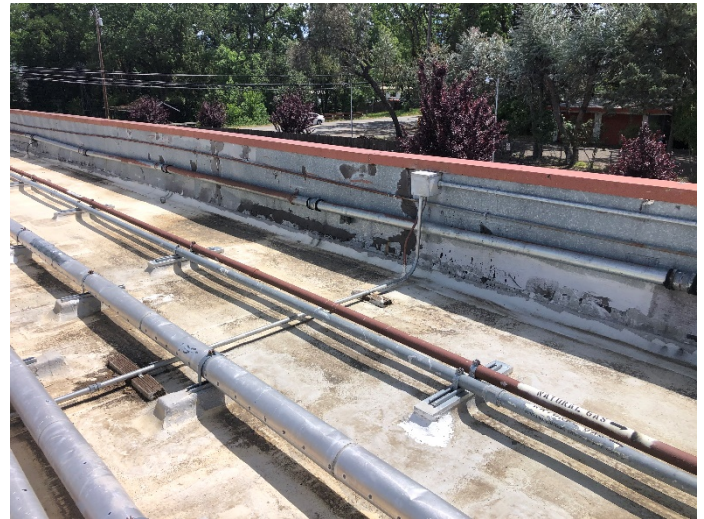
Photo #8 - Parapet Wall (Samples 112-28,29):
