Acceptance of Informational Report Regarding the Issuance of Emergency Coastal Development Permit EM_2023-0003 (McLellan) to Relocate the Single-Family Residence, Located at 34301 Pacific Reefs Road, Albion, APN: 123-340-19

NATURE OF EMERGENCY: Approximately twenty-two (22) feet of the ocean bluff collapsed in early March 2023, extending to the foundation of the existing single-family residence.

BRUNSG ASSOCIATES, INC.
5468 Skylane Blvd. Suite 201
Santa Rosa, CA 95403
(707) 528-6108

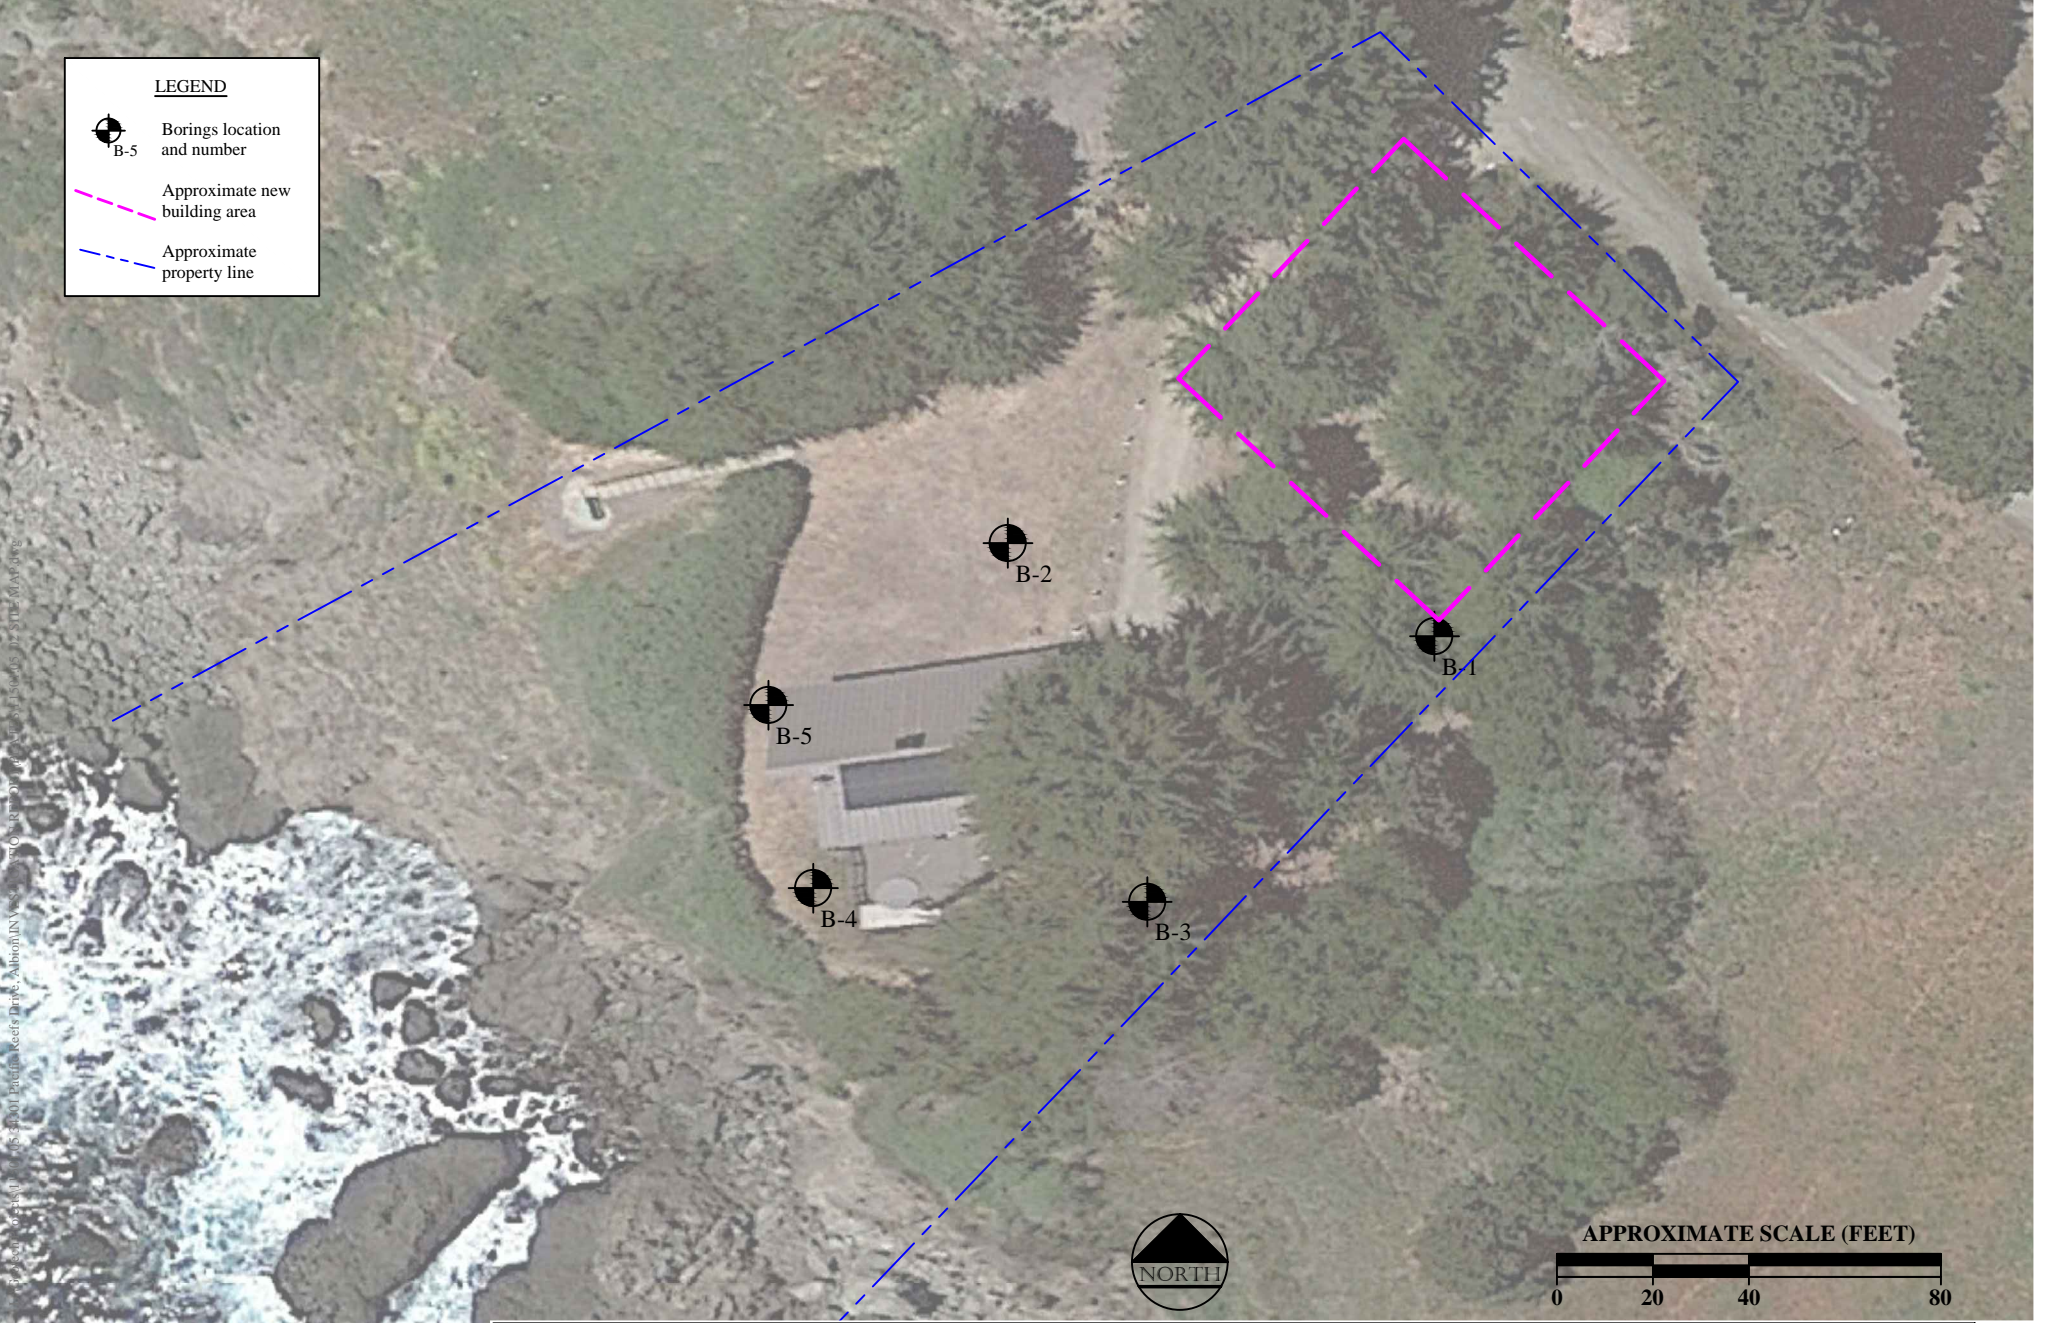
PLATE
2

The ocean bluff next to the residence collapsed in early March 2023. The bluff landslide headscarp extended to the residence foundations. Since a landslide “repair” is extremely difficult to nearly impossible to be permitted by coastal agency standards or performed economically, the house needs to be abandoned or moved back, away from the landslide, as recommended below. The intent of this investigation is to evaluate the site geologic conditions in order to determine the feasibility of moving the house away from the bluff landslide to a new, stable building site on the property. The proposed, new building site is shown on the Site Aerial Photograph, Plate 2.

Based upon our observations and analyses, we have determined a further bluff retreat potential of 44 feet over the next 75 years. Adding a safety factor of 1.5, we recommend a bluff setback of 66 feet for a “moved” or replacement residence.

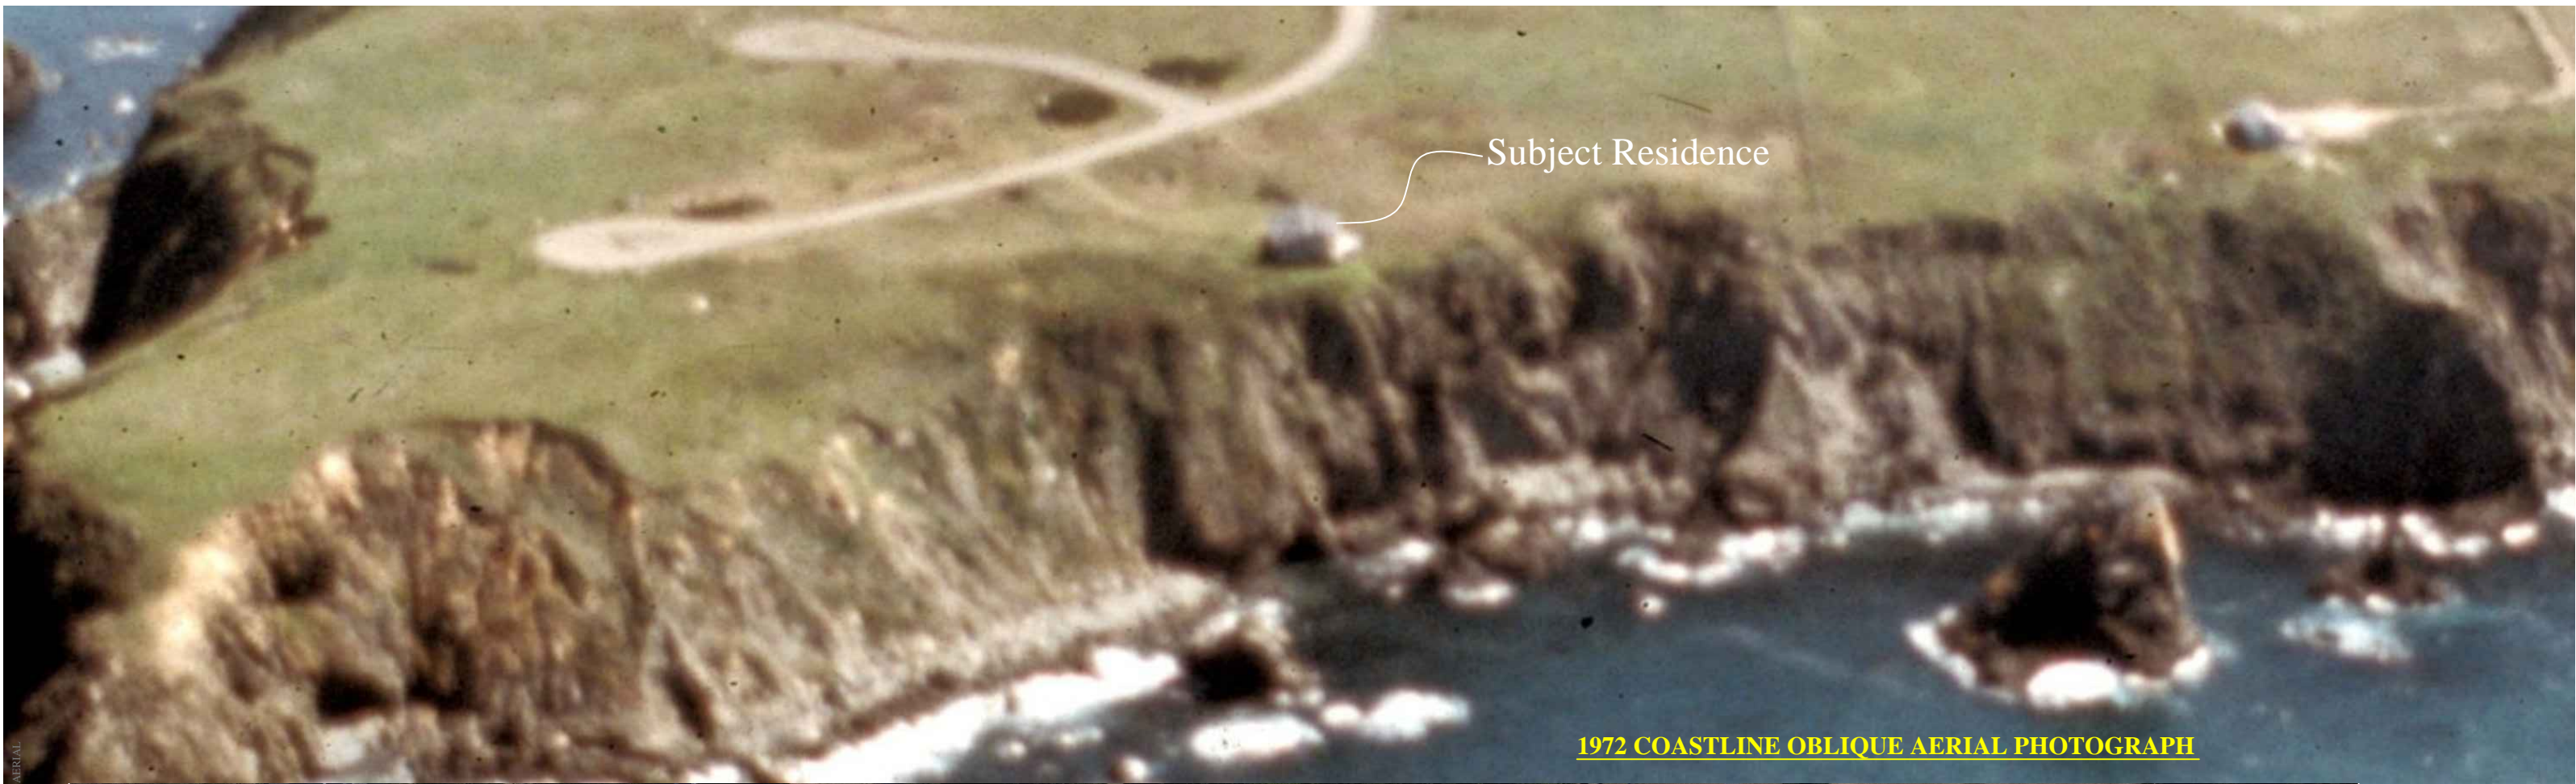
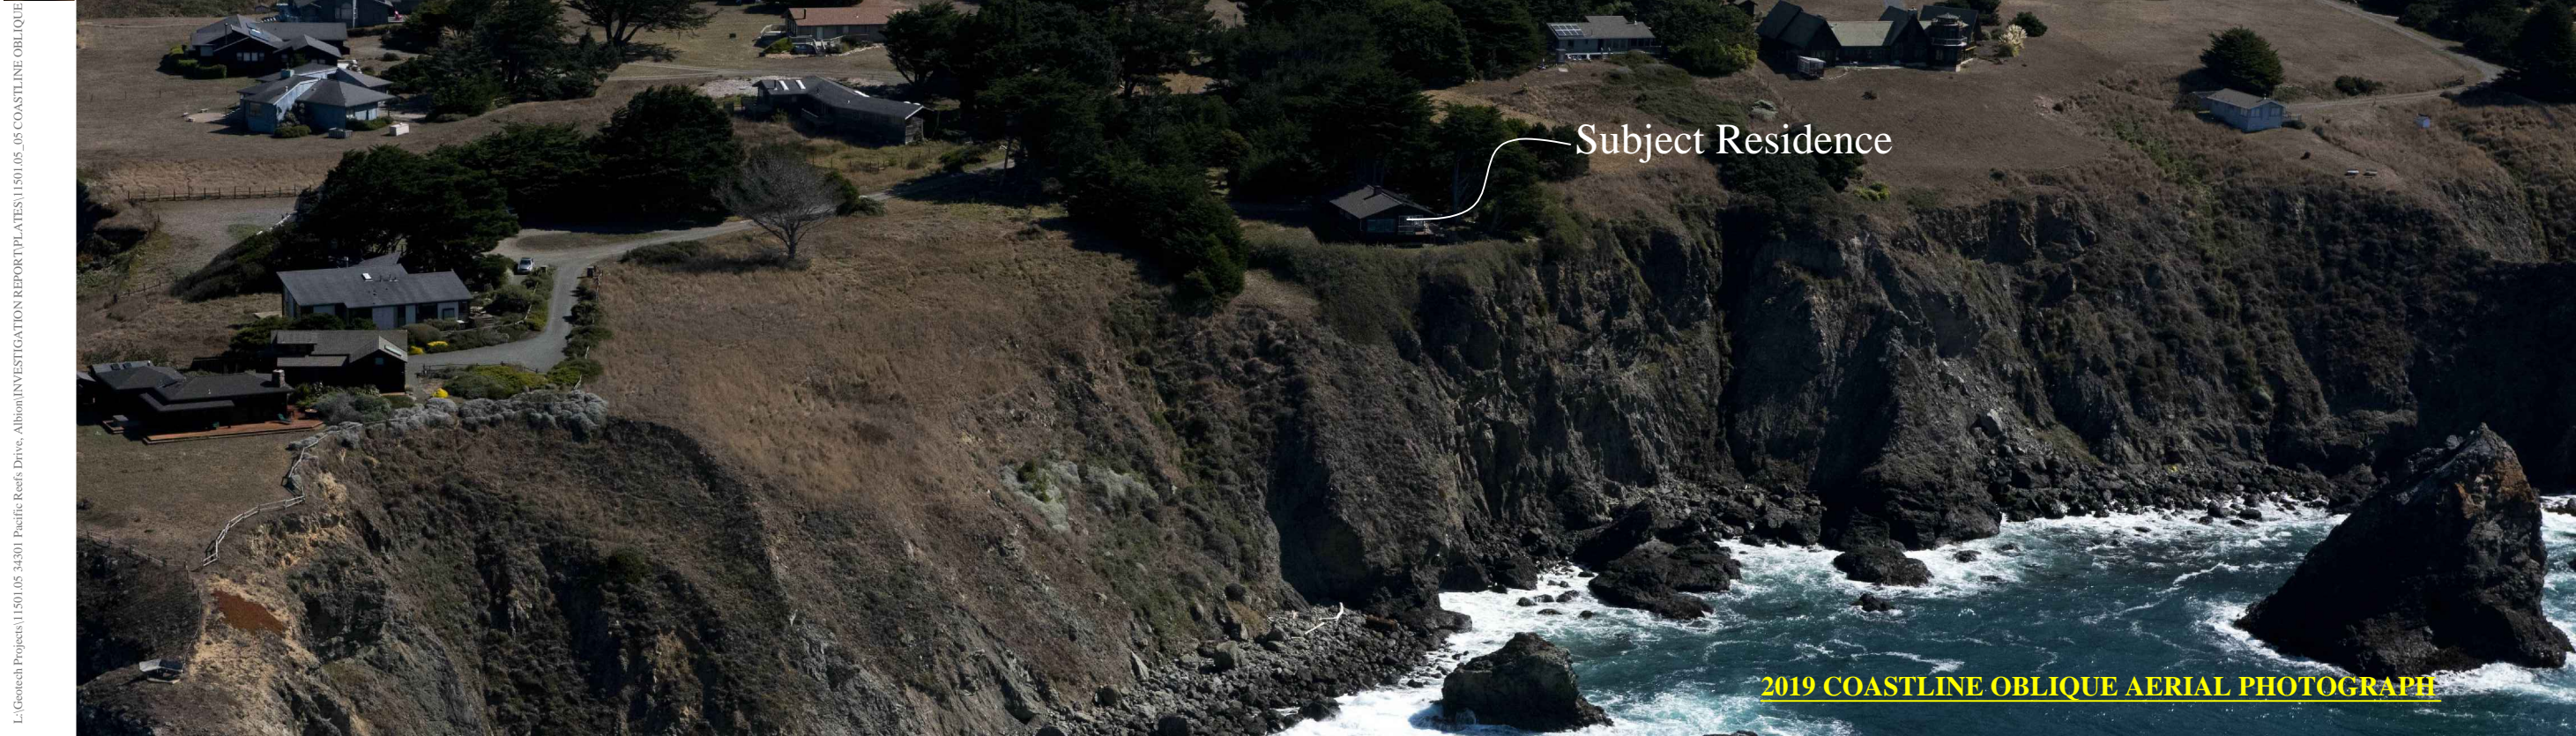
Our August 14, 2000 geotechnical investigation report determined that the bluff is eroding at an average rate of approximately two inches per year. This was accurate from the time of the house construction prior to 1972 (see Plate 5) up to early March 2023 (more than 51 years). Approximately 22 feet of the bluff, from the residence out to the bluff edge, failed in early March 2023. The landslide/bluff toe may have been weakened by the exceptionally strong storm waves in early January 2023. Those storm waves hit the Point Cabrillo Light House and at least two bluff houses in Little River. BAI observed evidence of January storm wave debris (rock fragments, ice plant, etc.) thrown up from the bluff faces onto terraces at project locations ranging from Westport to The Sea Ranch in Sonoma County. Factoring the 22 feet (rounding up to 25 feet) bluff loss over 50 years, the resulting bluff retreat rate is approximately 6 inches per year.

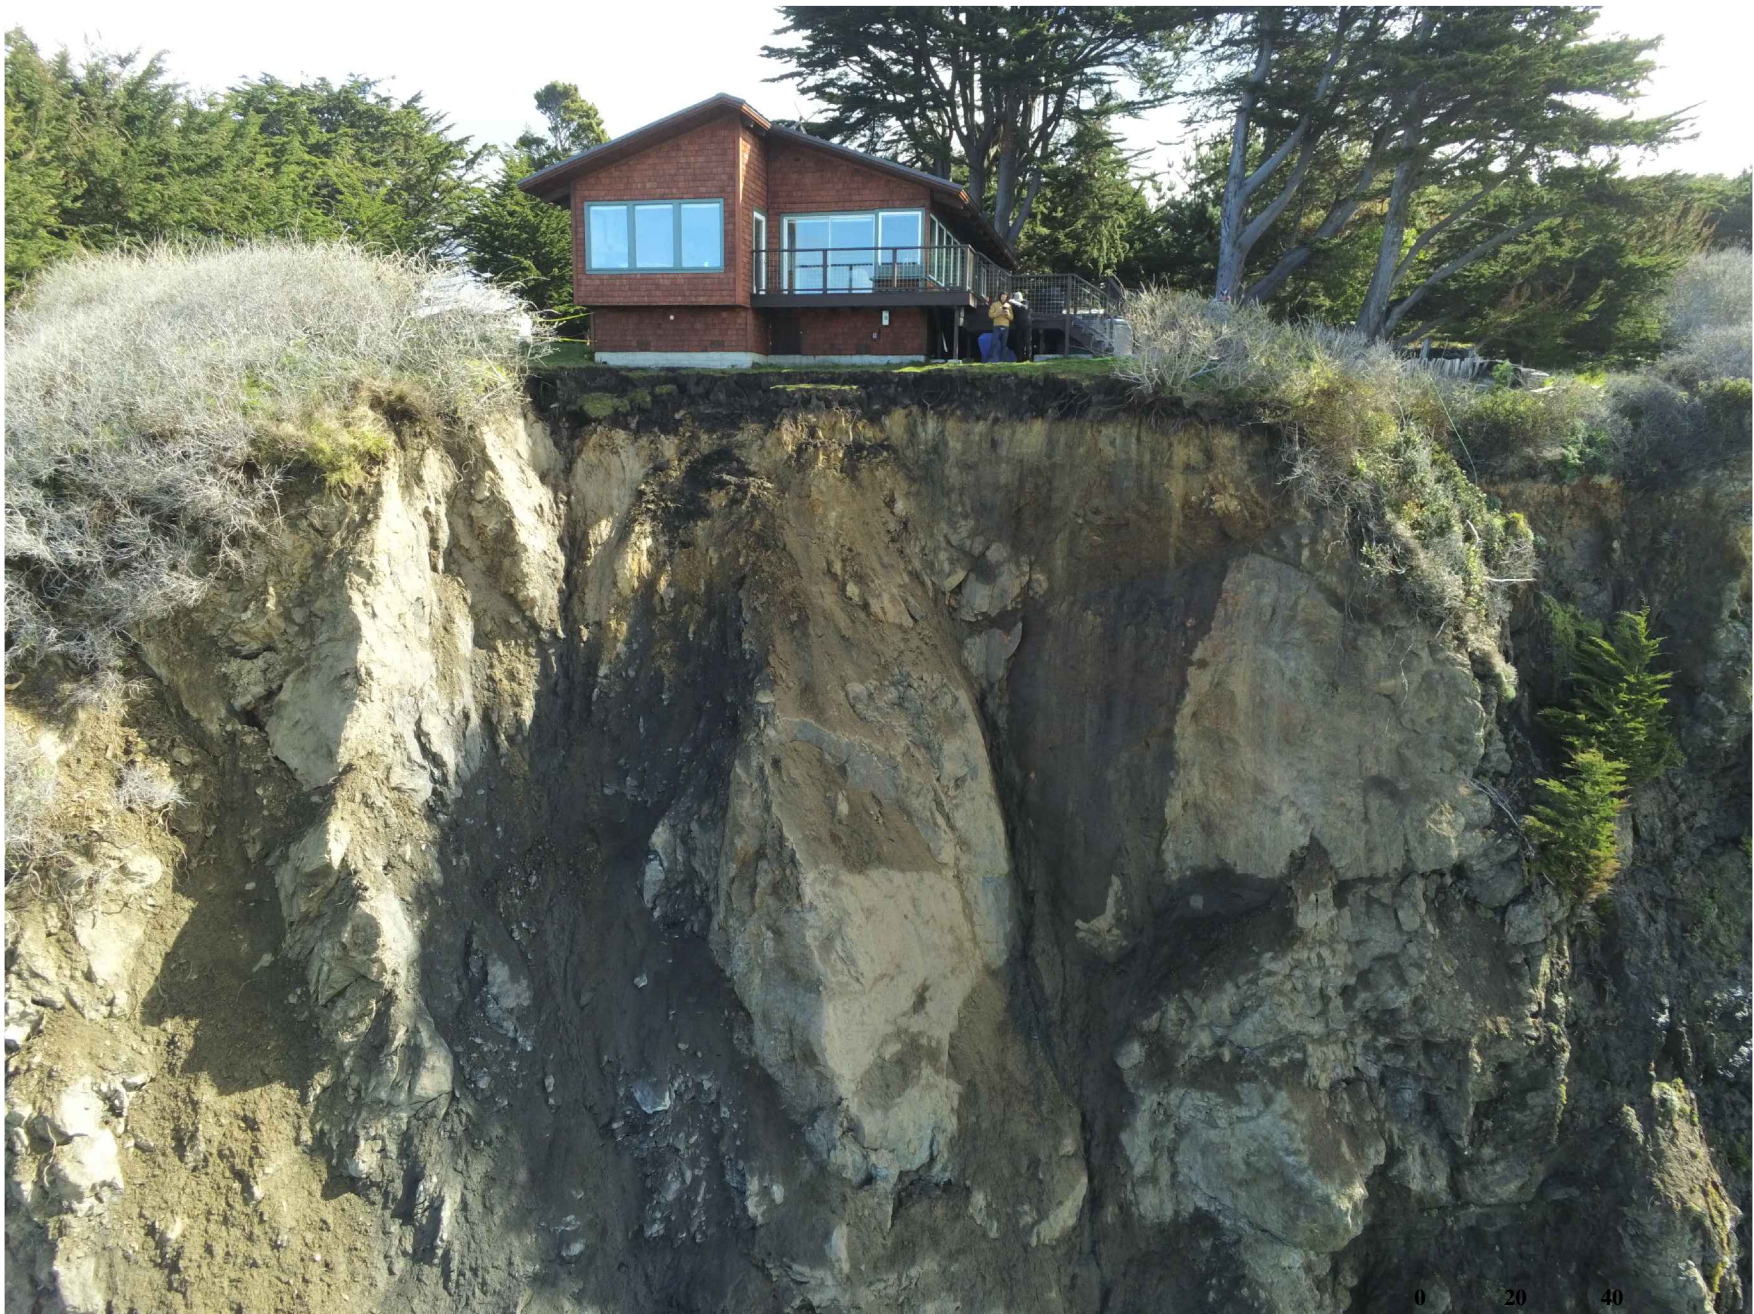
6

The property is situated near the southwest edge of a near-level, elevated, marine terrace that projects westward, forming Salmon Point. The terrace was created during the Pleistocene Epoch, when glaciation caused sea level fluctuations which created a series of steps or terraces cut into the coastal bedrock by wave erosion. The terrace is bordered by a steep ocean bluff that is approximately 100 feet high in the property vicinity, per Google Earth Pro. The bluff slope gradient varies from about one-half horizontal to one vertical (1/2H:1V) to near vertical. The existing upper bluff is shown in Drone Photograph A, Plate 6.

The bluff landslide extends from the southwest house foundation down to the bluff toe, as shown in Drone Photograph A, Plate 6. The landslide was a large rock fall that dropped catastrophically to the surf zone below. The landslide was comprised of Franciscan bedrock and terrace soils from the upper bluff.

We conclude that the house can be moved back or re-constructed onto a new foundation within a stable building site at the property. This should be done as soon as possible since further damage or loss of the house is imminent.

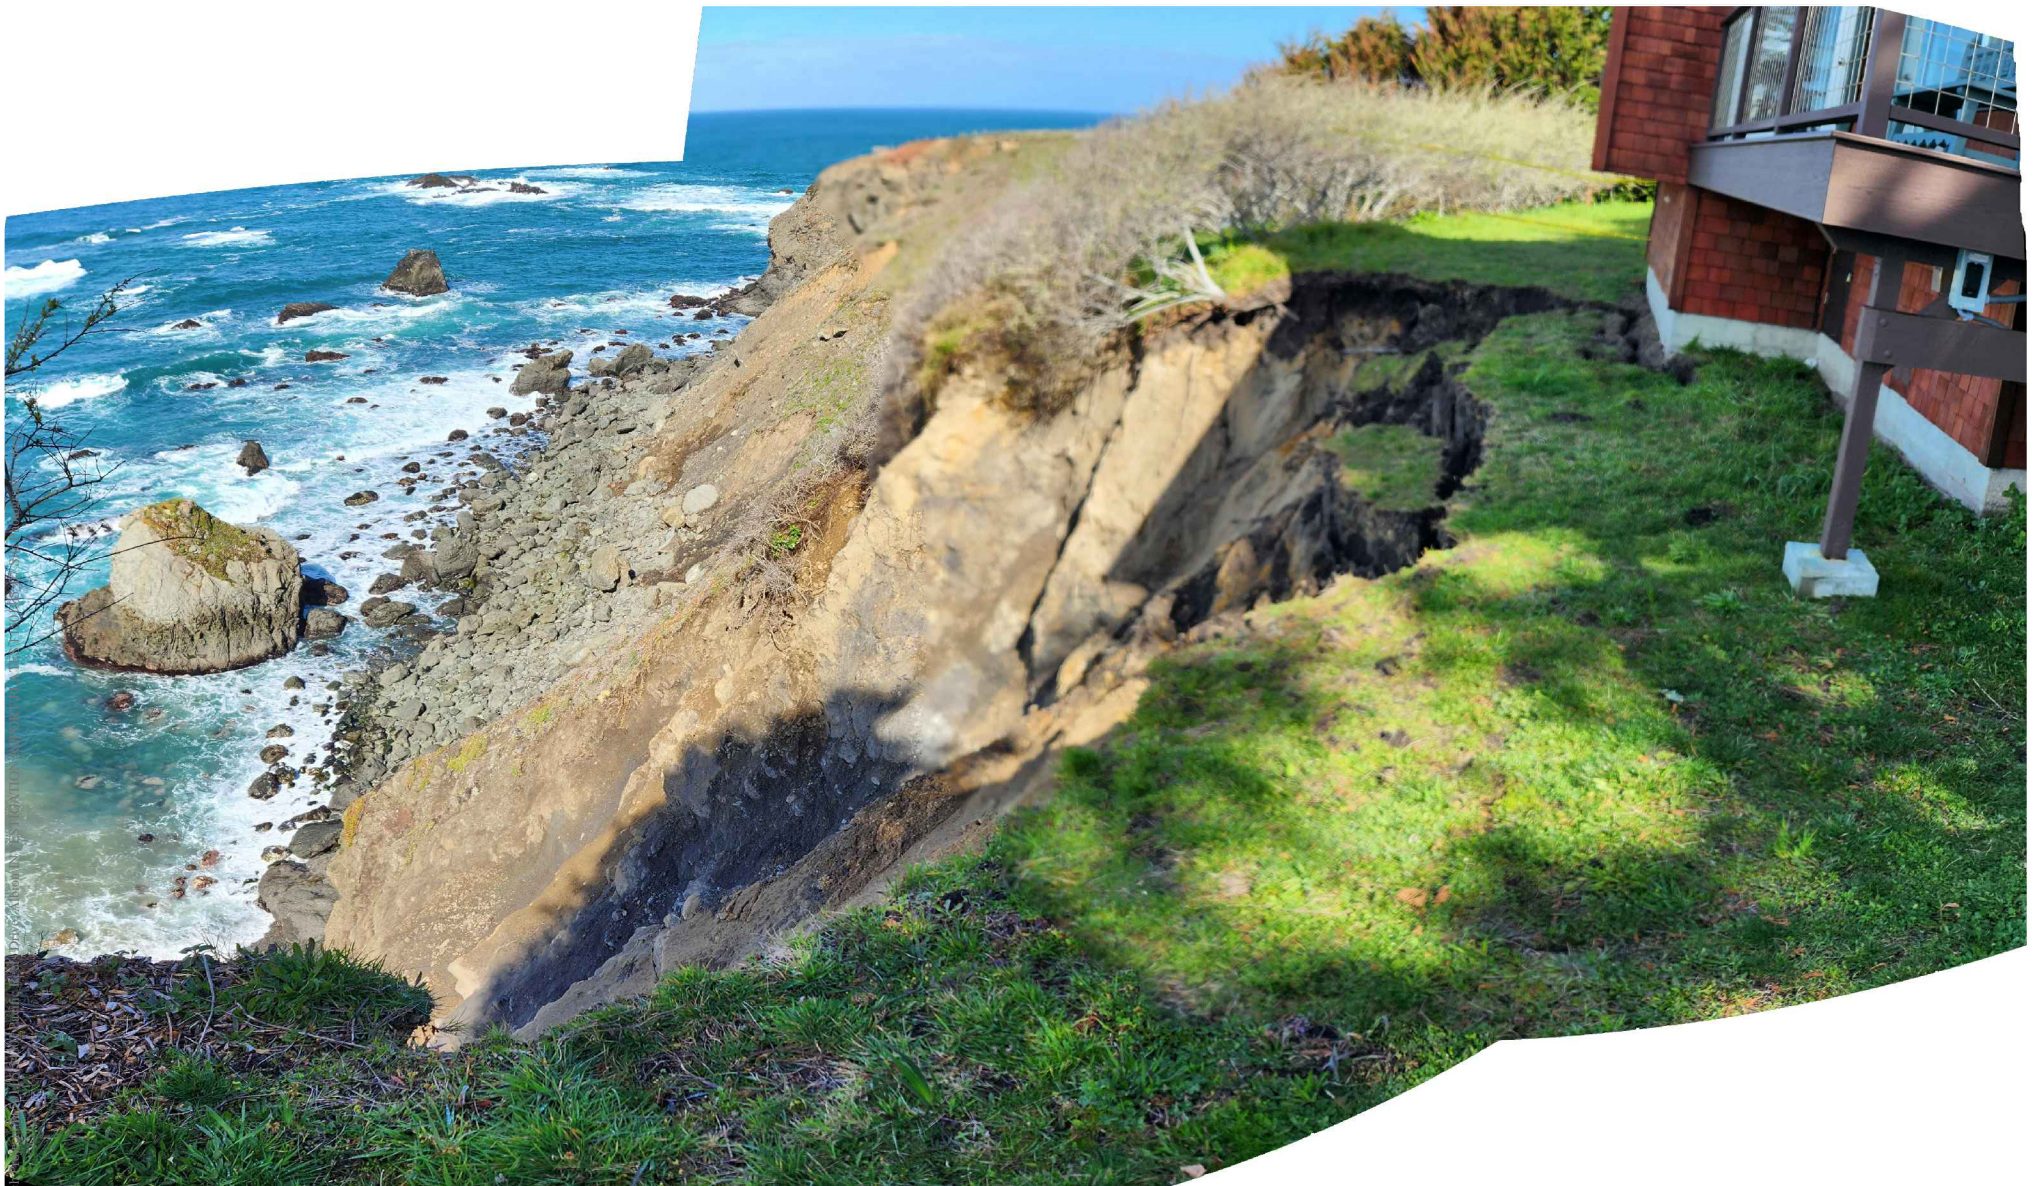
The existing residence is located at the bluff edge on the southwest end of the property. The southeast and southwest corners of the residence were approximately 22 and 20 feet from the bluff edge, respectively; as measured by Olsborg and Jim Reynolds with a 25-foot measuring tape on September 3, 2009. The bluff is currently at the landslide headscarp along the residence southwest foundation line (Site Photographs C and D, Plates 7 and 8, respectively).
