BRIDGE INSPECTION REPORT

Routine Inspection

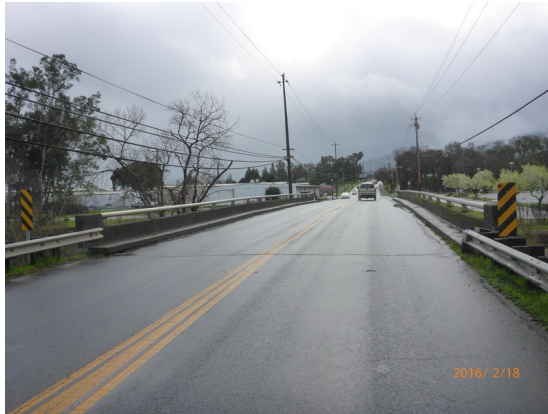
Routine-Roadway View (02/18/2016)

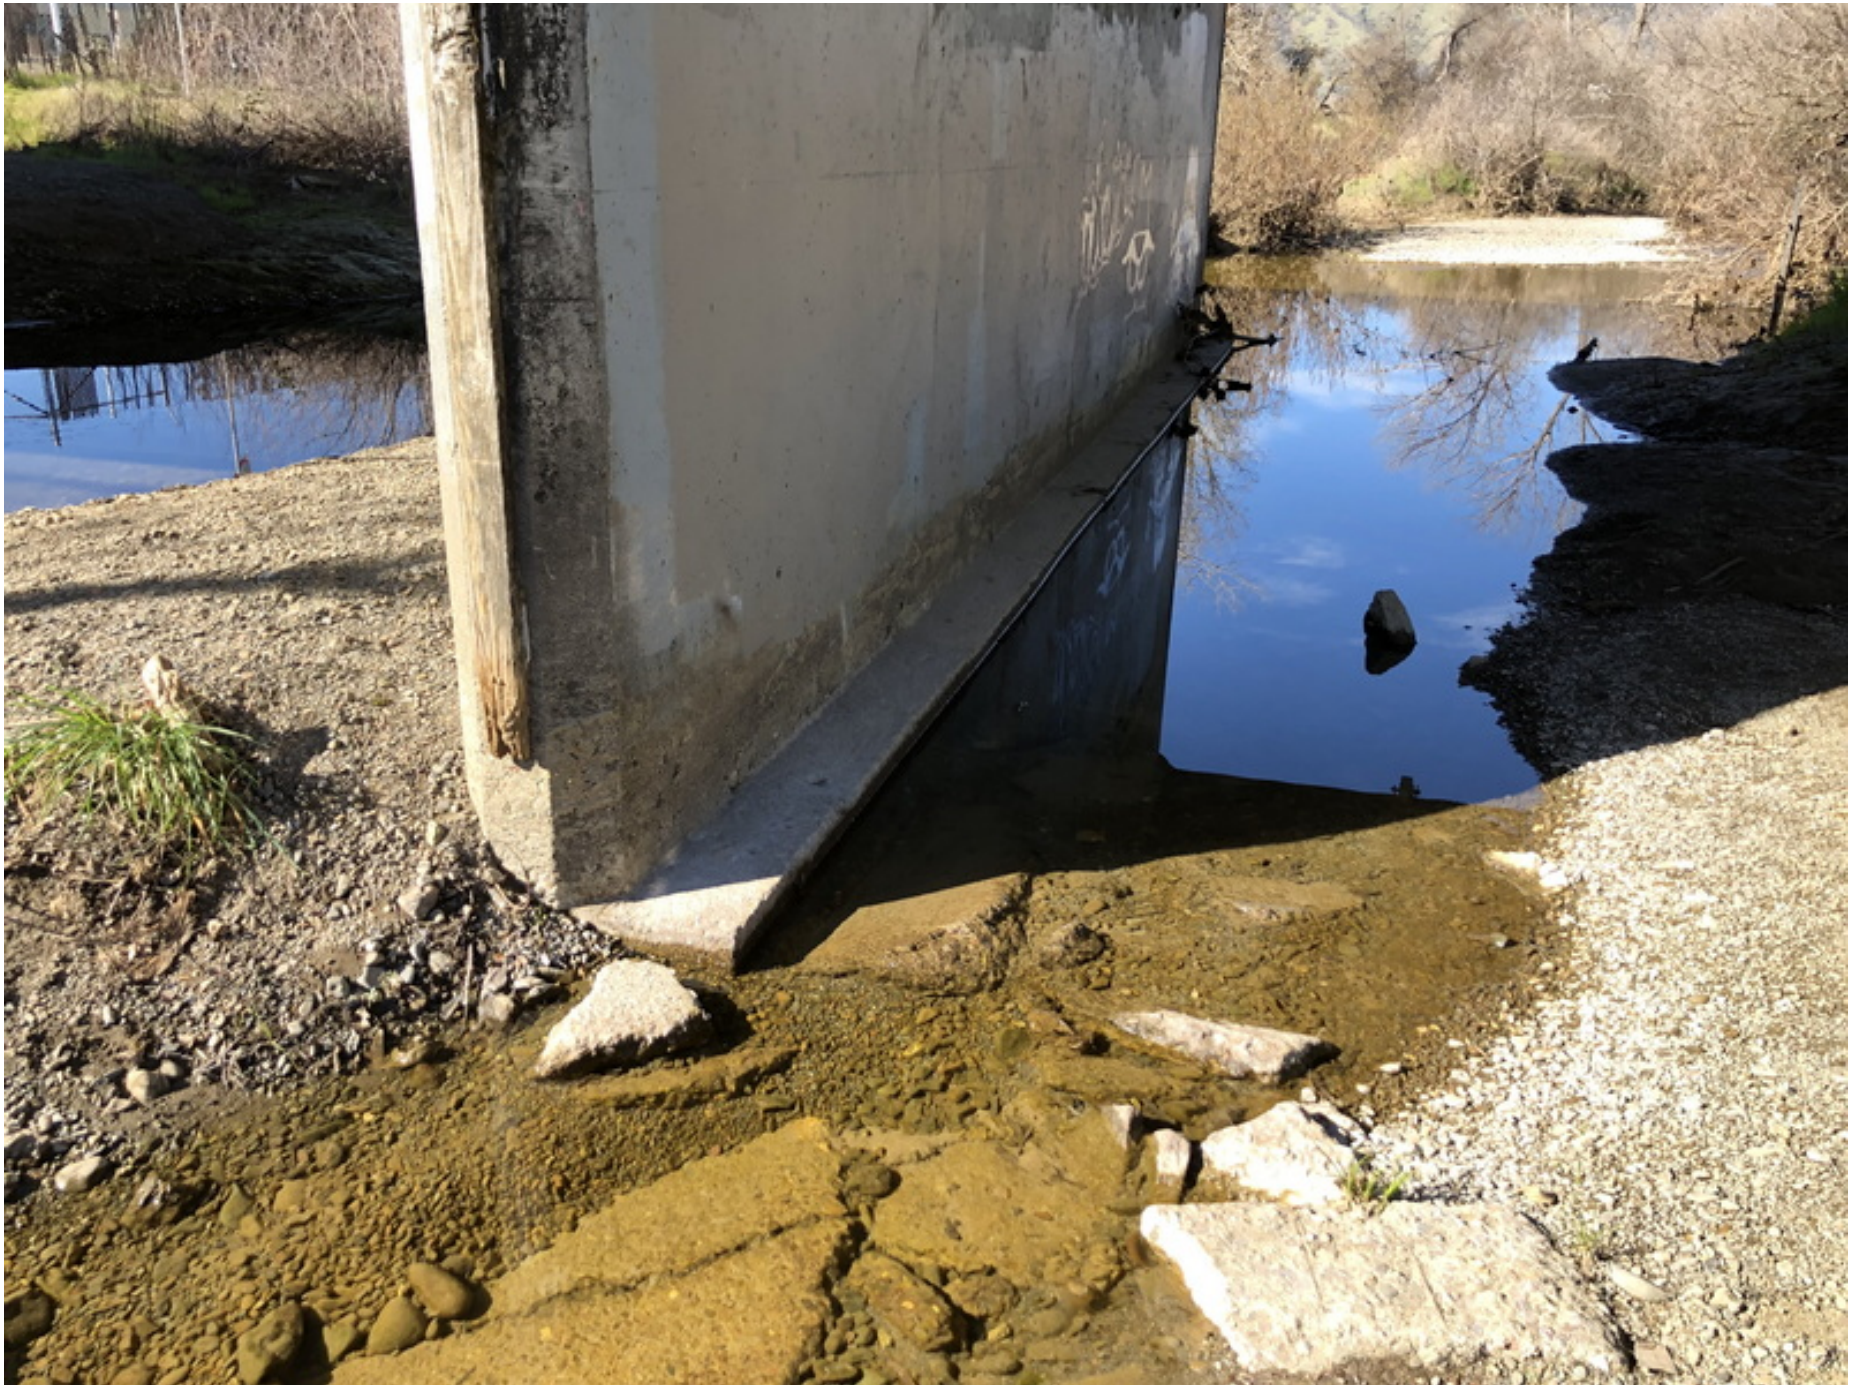
Photo #2
Showing the exposed footing from the right, downstream, end of Pier 3 (Span 3 side).

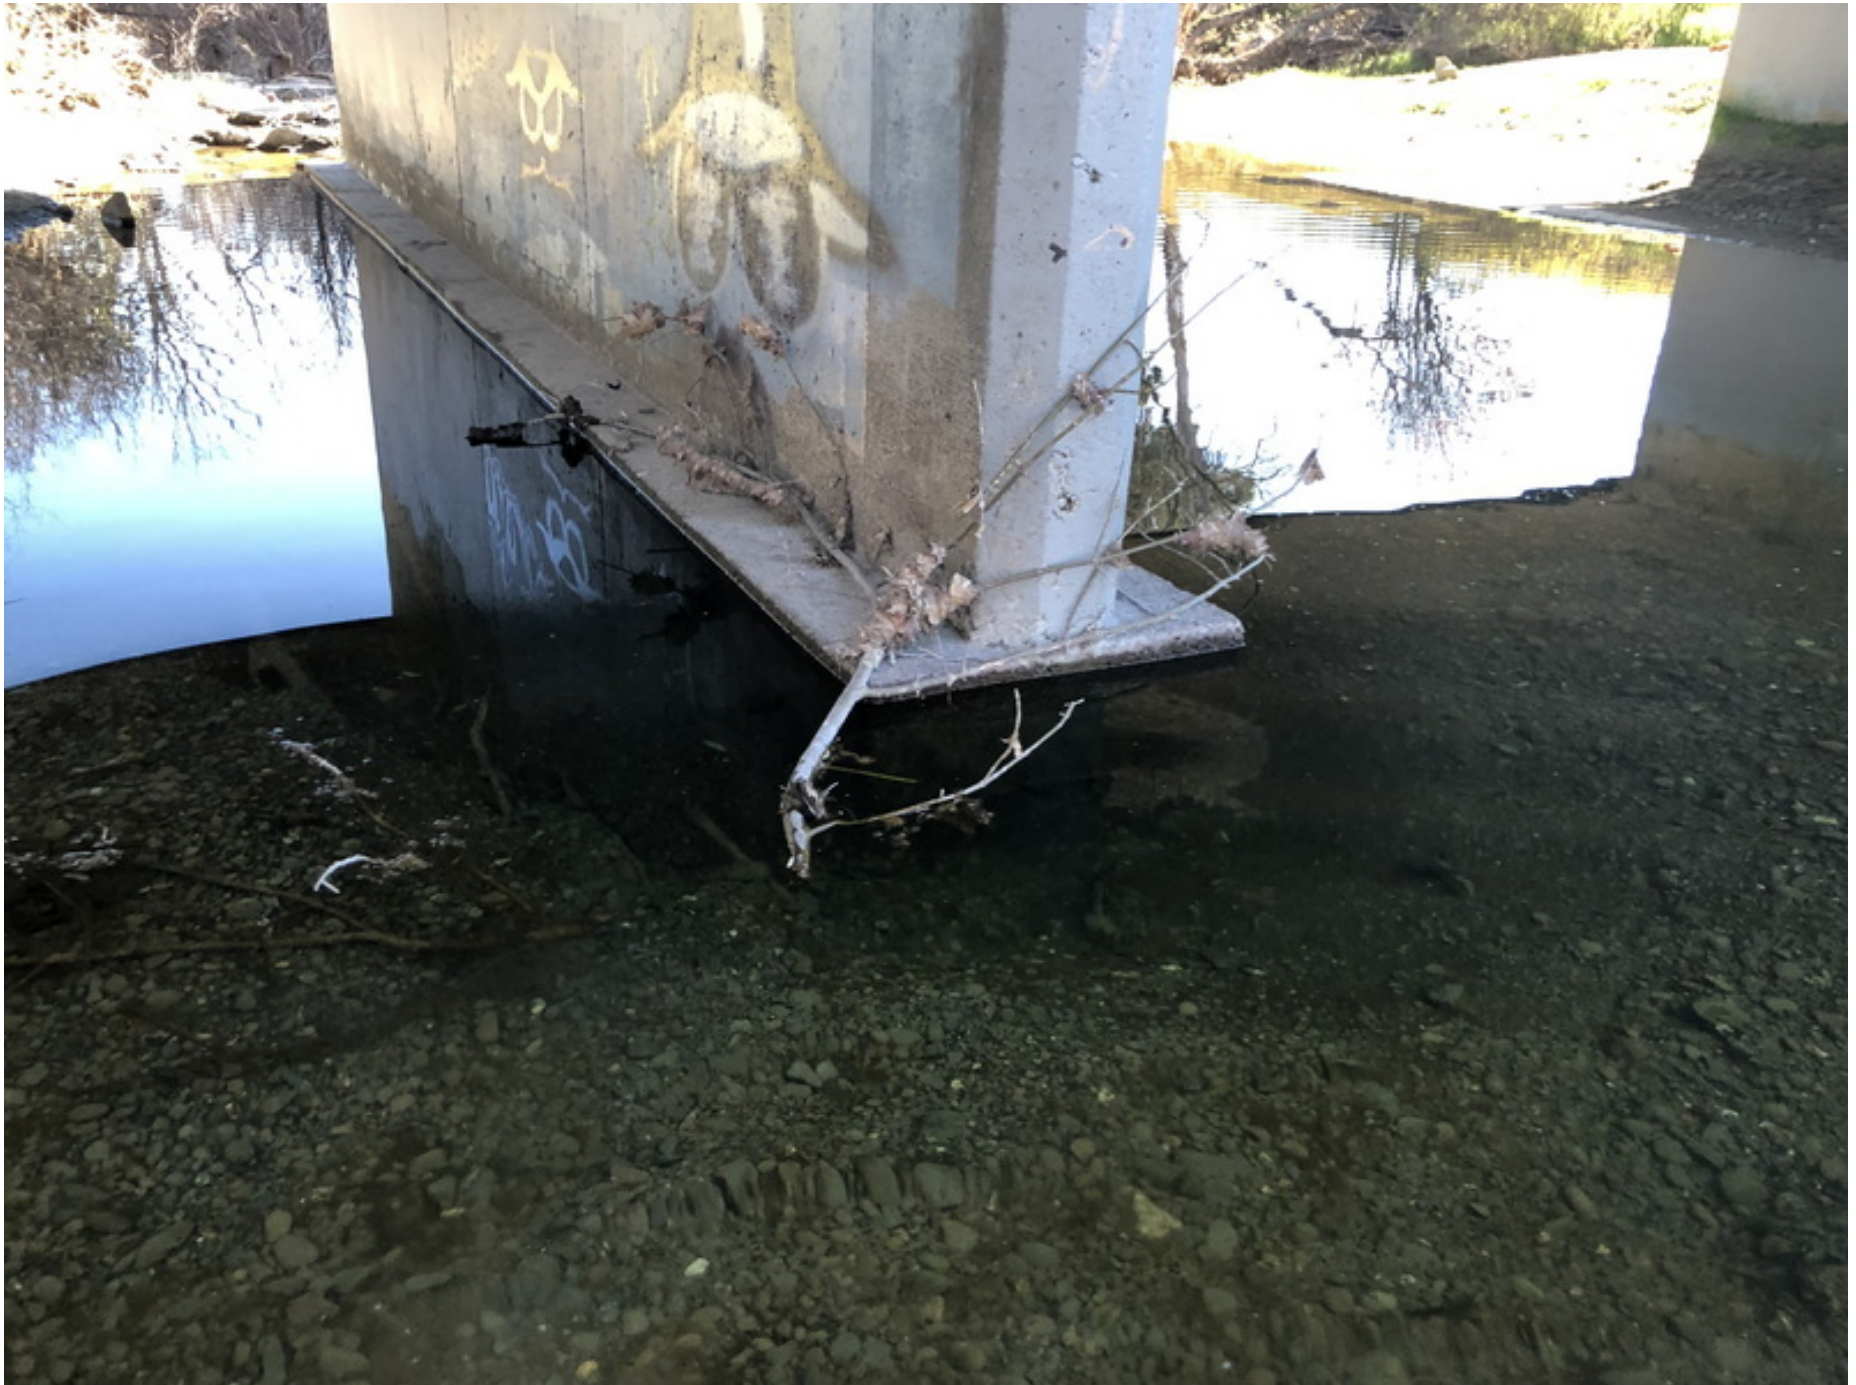
115 - Sub-Unusual Conditions
