Reference: 421068

October 6, 2021

### Subject: Caspar Point Road Culvert Improvements

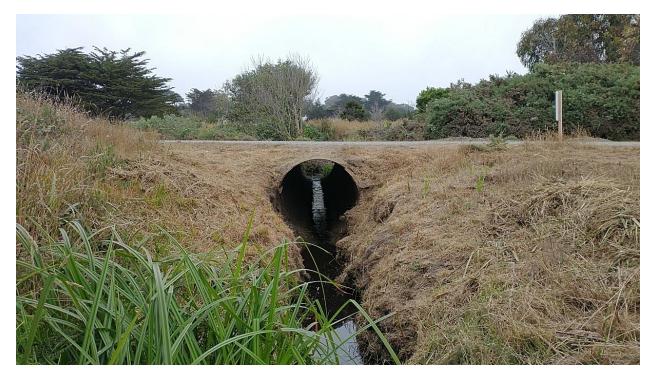
Photo 1. Downstream of culvert facing upstream

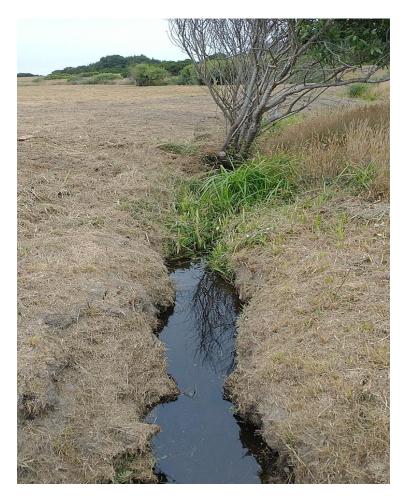
The channel downstream of the culvert outlet is also approximately two feet wide and slightly less entrenched than the upstream channel. The channel is severely constricted approximately 50 feet downstream of the culvert outlet. This condition persists for roughly another 200 to 300 feet in discrete sections before the channel widens and deepens again as it drains out to the Pacific Ocean.

Photo 2. Channel immediately downstream of culvert outlet

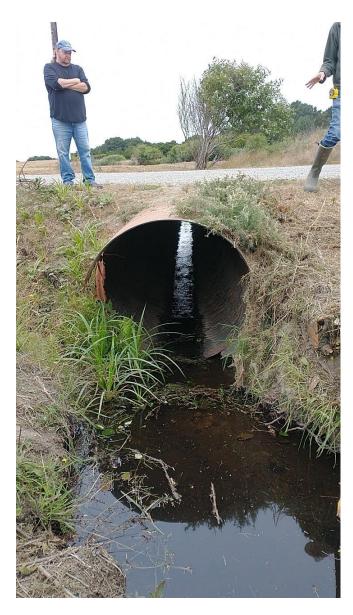
The culvert at Caspar Point Road is a corrugated metal pipe (CMP) with minimal gravel cover (approximately six inches) over the top of the pipe. The culvert is severely corroded in sections but is set on grade. The site can be characterized as a depositional environment with minimal evidence of channel-related erosion other than small amounts of incision in the channel bed and around the channel inlet and outlet. The channel makes a 78-degree turn to the north as it enters the culvert inlet. A maintained ditch to the west of inlet on the south side of Caspar Point Road starts at the inlet and continues approximately 100 feet to the west.

Photo 3. Culvert inlet facing downstream

Culvert embedment may also be necessary to create a natural channel bottom to provide for habitat for aquatic species. Special consideration should be given to the culvert material due to the coastal saltwater influence. A metal culvert is required for structural purposes, but an additional lining or coating should be specified to mitigate against the corrosive saltwater environment.

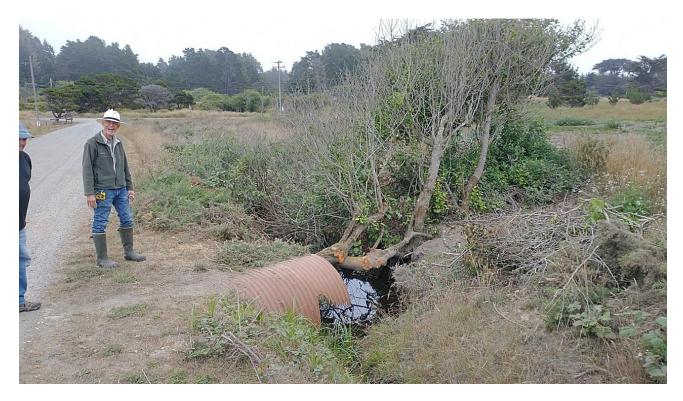
Photo 4. Culvert inlet standing on the west side

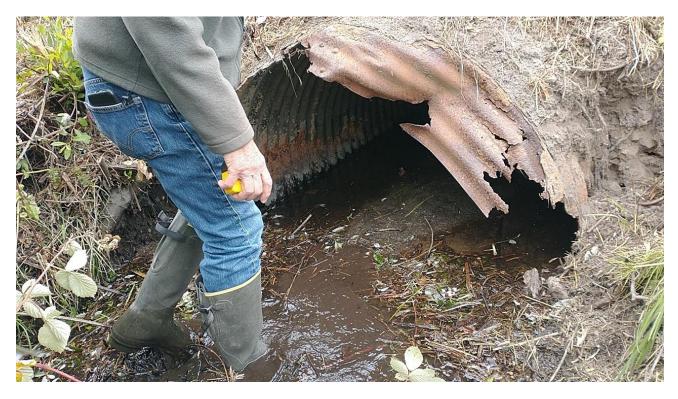
Photo 5. Caspar Road culvert outlet facing upstream

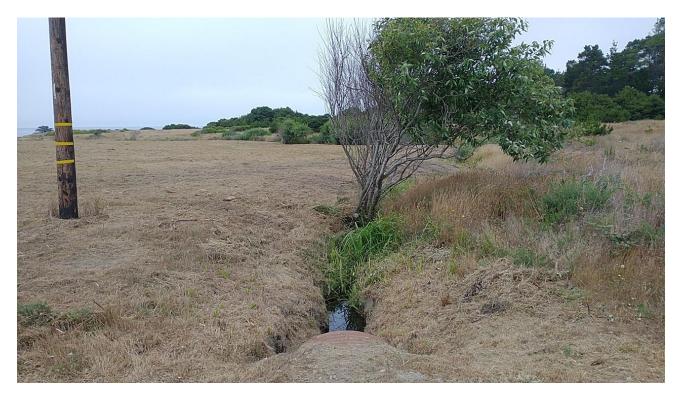
Photo 6. Downstream channel below culvert outlet

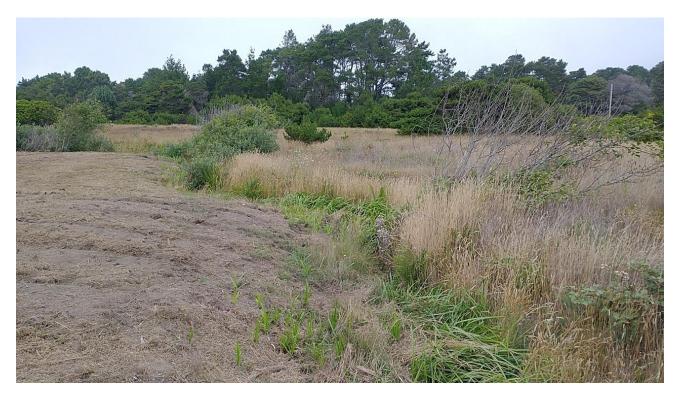
Photo 7. Downstream channel approximately 50 feet below outlet

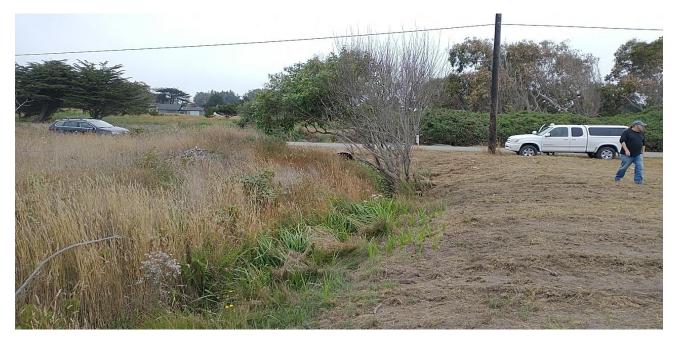
Photo 8. Downstream channel facing upstream
