1220 Concord Avenue, Suite 450
Concord, CA 94520
P (510) 547-7771
Terracon.com

Re: Limited Asbestos and Lead Survey Report
890 N Bush Street – Front Porch
Ukiah, CA
Terracon Project No. R1247191

**SITE PHOTOGRAPHS:
MARCH- 11, 2024
County of Mendocino-890 N.
Bush St.**

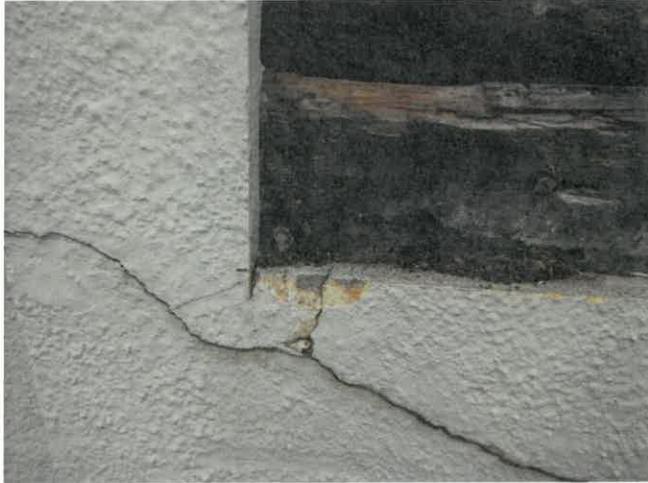
PHOTO 1. Column with Black Paper.

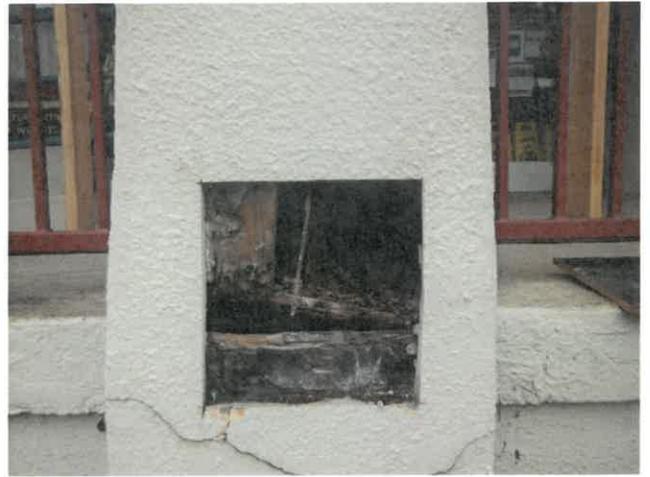
PHOTO 2. Inside Column

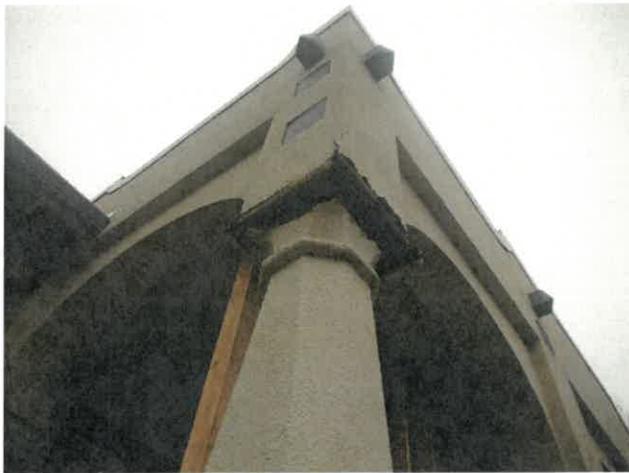
PHOTO 3. Upper Column

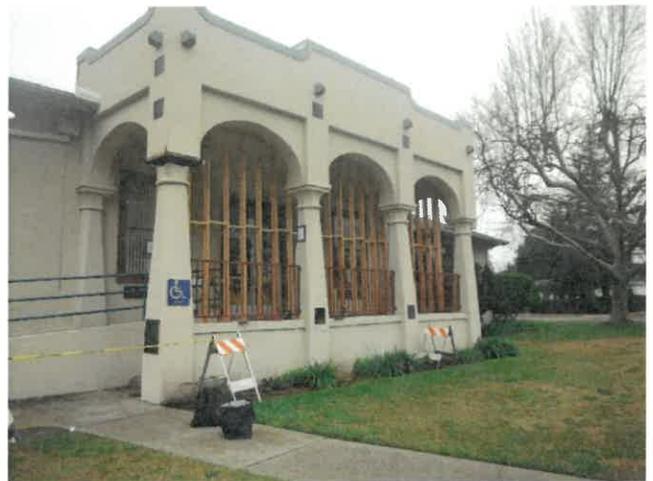
Sample #	Material Description	Sample Location	Lead Content (mg/kg, ppm)	Condition
PB-1	Beige paint on concrete wall	Exterior front porch	1,300 ppm	Fair

PHOTO 4- Front Porch-East Front to be demo

- Asbestos was not detected in the three (3) suspect ACMs sampled.
- Lead was detected in the beige paint on the exterior walls and columns.
 - Disturbance of materials containing detectable concentrations of lead must be conducted in accordance with Cal/OSHA's lead in construction regulation (8 CCR 1532.1), CDPH's regulation 17 CCR 35001), and the EPA's 2008 Lead-Based Paint Renovation, Repair and Painting (RRP) Rule (40 CFR 745 Subpart E).
