ENGINEERING GEOLOGIC RECONNAISSANCE

Sea Cave Exploration, Mapping and Evaluation

**POINT ARENA LIGHTHOUSE
45500 LIGHTHOUSE ROAD
POINT ARENA, MENDOCINO COUNTY, CALIFORNIA**

Project No. 11995.02

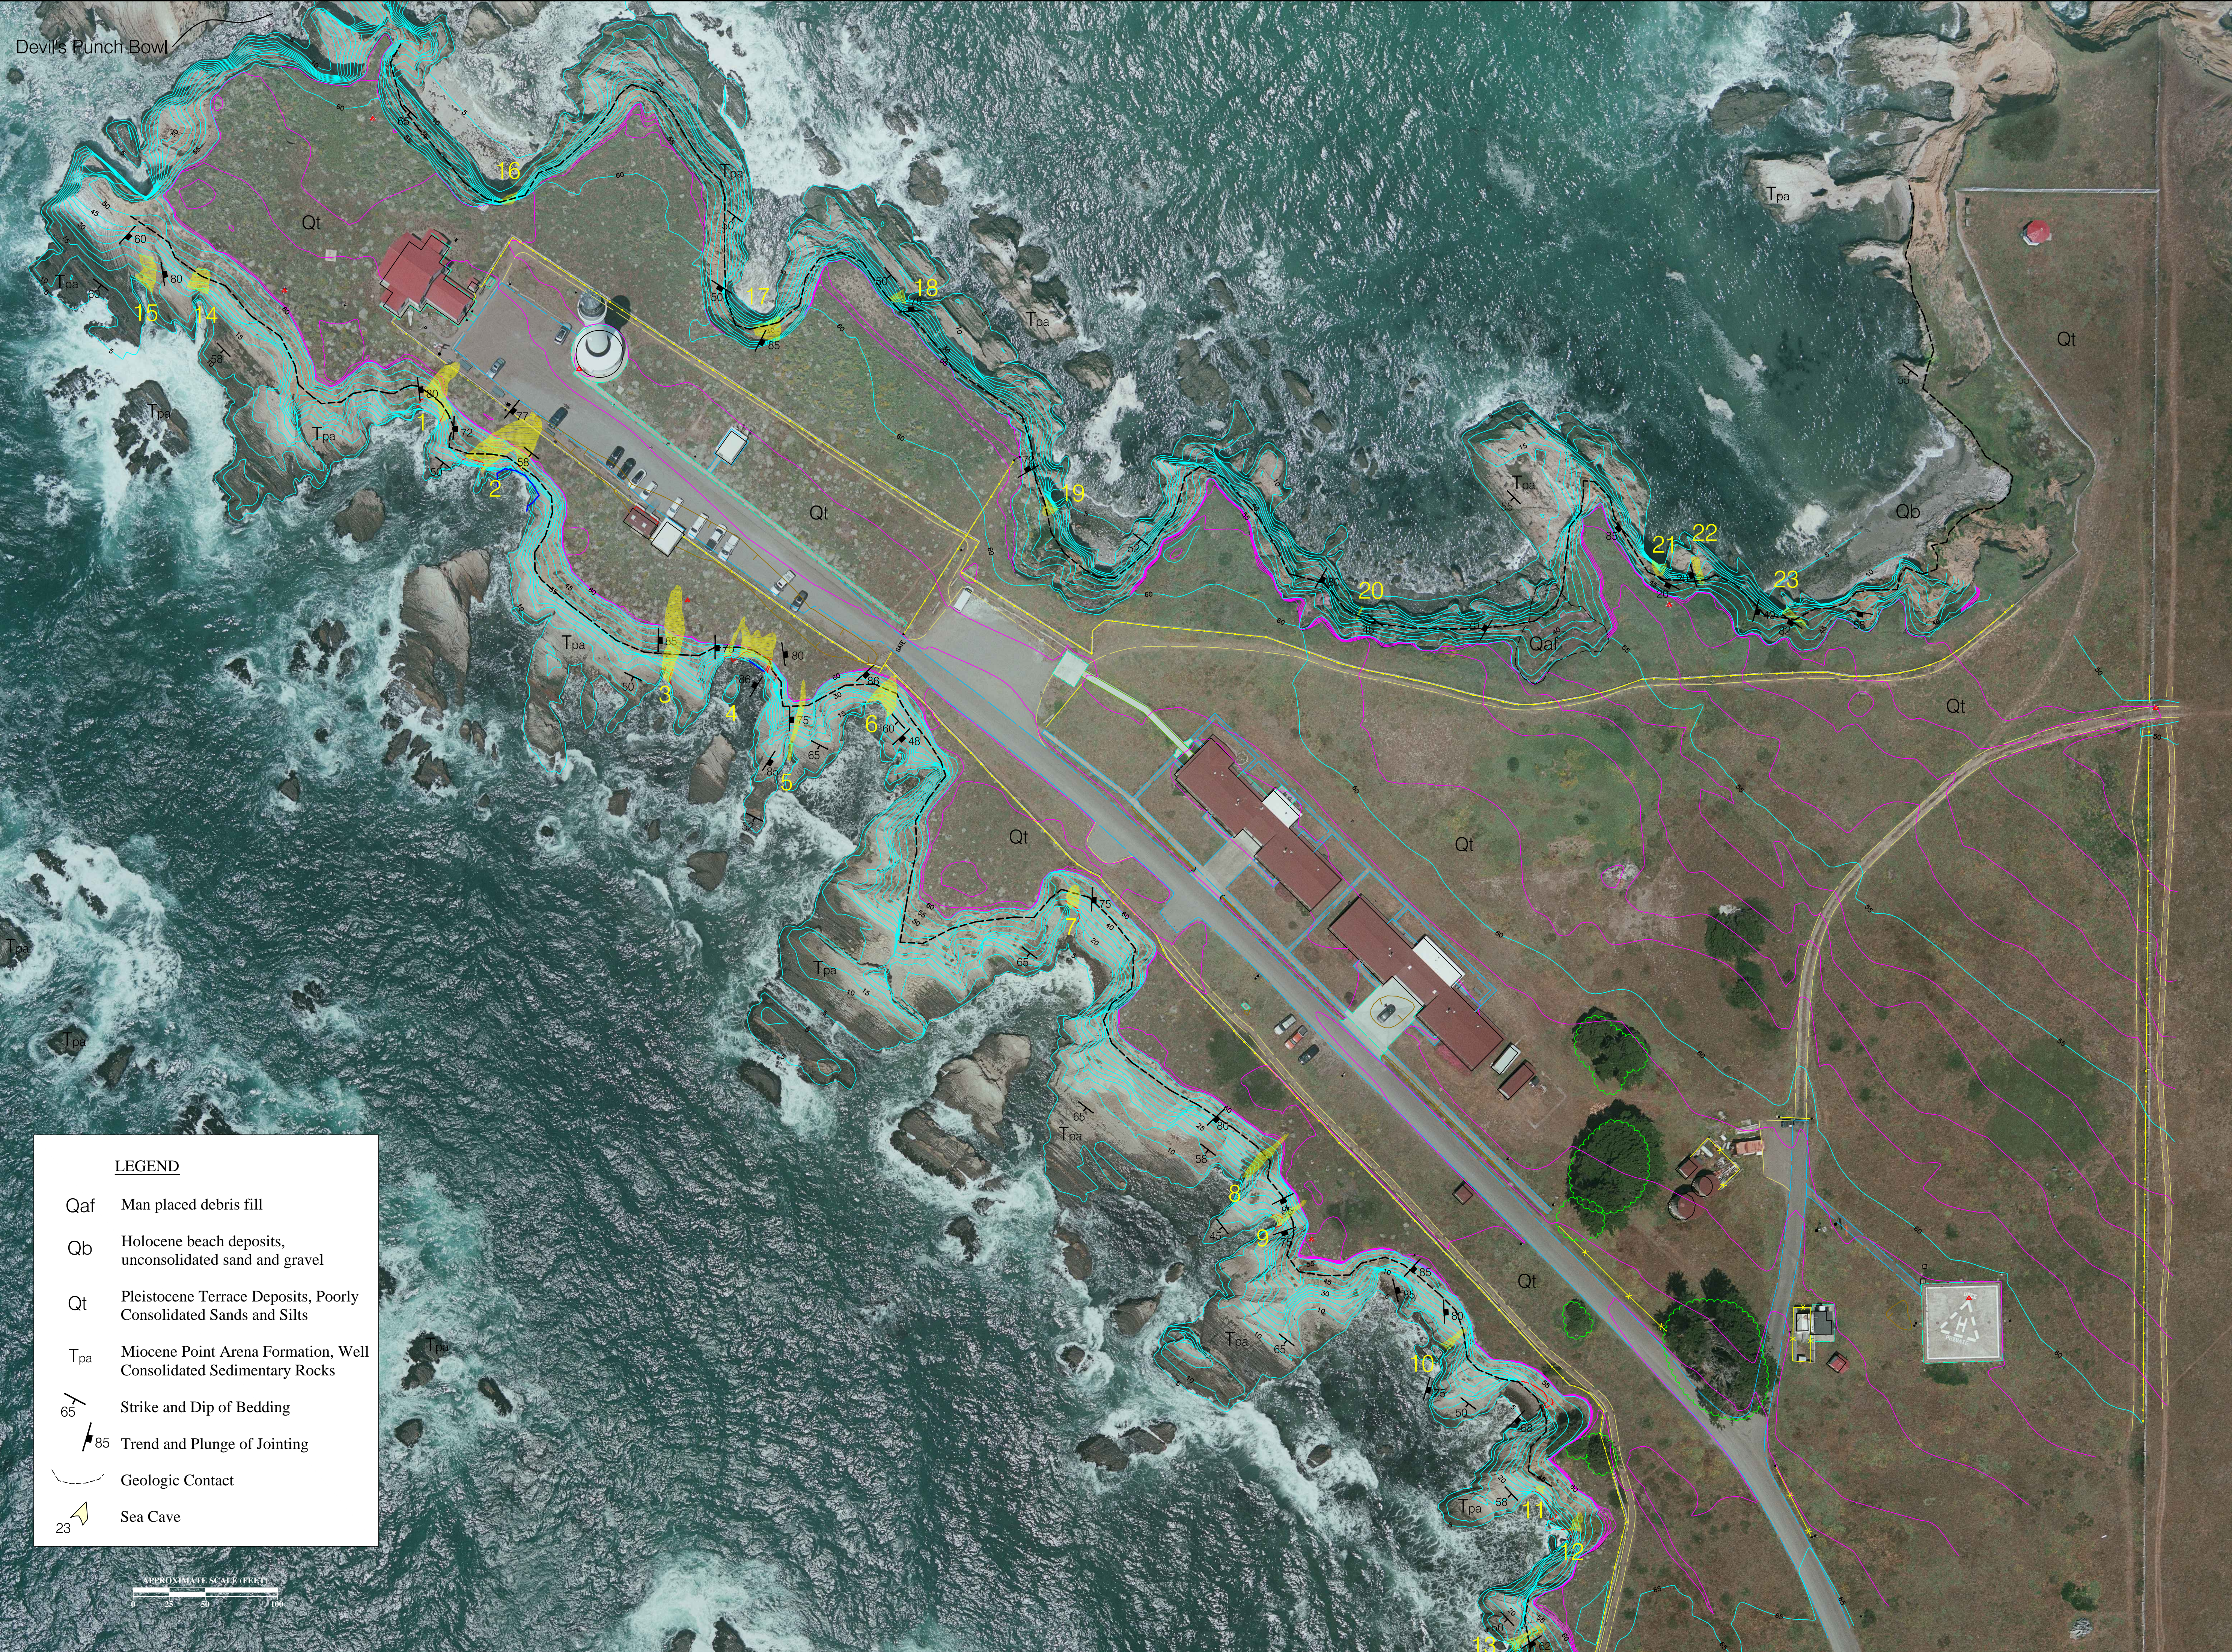
SITE GEOLOGIC MAP
POINT ARENA LIGHTHOUSE
 45500 Lighthouse Road
 Point Arena, California

The peninsula in the developed areas is penetrated by 23 sea caves of measurable dimensions. Some of the caves are shown on the Sea Cave Photographs on Plate(s) 5. The sea cave outlines are shown on Plate 6. The caves are as much as 70 feet in length (depth) and are typically about 15 feet wide by 15 feet in height (floor to cave roof). Cave Number 2, the closest to the lighthouse (40 feet), is shown in cross section and profile on Plate 7.

The Point Arena peninsula is comprised of Miocene Epoch sedimentary rocks consisting of sandstone, siltstone, and sandy mudstone of the Point Arena Formation (Site Geologic Map, Plate 6). The Site Geologic Map shows the geologic features at the site, including the outline of the sea caves. The area rocks were previously assigned to the Miocene Monterey Group; however, geologic researchers have determined that the Point Arena Formation rocks were deposited in a separate depositional basin (Loomis & Ingle, 1988). Therefore, the Point Arena Formation is a separate rock group.
