RE: CDP\_2018-0011  
Owner: Williamstown Friendly Village  
Applicant: Brian Temple  
Site: 9350 North Highway 1  
Mendocino, CA 95460  
APN: 119-340-18

September 30, 2019

RE: Temple Residence Stabilization / Bishop Pines  
CDP\_2018-0011  
9350 North Highway 1  
Mendocino, CA, 95460  
APN 119-340-18-00

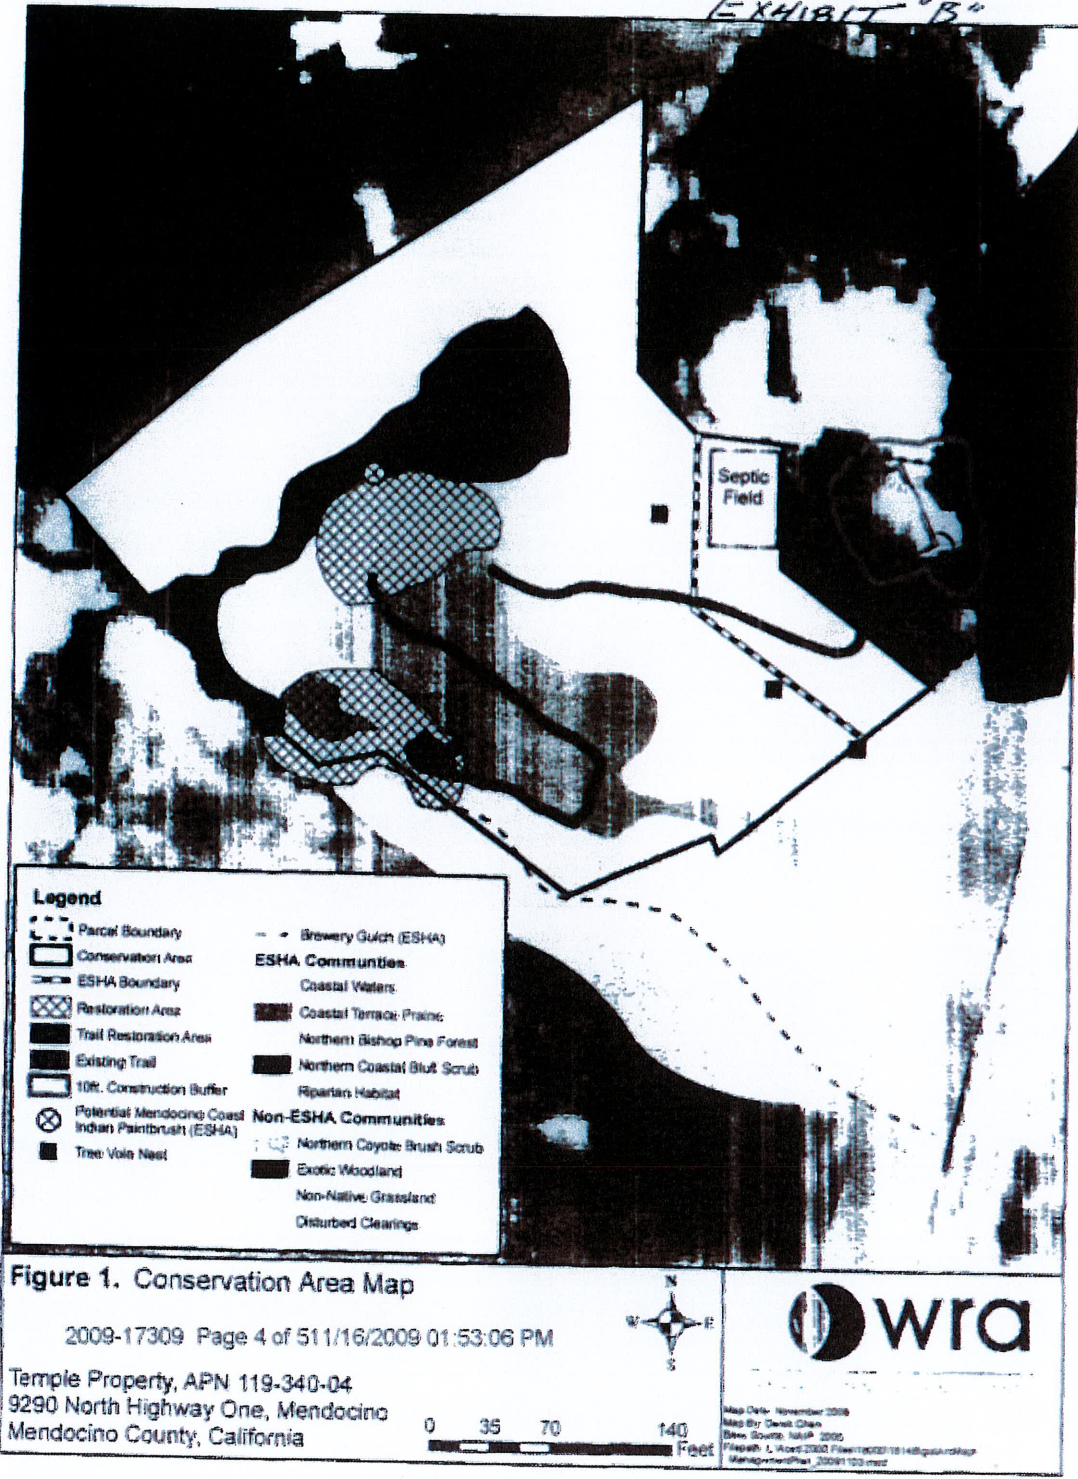
Figure 2. Conservation Area Map, as illustrated in Exhibit B in Restrictive Covenants, Document #2009-07309, Mendocino County Official Records, recorded November 16, 2009.

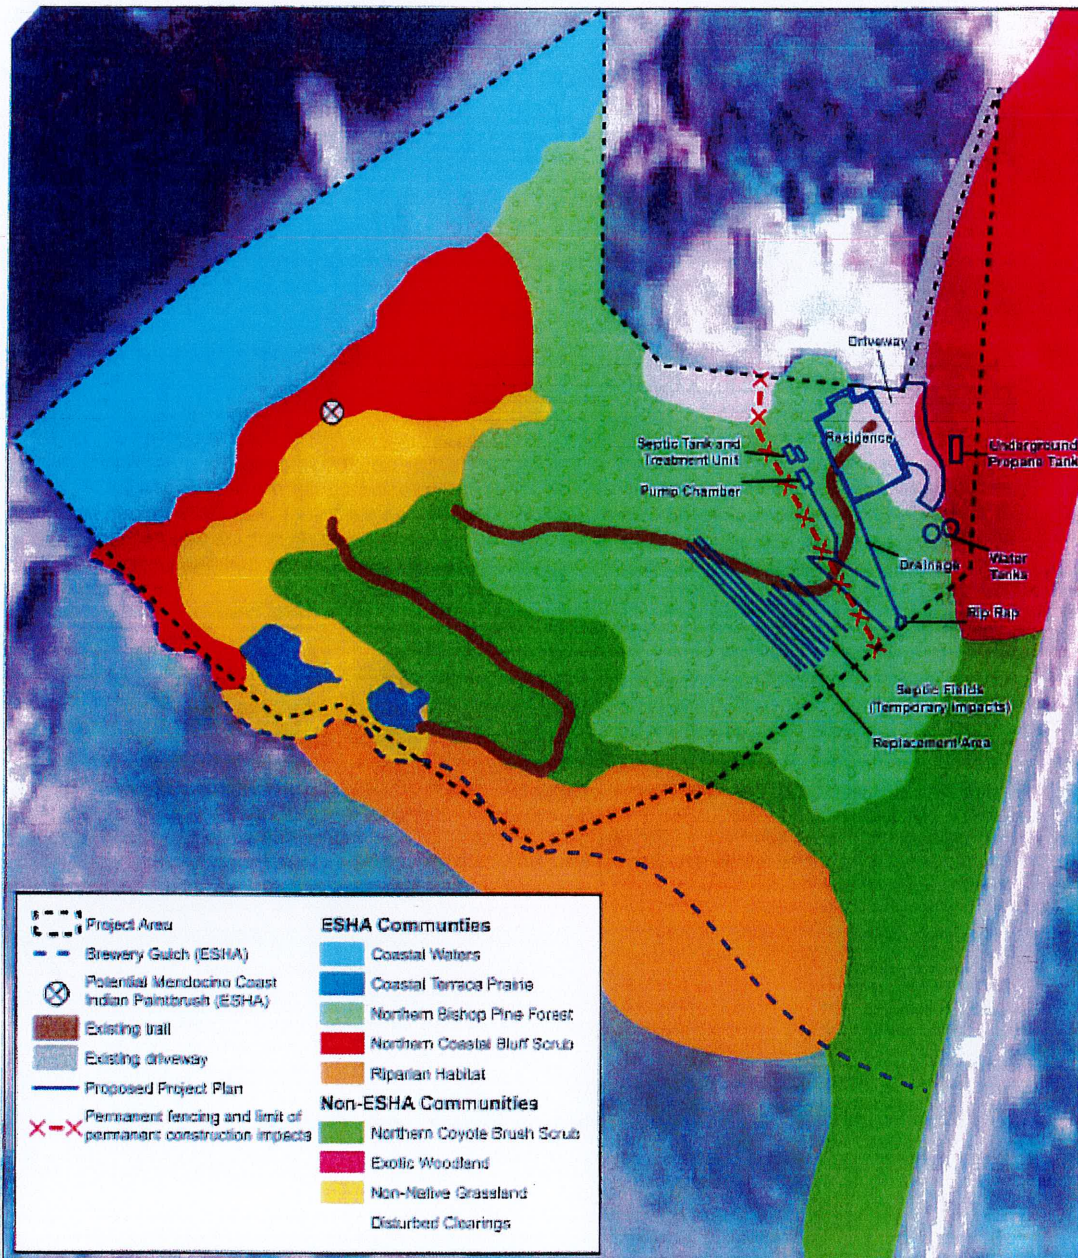
Figure 2. Proposed Project ESHA Map

Figure 1. WRA's Figure 2 from their Bio Compliance Report, dated 2008.12 (fig dated 11.2008) [illustrates the ESHAs prior to development of the residence]

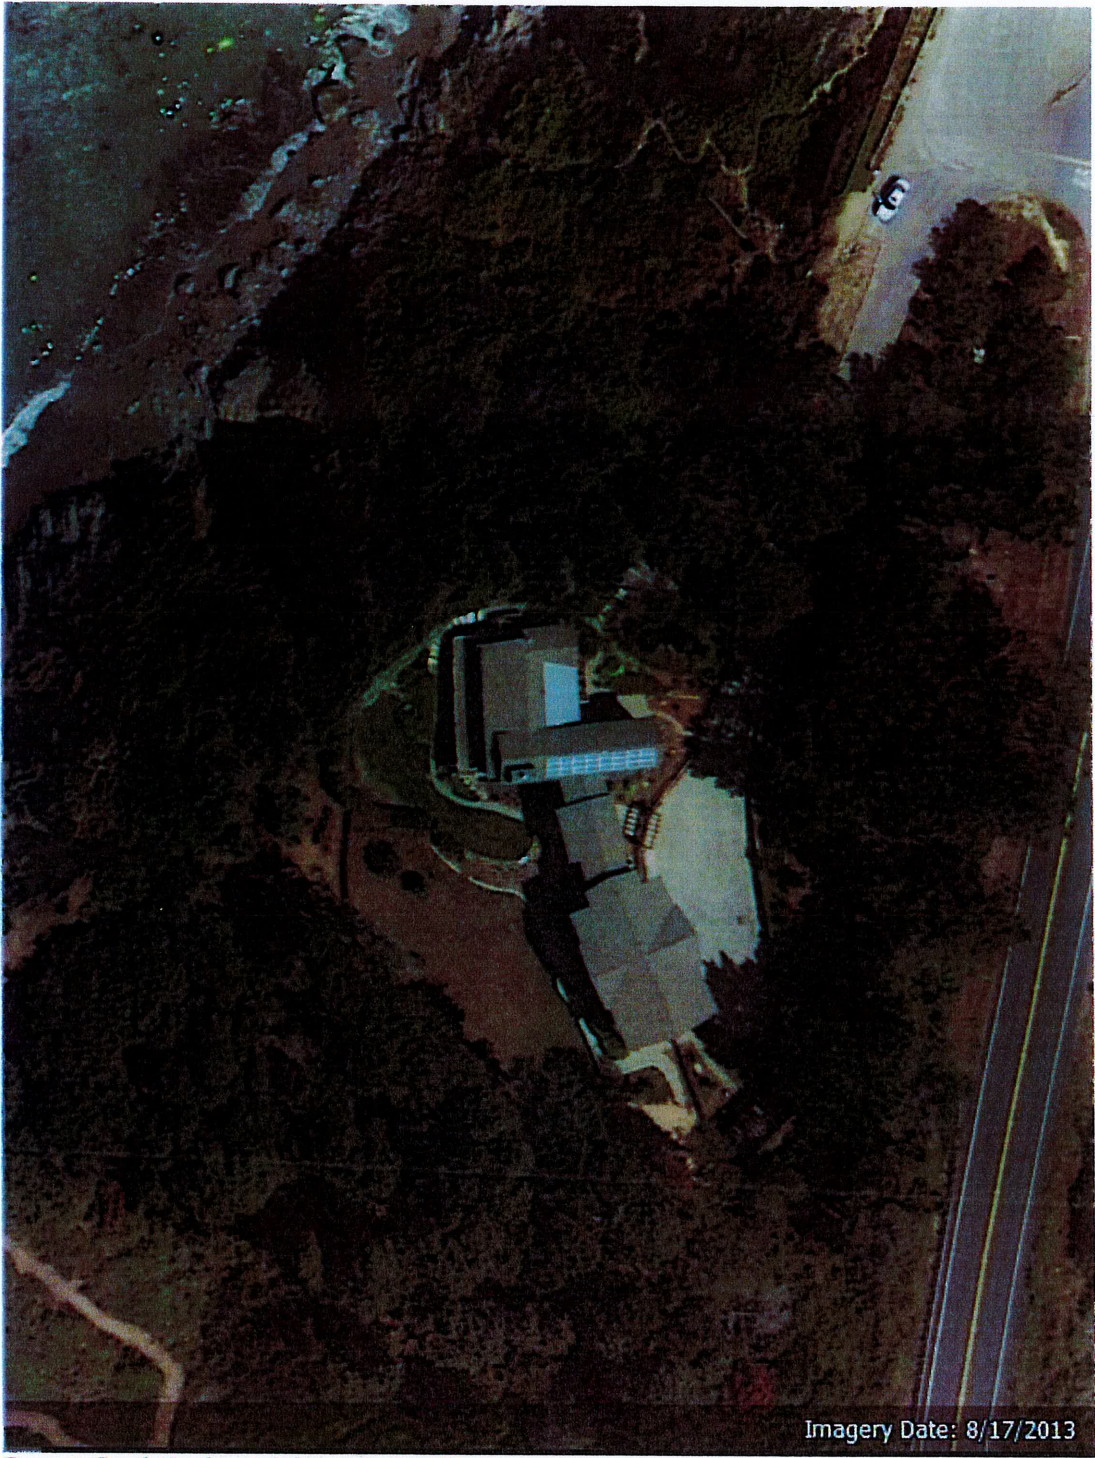
I have attached several photos that demonstrate that native vegetation around the residence was not impacted by the project. **Figure 4** is an aerial photograph of the site in 2013; after the residence construction was complete, but before the landslide. **Figure 5** is an aerial photograph of the same location on 7/2/2018, after the landslide and emergency CDP approval, and during residence stabilization activities. The landslide threatening the residence can be seen to the northwest of the residence and the northern portion of the deck has been removed to access locations to drill new foundation piers. **Figures 6 – 8** are photographs taken on August 13, 2019, and show the condition of the site now that the residence stabilization is complete and the deck has been replaced. These photos show that the native trees beyond the landscaped curtilage of the residence are still present and show no signs of having been impacted by the project.

*Figure 4. Google Earth aerial photo taken in 2013.*

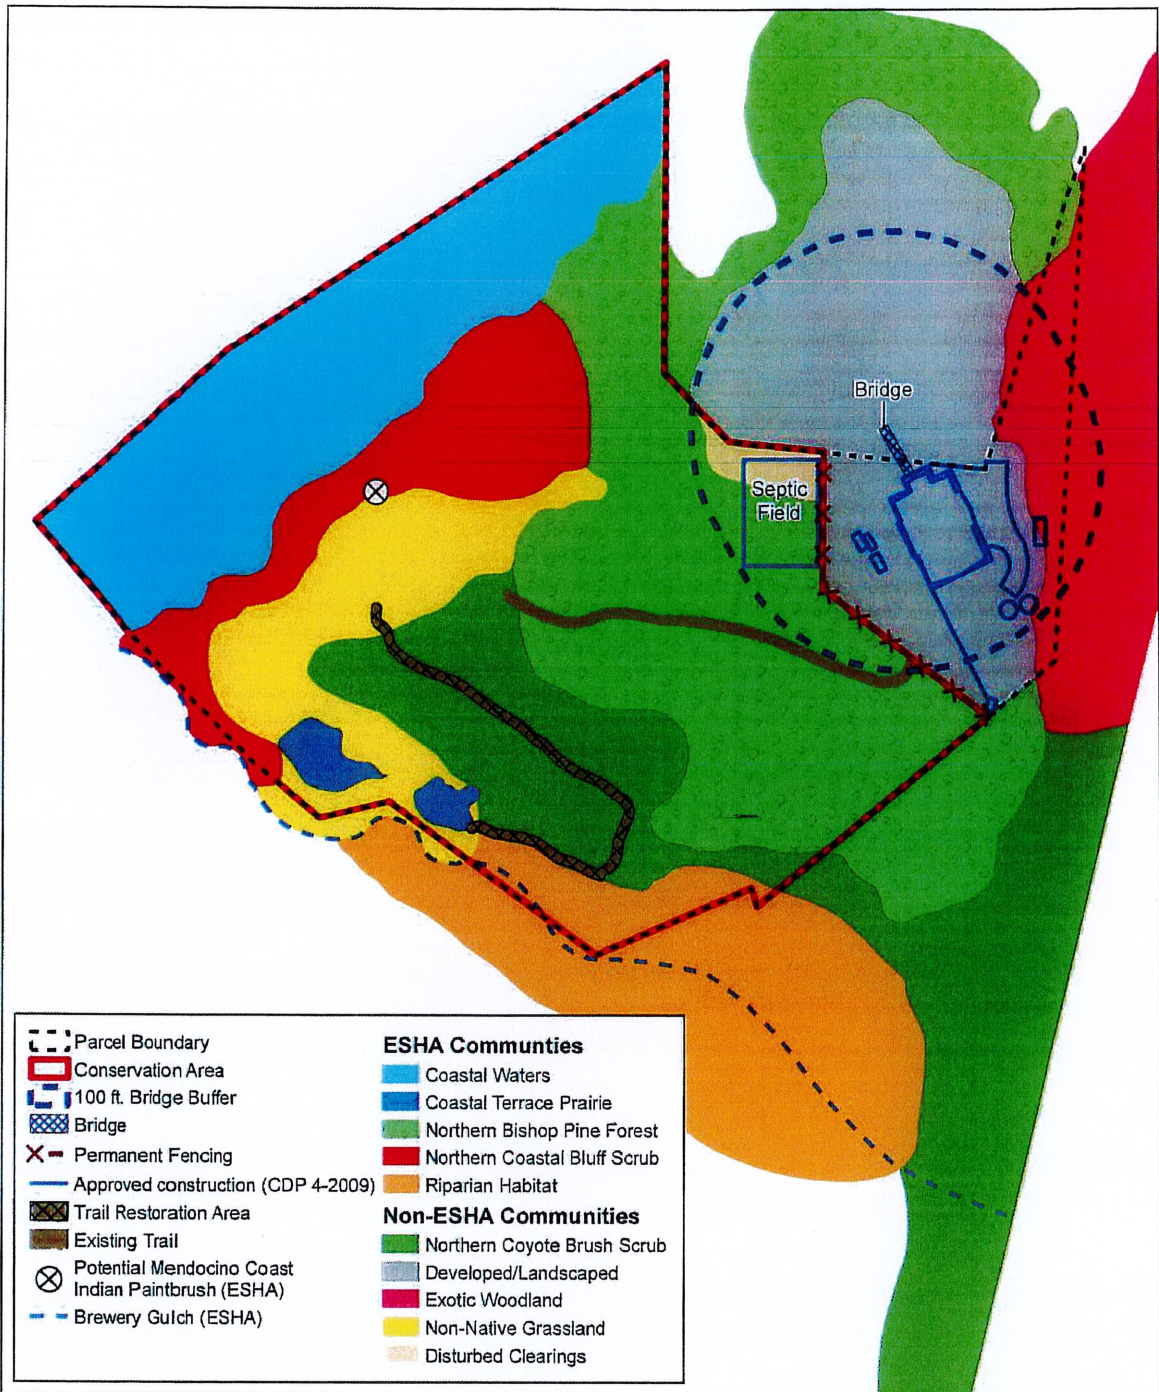
**Figure A1. Proposed Bridge Impact Assessment**

Figure 3. WRA's Fig A1 from their Addendum addressing the Bridge Addition, dated October 2010 [illustrates the developed/landscaped area as result of the southern residence]

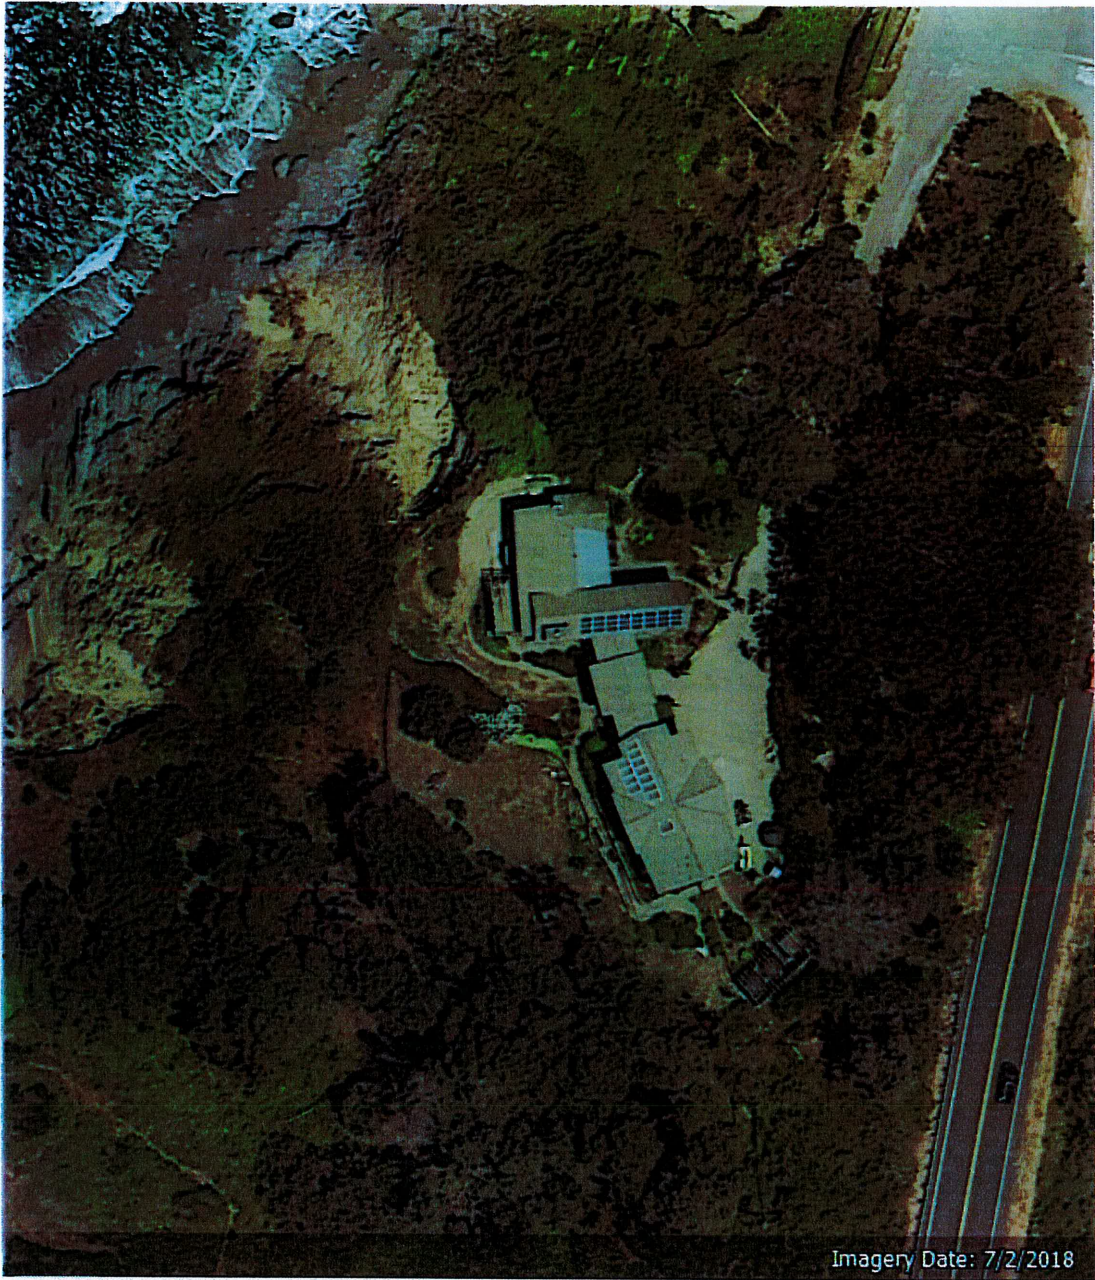
*Figure 5. Google Earth aerial photo taken 7/2/2018. The slide can be seen to the northwest of the residence. This photo was taken during the residence stabilization process, the deck and lawn have been replaced, as reflected in the photos of the site below.*

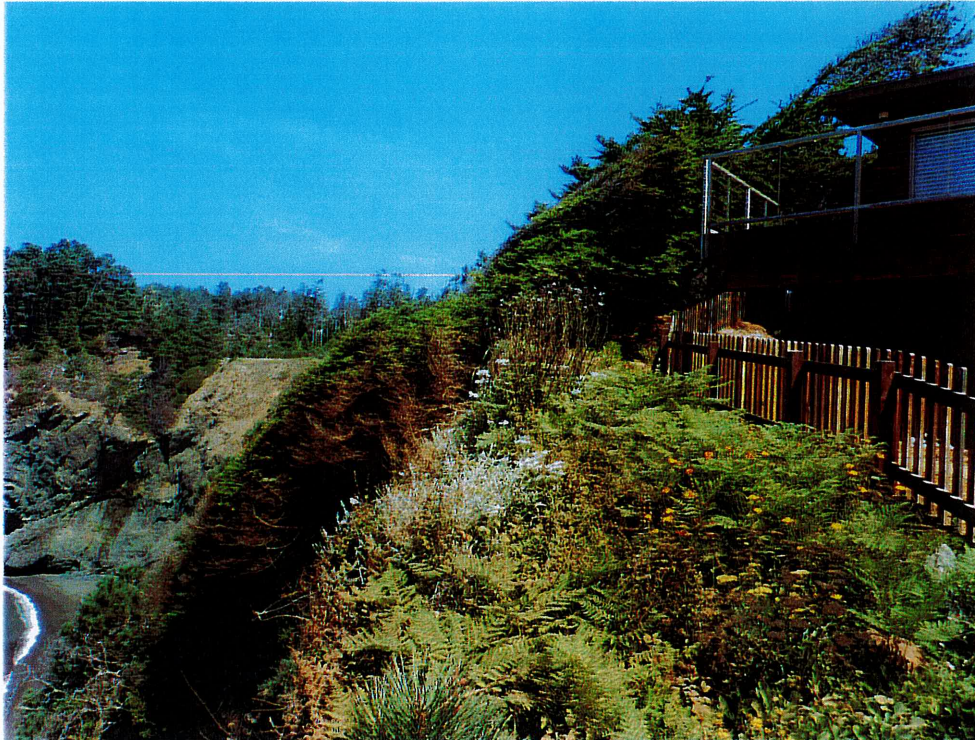
*Figure 6. Looking north past the northwest corner of the residence. Native vegetation can be seen directly adjacent to the northern side of the residence. Leafless branches of the fir trees at the lower middle of the photo show where vegetation is absent due to the landslide.*

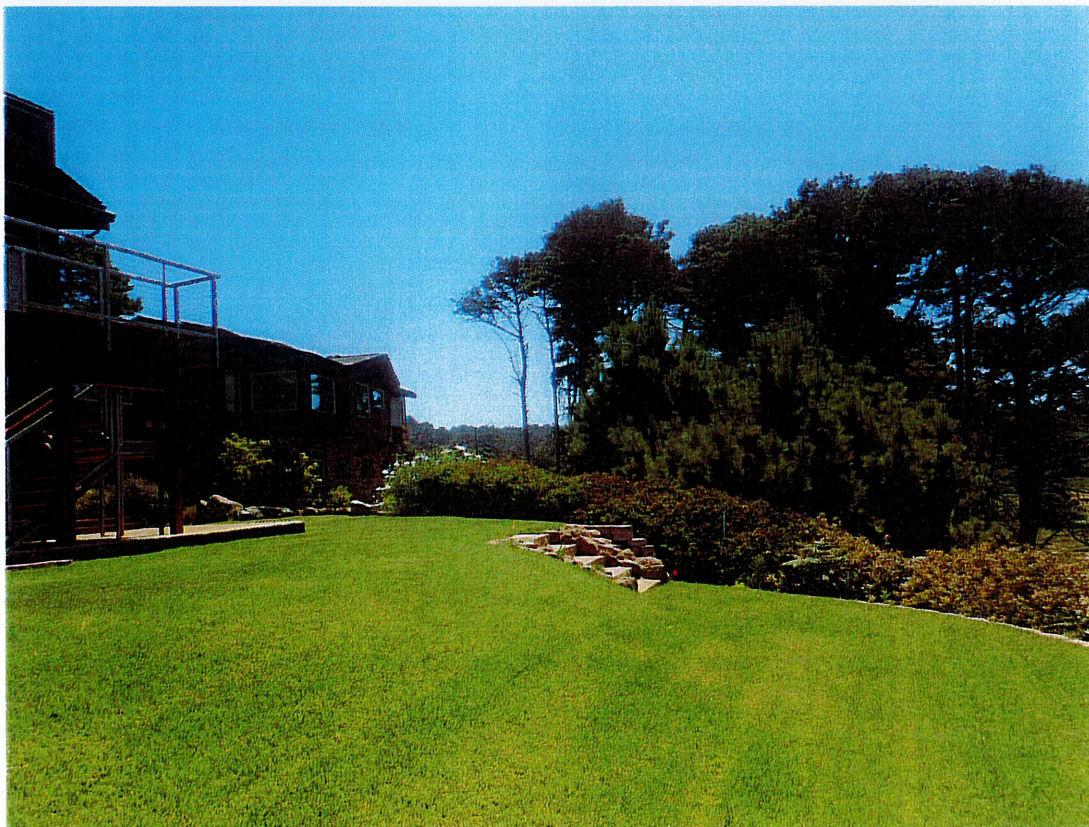
*Figure 7. Looking south from the lawn area to the west of the northern portion of the residence. Native bishop pine trees planted in this area remain. The Bishop pine trees in the background are a portion of the stand reported in the supporting documents for the 2009 and 2010 CDP applications.*

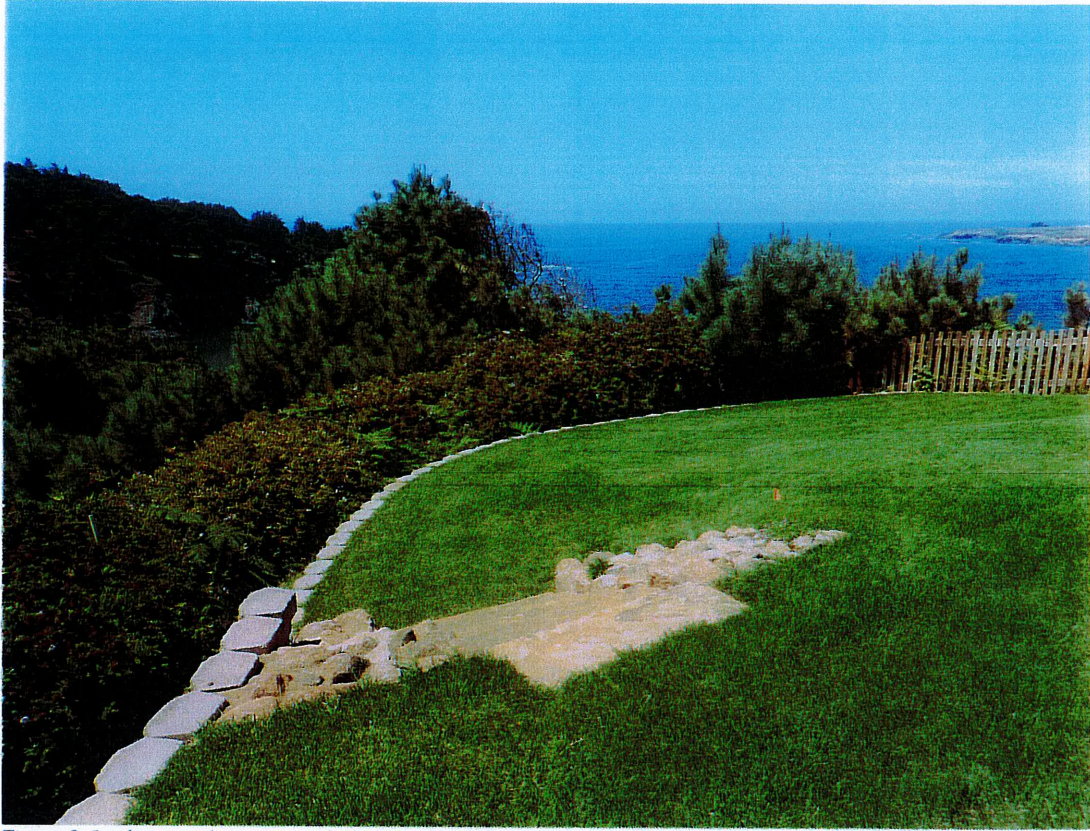
*Figure 8. Looking southwest toward Chapman Point from the lawn adjacent to the northern portion of the residence. Wind stunted Bishop pine trees growing from the bluff slope can be seen just beyond the shrubs and fence surrounding the lawn.*
