pbscommissions - Re: CDP_2019-0034 Caltrans Permit to restore the storm drain crossing Highway One to the Original location.

Re: CASE#: CDP_2019-0034
DATE FILED 8/30/2019
OWNER/APPLICANT: CALIFORNIA DEPARTMENT OF TRANSPORTATION (CALTRANS)
AGENT: FRANK DEMLING

2004 and 2008 Photos showing Progressive Damage from Realignment of Highway One Stormdrain

2008 Terry Barber Hydrological Report

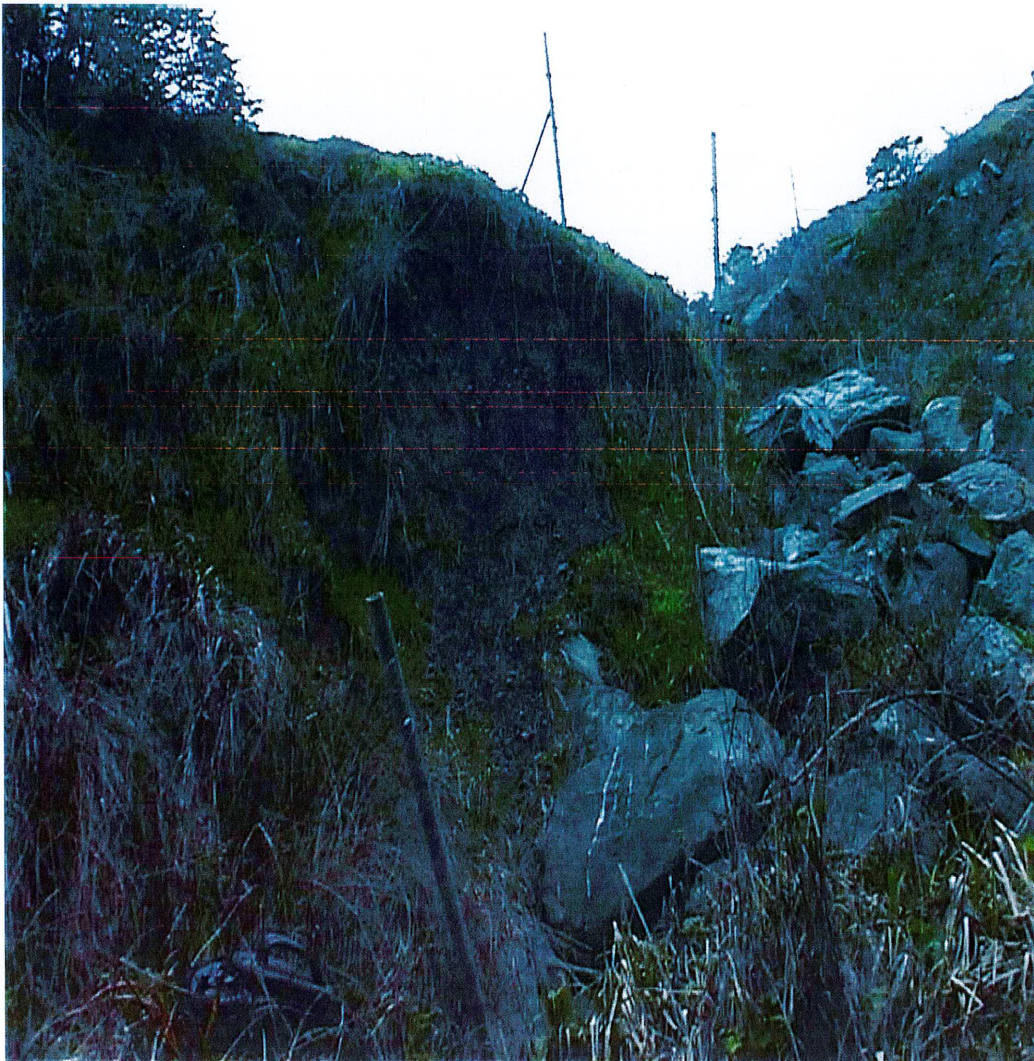
2004 photos showing the erosion west of the drainage. Note the location of the CALTRANS white fence.

Note the migration of the rocks off the top of the slope exacerbating erosion and impacting habitat.

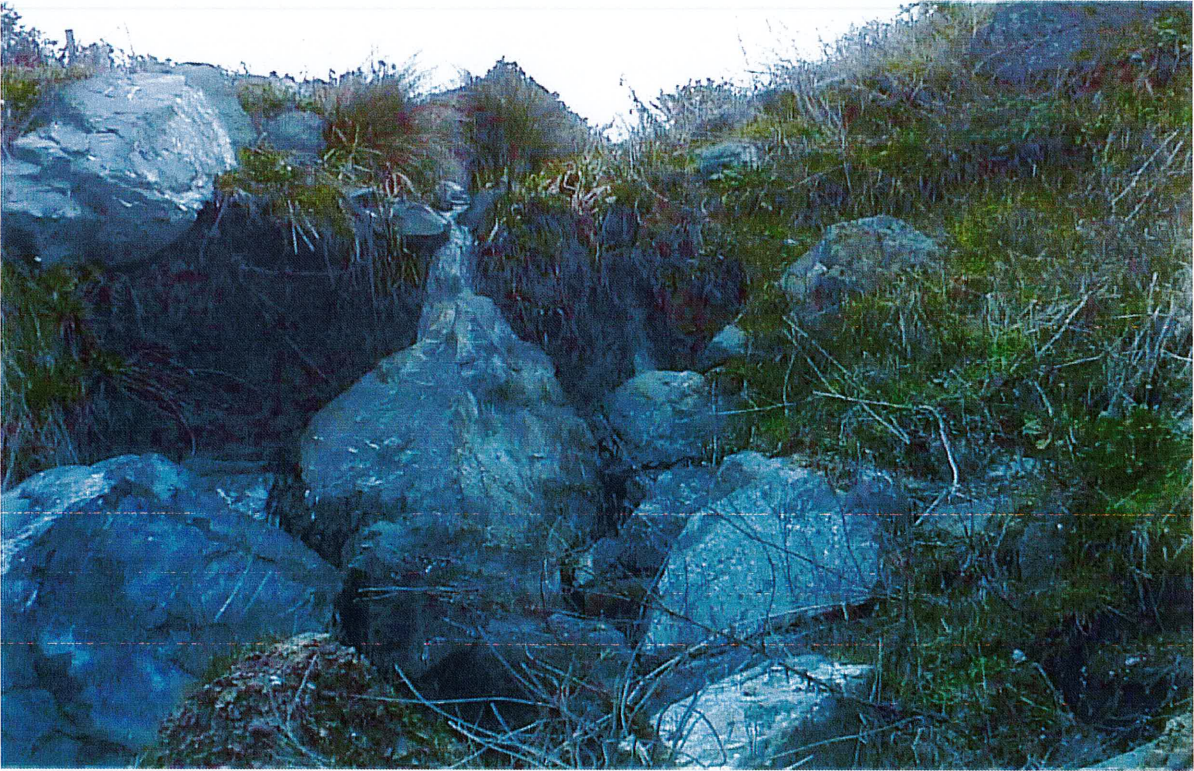
Rock revetment failing on road slope after the reconfigured drainage.

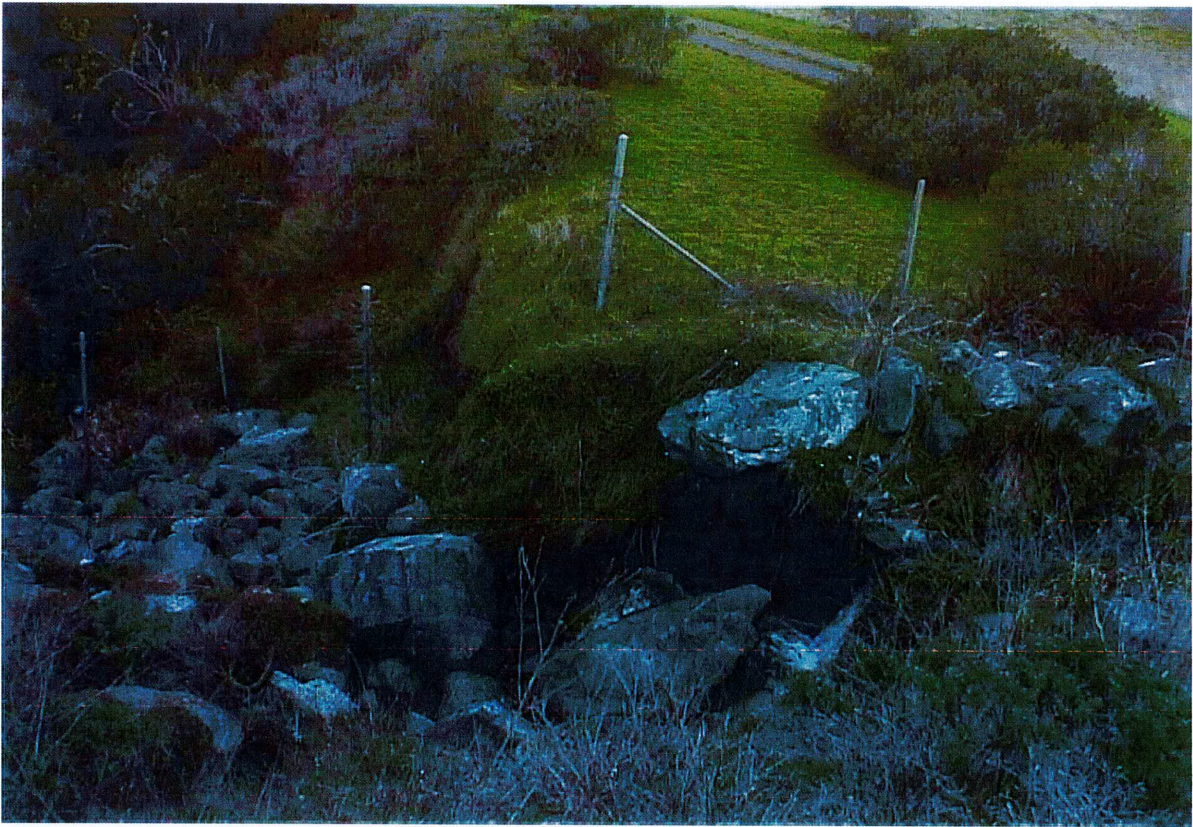
Looking from Highway One to show the extent of rock placed on the side slope of the highway. Later pictures show the rocks just sliding into the creek, actually deepening slide slopes and widening creek. Note the elevation of the CALTRANS fenceline.

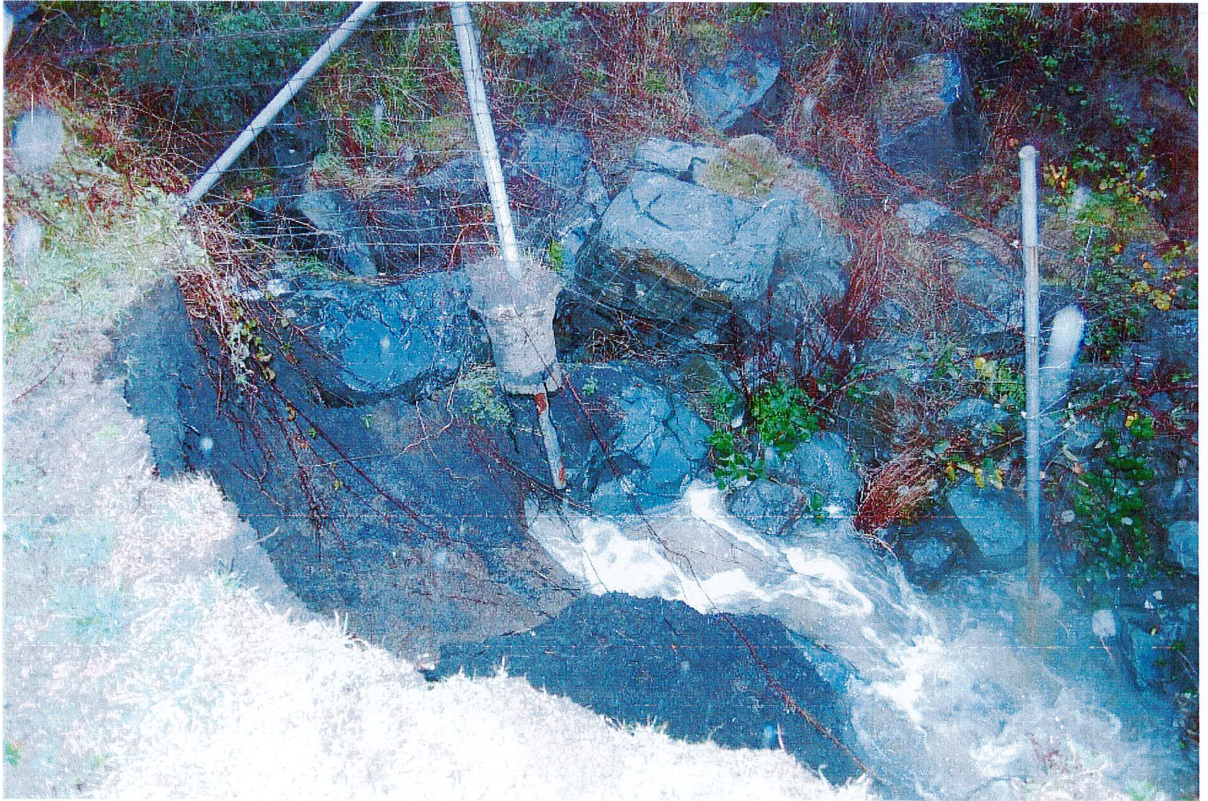
Extent of erosion by 2008 at the Cal Trans Boundary. Note that the fence shown above is, four years later, hanging in mid-air. Note the Impact on the deepening of the creek, and migration of boulders that had been added to stabilize the highway. Creek slope was eroded on our property and destabilizing the slope adjoining our driveway.

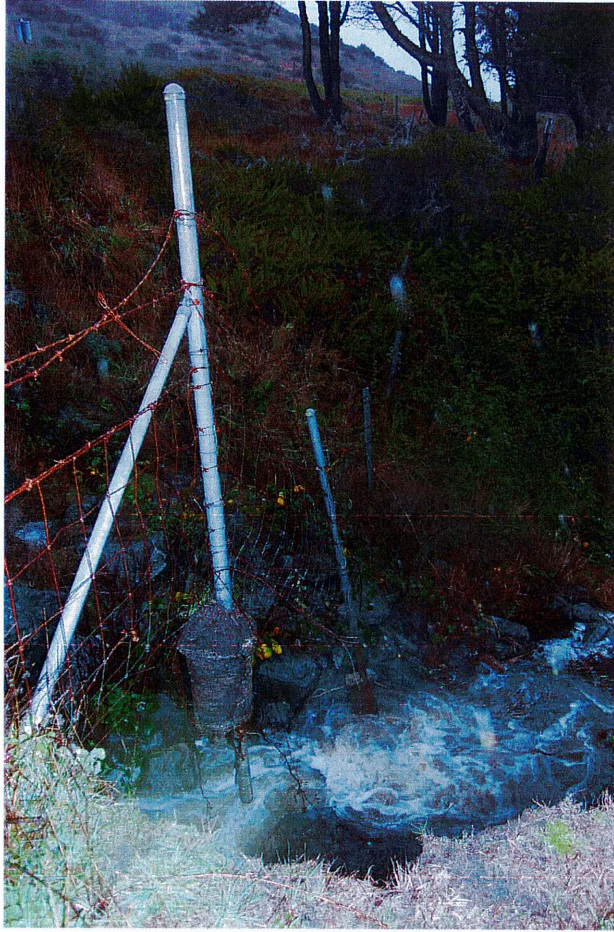
Looking towards southern side back in 2008, also showing erosion, rock migration and steepening of the slope.

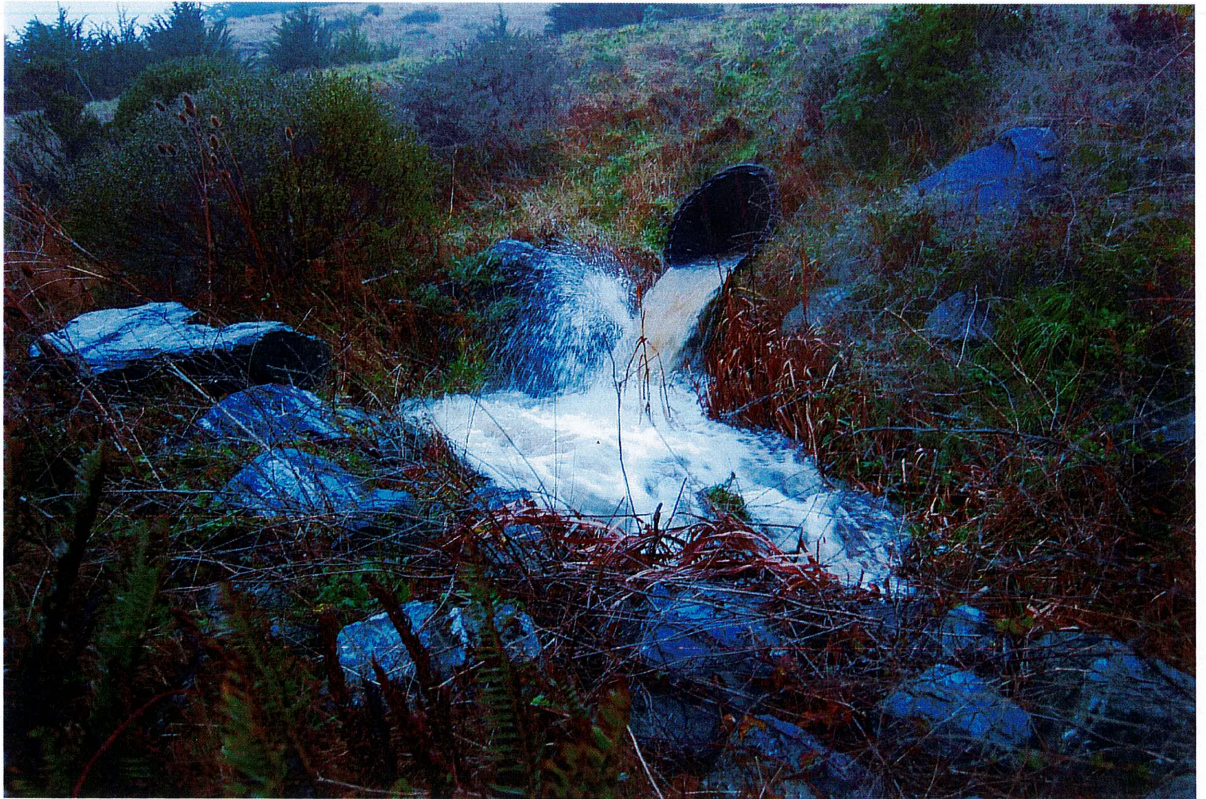
2008 showing the outfall of the diverted storm drain under Highway One, the turn to the south, towards the creek and unpermitted rocks that served to direct the flow.
