COUNTY OF MENDOCINO
DEPARTMENT OF PLANNING AND BUILDING SERVICES

CASE#: CDP_2021-0006

OWNER/APPLICANT: MENDOCINO COUNTY DEPARTMENT OF TRANSPORTATION

Gualala Road, CR 501, M.P. 0.33

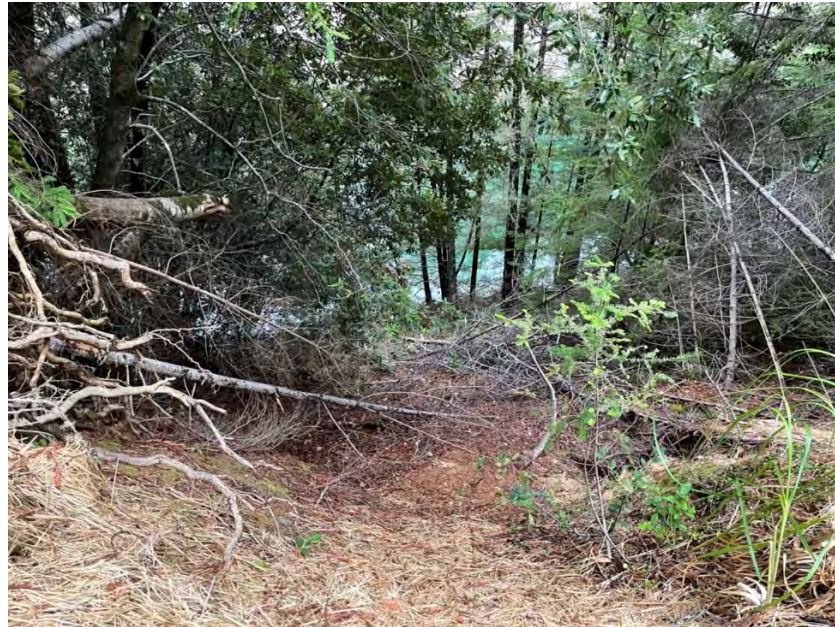
Photo 1. Gualala MP 0.33 Project Site Facing East Looking East

Three translational debris failures were observed within the immediate site vicinity: (1) an approximately 175-foot long wide failure located along the inboard slope, extending about 70 feet above the roadway (appears recent); (2) an approximately 135-foot wide failure located along the outboard slope (appears older with predominantly immature tree growth); (3) an approximately 40-foot wide failure (recent) located along the outboard slope and within the center of the older failure (2). Based on our conversations with nearby neighbors, the inboard slope has undergone reoccurring failure (1), depositing slide debris on the roadway and/or outboard slope below. Slide debris was observed along the outboard shoulder/slope, presumably deposited from the inboard slope failure(s). The toe of both outboard slope failures (2, 3) extend to the river. The pavement appears to be in relatively poor condition; alligator cracks and slumping was observed at the site. It is our understanding that MCDOT is only seeking recommendations to stabilize the roadway adjacent to the 40-foot wide recently failed outboard slope section (3, see Photo 1).

Based on the boring data and site observations, the slope failure (3) occurred predominantly within the Unit 1 fill material. The primary causes of failure are likely to be the inherent weakness of the Unit 1 material on an over-steepened slope and high seasonal storm water infiltration in combination with a build-up of seepage pressures within/along the soil-rock interface. Saturation and undercutting at the toe of the slope by the river and erosion and surcharge loading from debris deposited by the inboard slope failure (1) could also be considered contributory causes of the failure.

Based on the field exploration and analysis, a soldier pile tieback wall is considered appropriate for this site. This repair option can be accomplished with a minimum 11-foot high wall across the alignment. It would have the advantages of achieving a relatively high level of security through use of deep foundation elements with anchored tiebacks, provide a measure of internal structural flexibility with relative independence from subsequent downslope or adjacent movement and require limited slope excavation requirements with little site/traffic disturbance during construction.

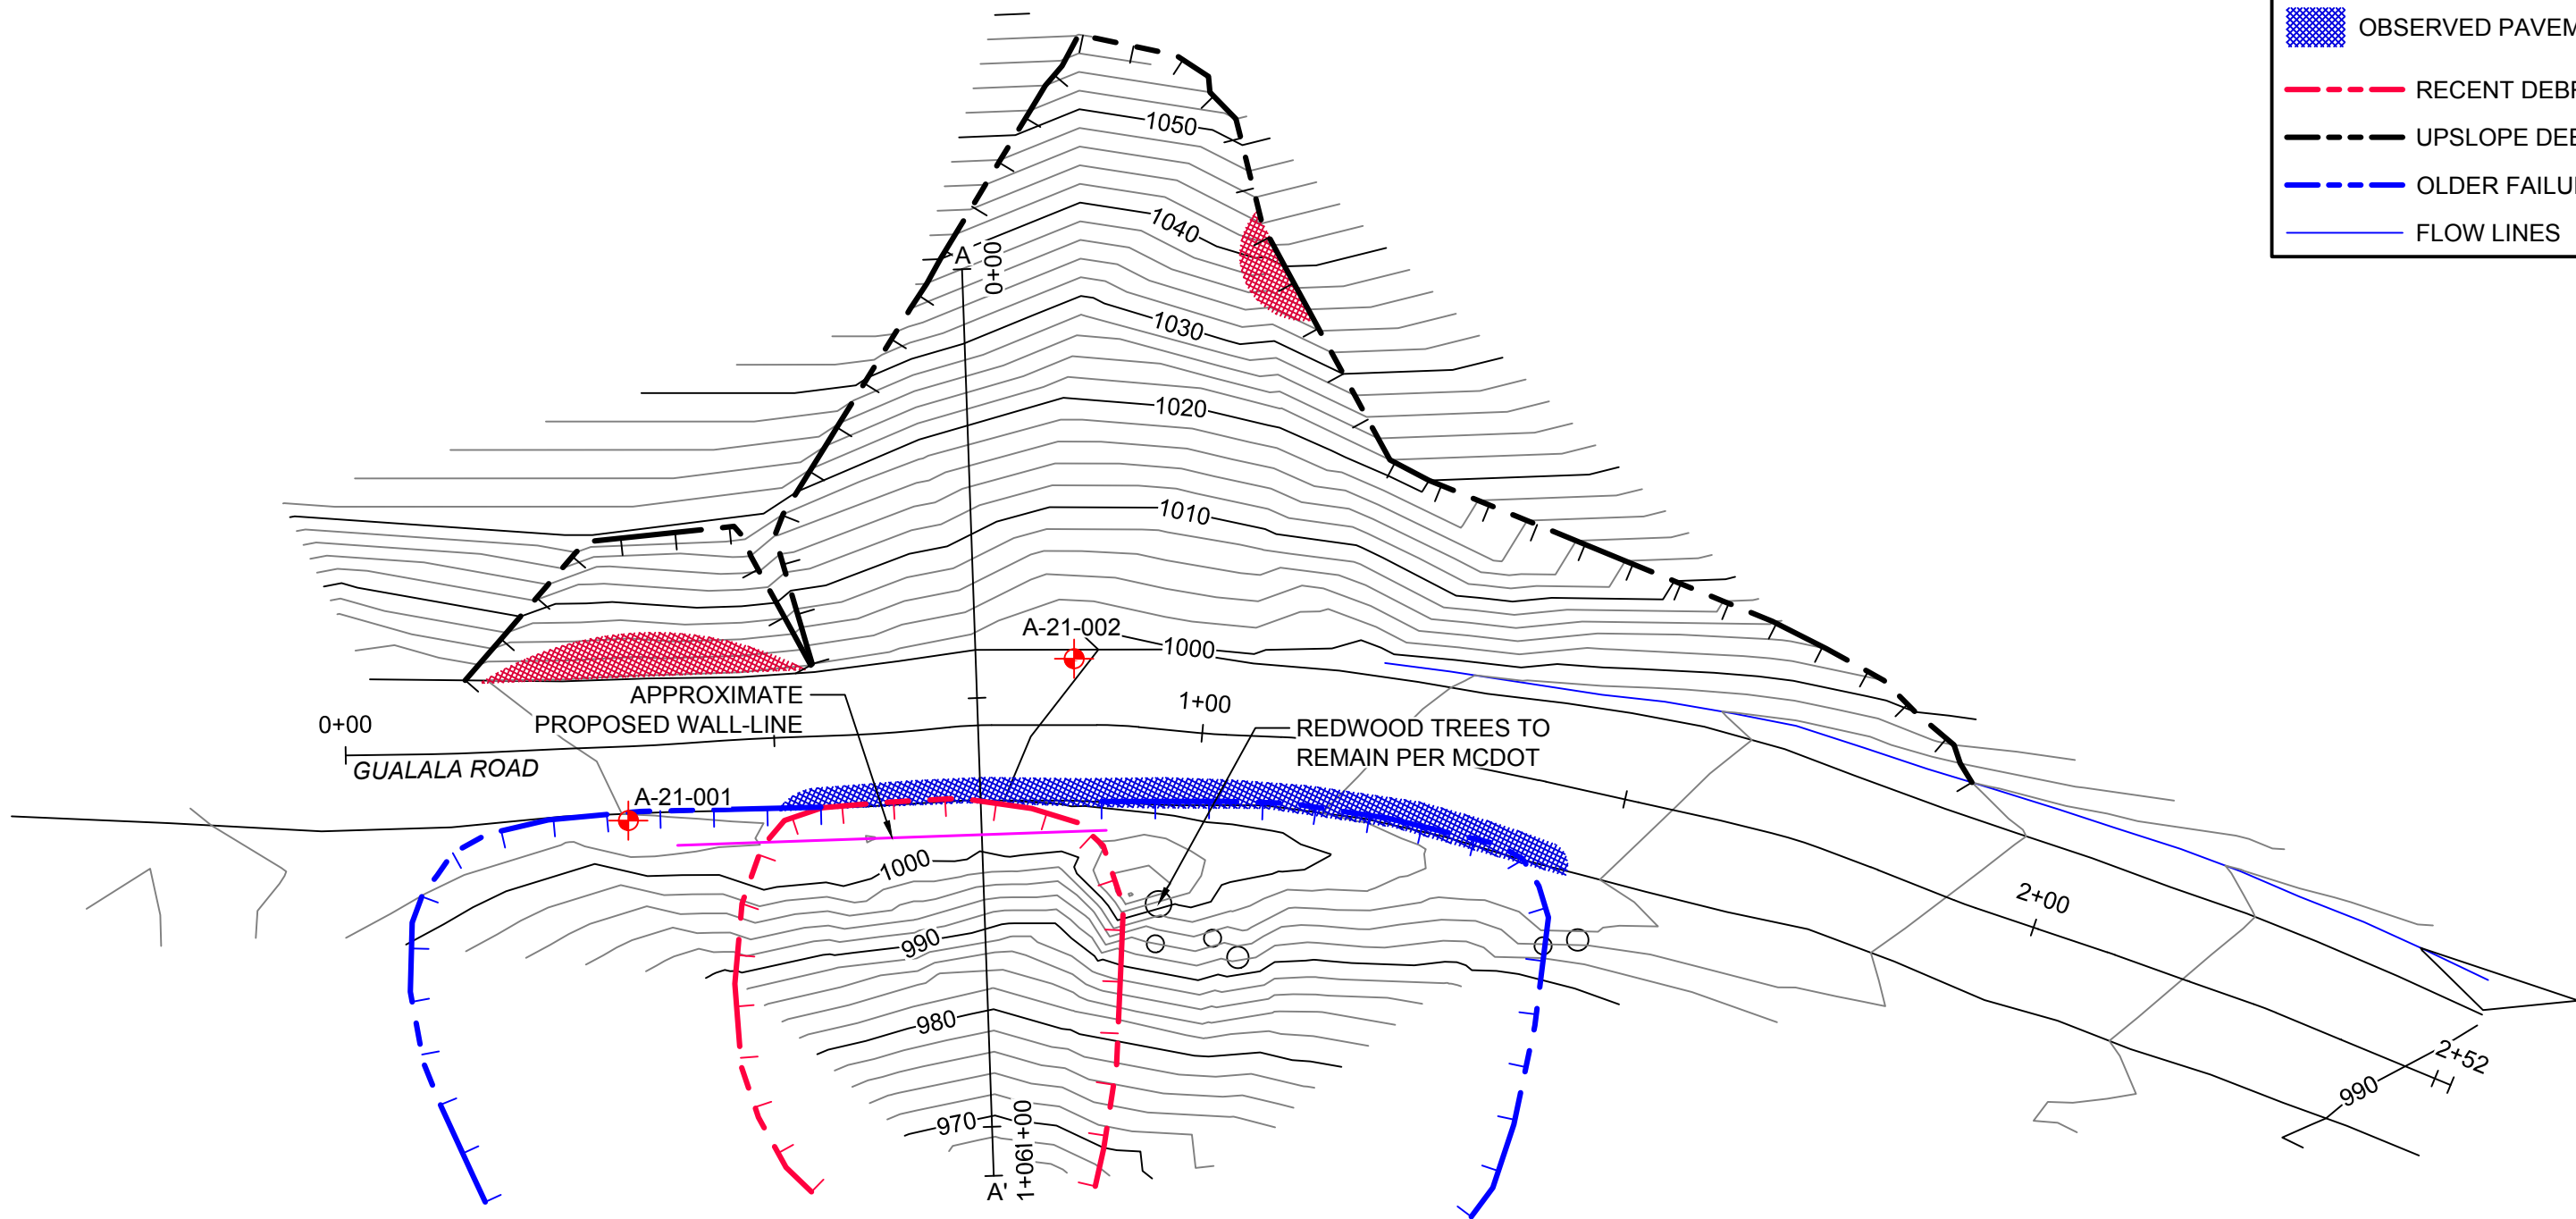
Figure 4
Exploration
Map
Proj. No: 19-563.2
Scale: 1" = 20'
Date: 07/23/21

OBSERVED PAVEMENT DAMAGE

The soldier pile wall will be approximately 50-foot-long (proposed wall length and layout line provided by MCDOT) and positioned about 12 feet (and varies) from the existing roadway centerline with layout line as shown on Figure 4. A minimum wall height on order of 11 feet is anticipated within the failure area.
