**ZONING ADMINISTRATOR
STAFF REPORT- ADMINISTRATIVE**

**MARCH 14, 2019
AP_2018-0061**

REQUEST: Administrative Permit request for a large mixed light cannabis cultivation site (Type 2B (10000 ft²); AG_2017-0779) of no more than 10,000 ft² of canopy.

EXHIBIT Q: AP_2018-0061-Site Inspection Photographs

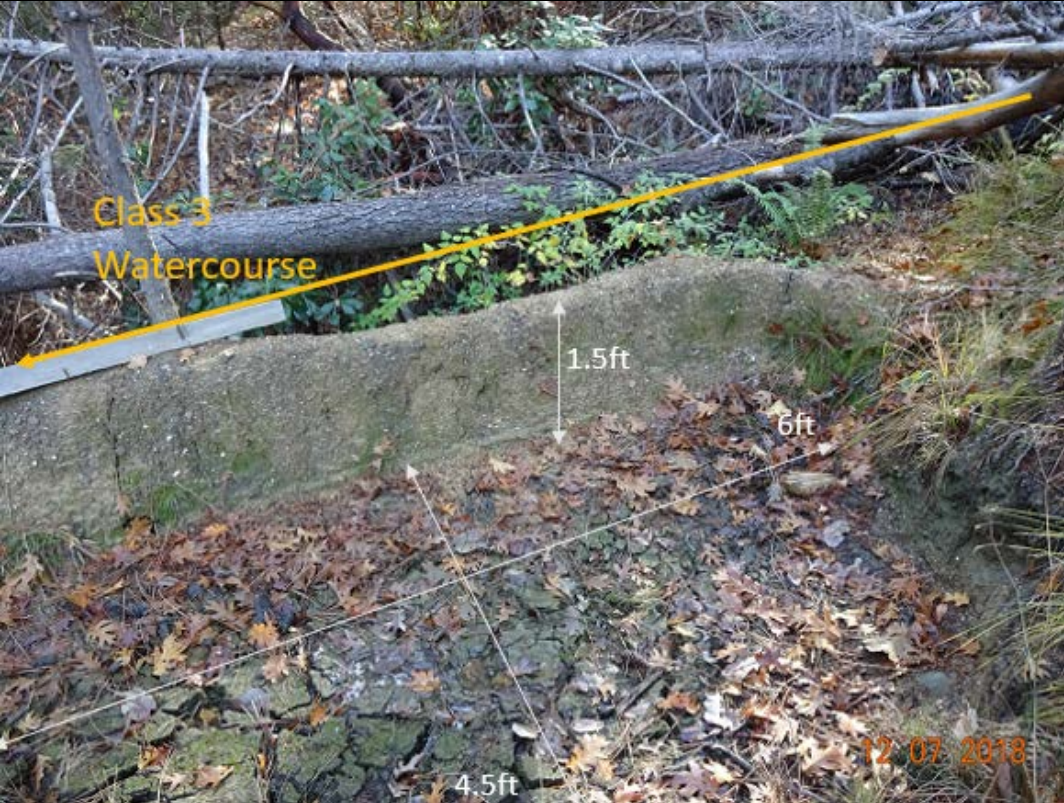
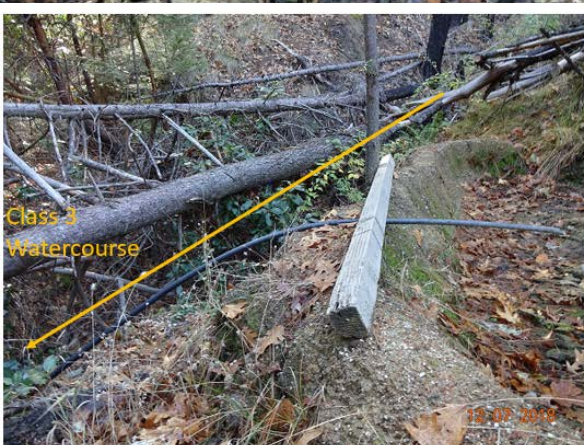
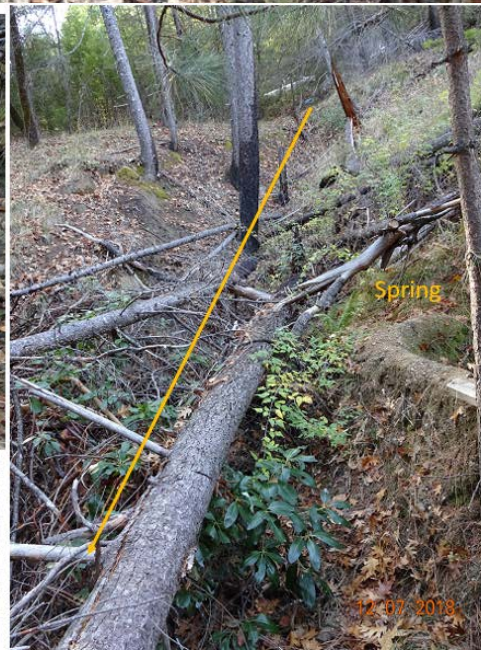
Total Number of PODS: 5 observed PODs on 12/7/2018 inside of APN: 035-400-04
POD ID: 1
Source Water: Surface Water
Diversion Type: Point of Diversion to Storage
POD Lat/Long: 39.651442°, -123.039454°
POD Description: Spring located adjacent to class 3 watercourse. Natural water flow was blocked by sandy clay berm. 6 feet x 4.5 feet, depth 1.5 feet. Bottom of the spring was wet.

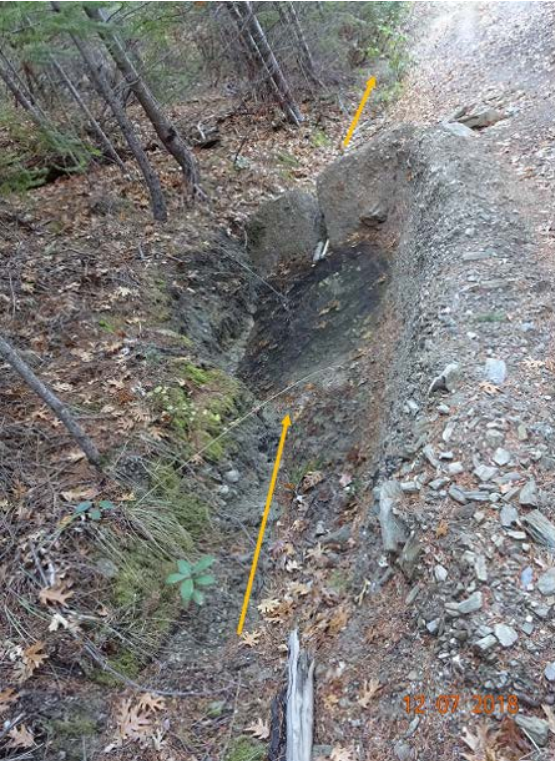
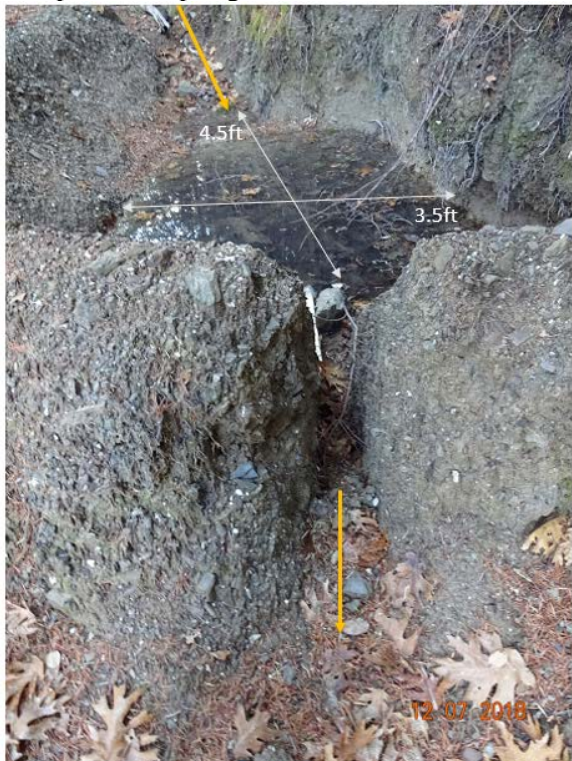
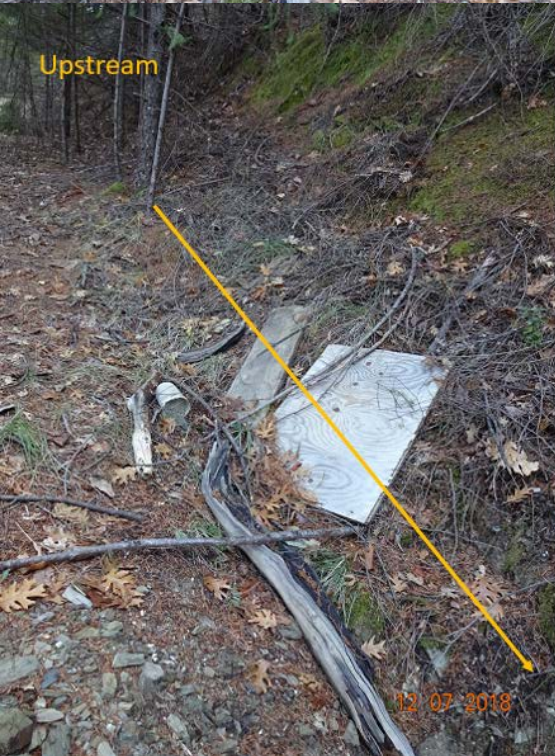
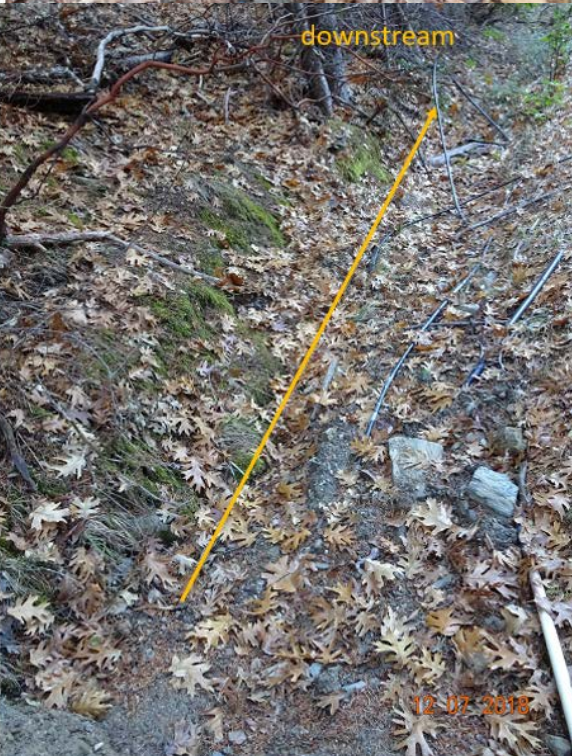
POD ID: 2
Source Water: Surface Water
Diversion Type: Point of Diversion Storage
POD Lat/Long: 39.653362°, -123.038254°
POD Description: Build June 2018 by cultivator. Spring was located at westside of sandy clay berm dammed by . The spring size was 4.5 feet x 3.5 feet, and water accumulated about 2 ~ 3 inches depth. This spring is not listed as a source of water on B4 form.

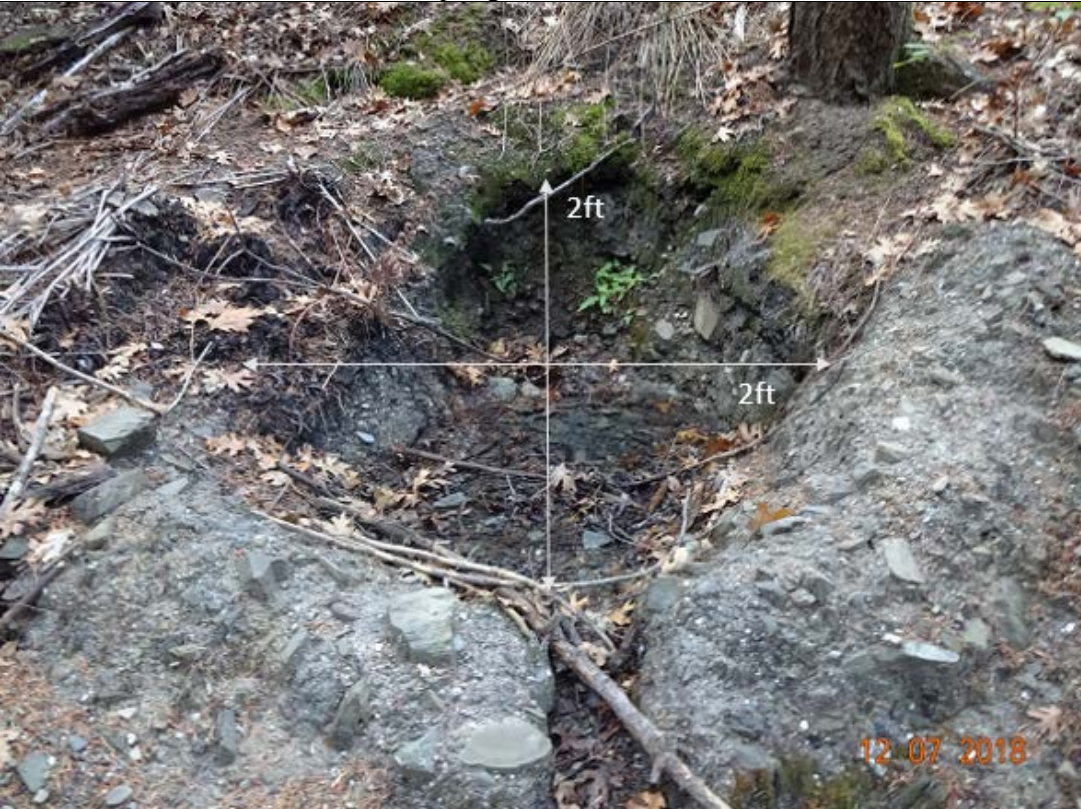
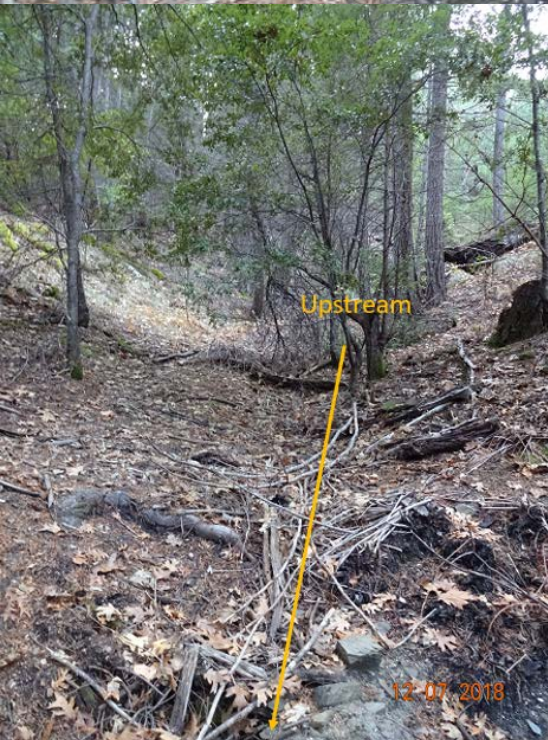
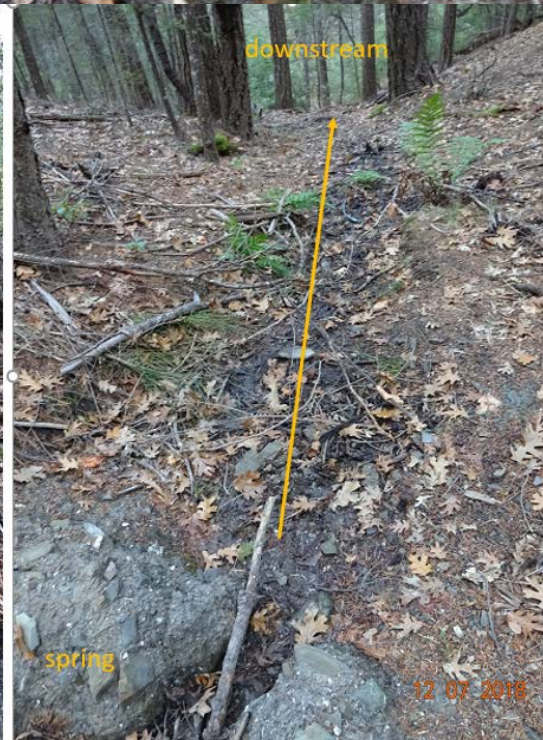
POD ID: 3
Source Water: Surface Water
Diversion Type: Point of Diversion Storage
POD Lat/Long: 39.650803°, -123.037800°
POD Description: The spring is located on class 3 watercourse and appears to be hand dug. The spring size was 2 feet x 2 feet with approximately 1-inch of accumulated water at the bottom. This spring is not listed as a source of water on B4 form.

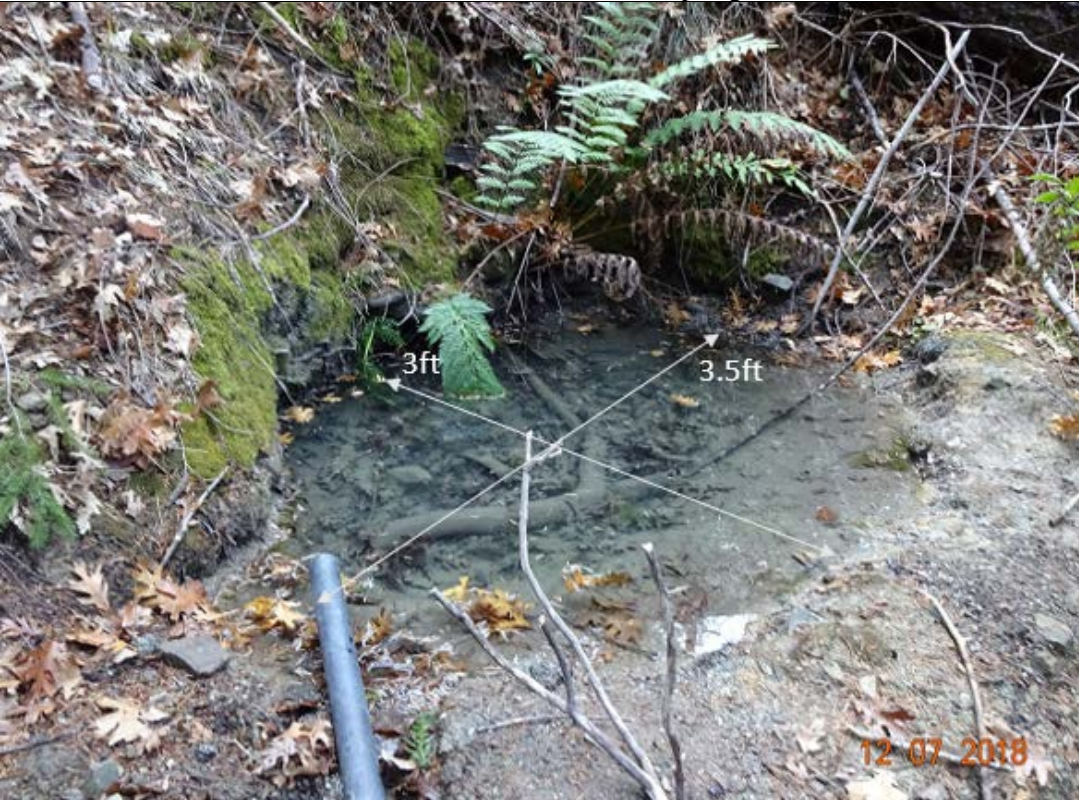
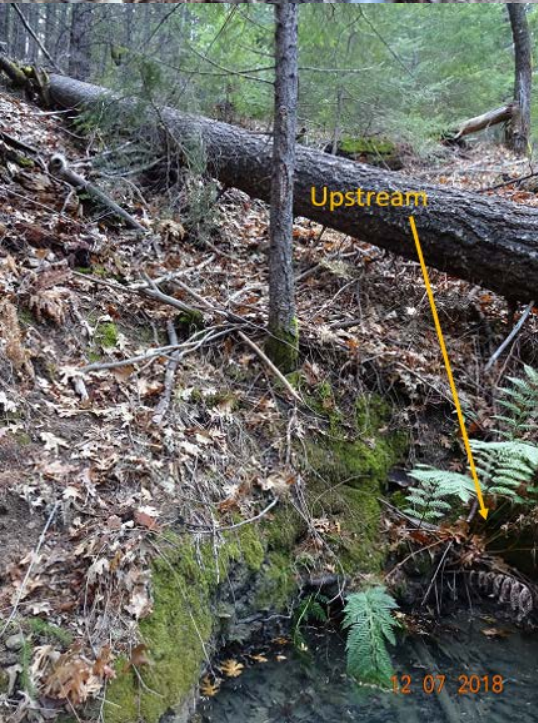
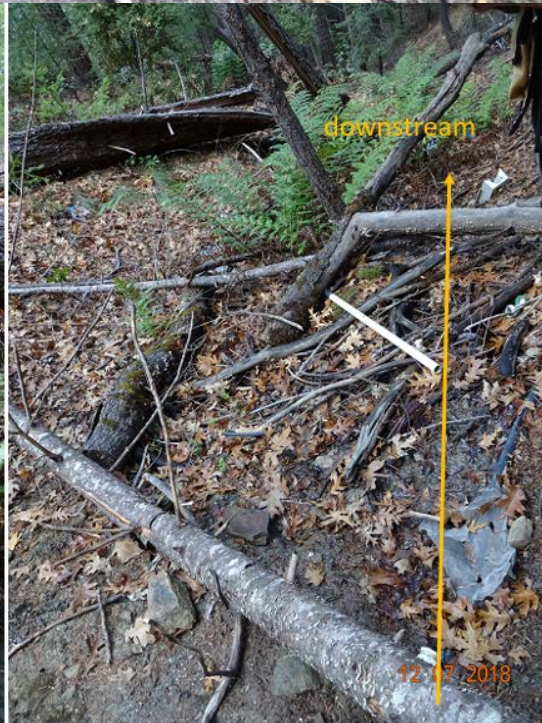
POD ID: 4
Source Water: Surface Water
Diversion Type: Point of Diversion Storage
POD Lat/Long: 39.651659°, -123.034398°
POD Description: Spring was located upstream of POD 3 on class 3 watercourse, looks hand dug Spring. The spring size was 3 feet x 3.5 feet with approximately 5-inches of accumulated water at the bottom. This spring is not listed as a source of water on B4 form.

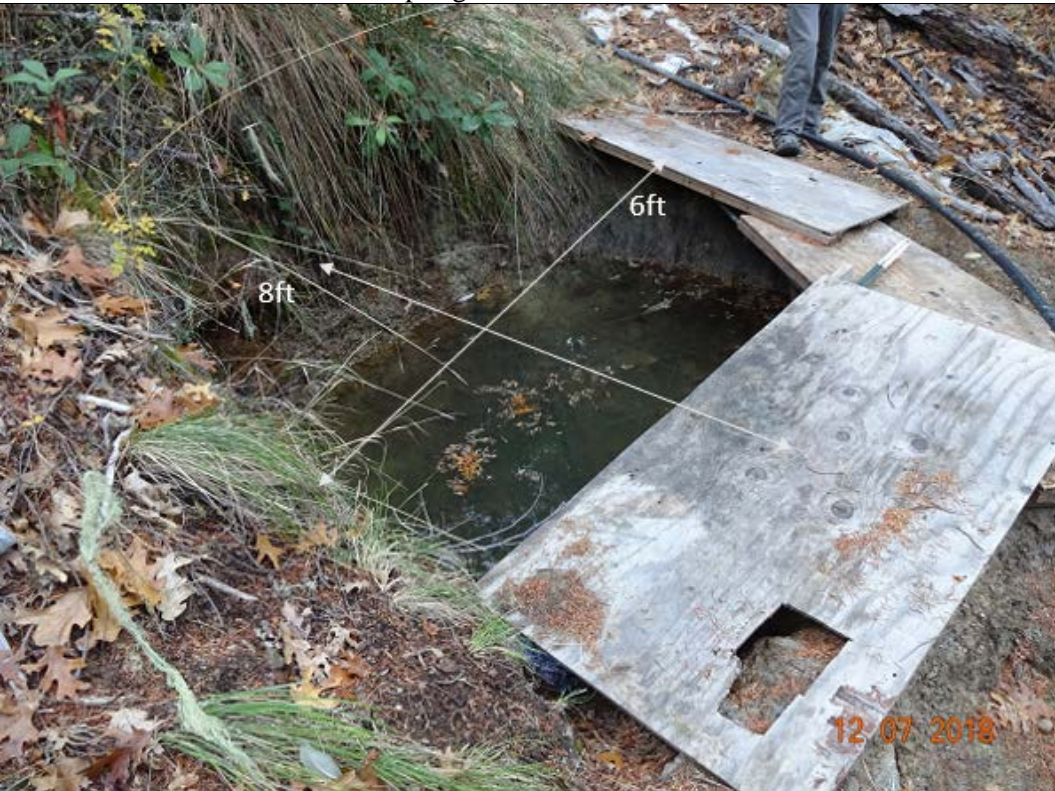
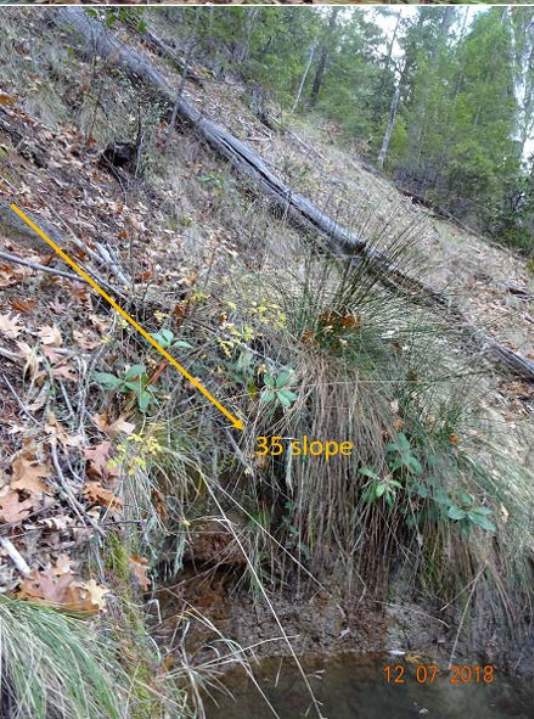
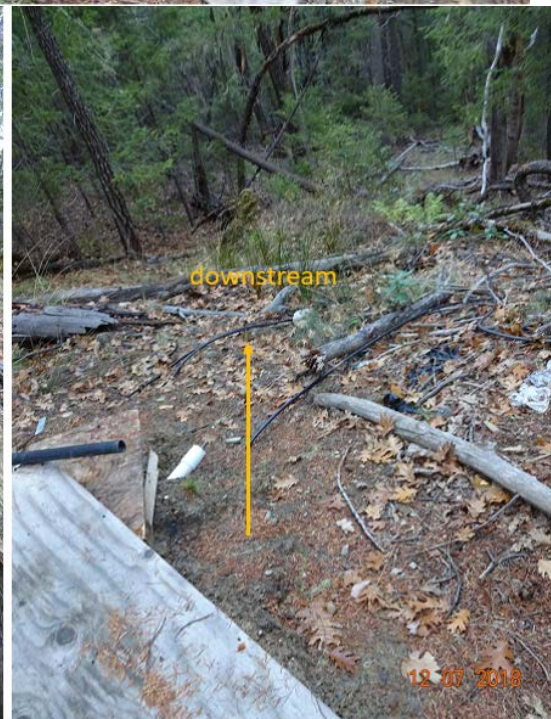
POD ID: 5 (Spring 2)
Source Water: Surface Water
Diversion Type: Point of Diversion Storage
POD Lat/Long: 39.650803°, -123.037800°
POD Description: Spring was located at steep hill with an approximate 35-degree slope. The spring size was 6 feet x 8 feet with approximately 3-feet of accumulated water at the base. This spring is listed as a source of water "Spring 2" on B4 form.

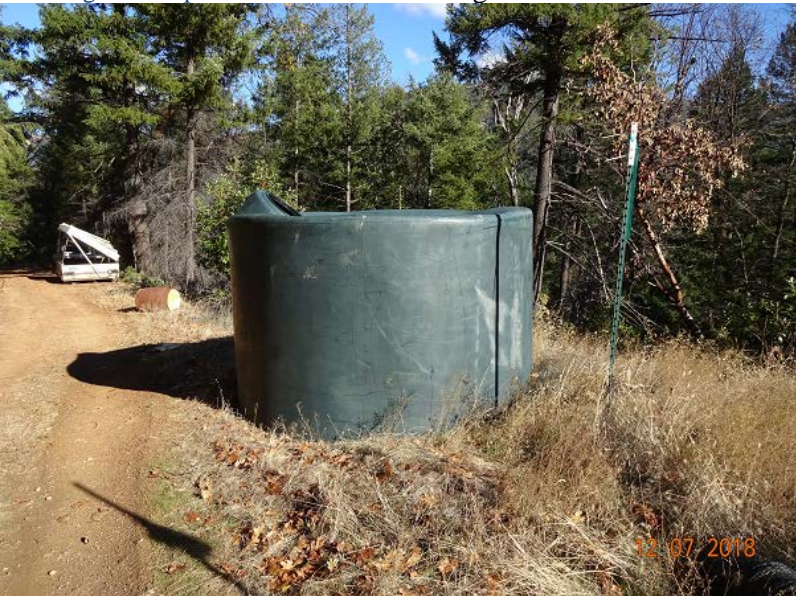
Total Number of Storage: Total 6 (4 tanks and 2 ponds)
POD ID: 5 and Spring could not visit on 12/7/2018
Storage ID: 1
Storage Type: 2500 Gallon Tank
Storage Lat/Long: 39.652018°, -123.039711°
Storage Capacity (Gal): 2500 gallons
Storage Description: Fullstorage tank for POU1.

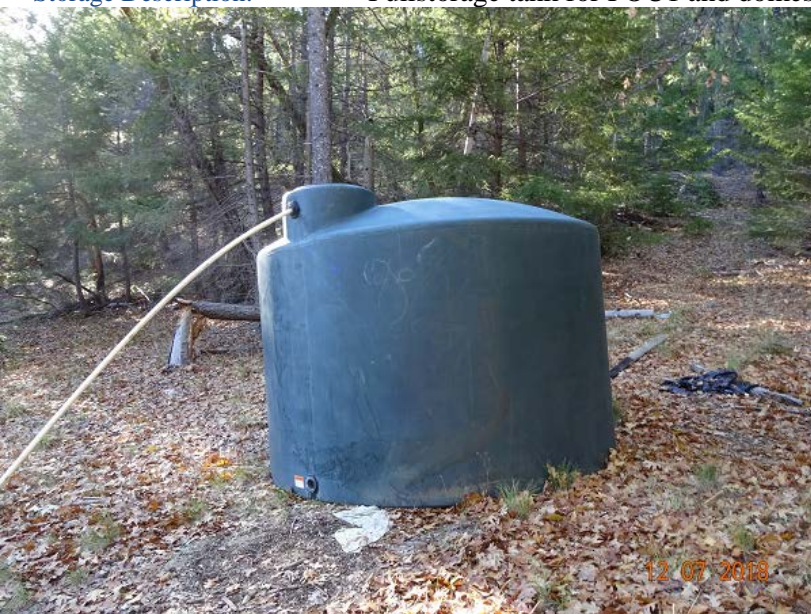
POD ID: 5 and Spring could not visited on 12/7/2018
Storage ID: 2
Storage Type: 2500 Gallon Tank
Storage Lat/Long: 39.651995°, -123.039948°
Storage Capacity (Gal): 2500 gallons
Storage Description: Fullstorage tank for POU1 and domestic use

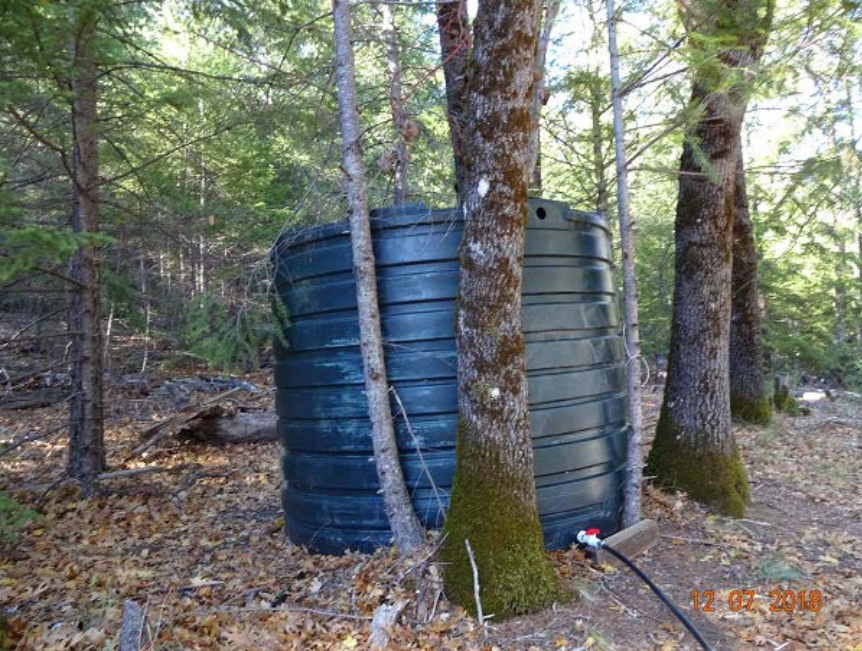
POD ID: 5 and Spring could not visit on 12/7/2018
Storage ID: 3
Storage Type: 3000 Gallon Tank
Storage Lat/Long: 39.652199°, -123.040228°
Storage Capacity (Gal): 3000 gallons
Storage Description: Fullstorage tank for POU1 and domestic use

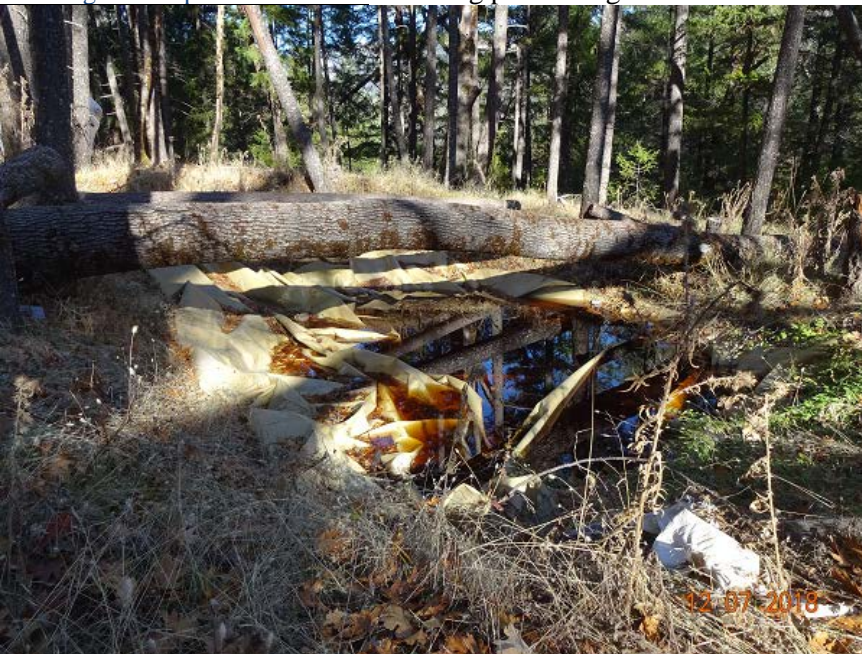
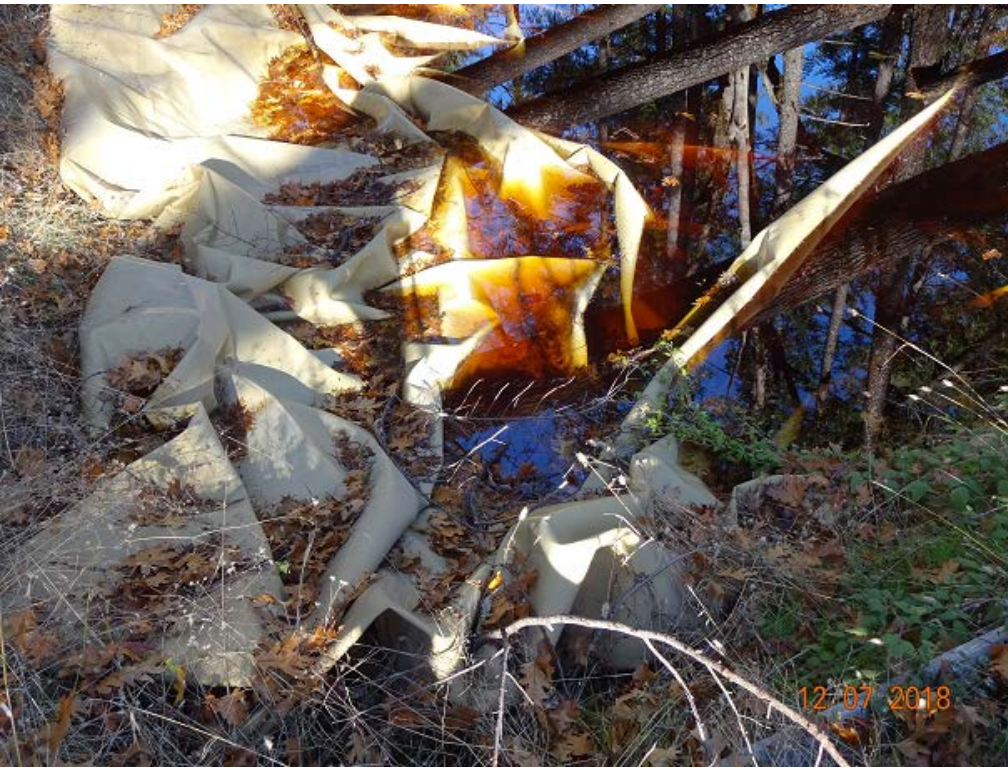
POD ID: Rainwater
Storage ID: 4
Storage Type: Pond/Broken Bladder
Storage Lat/Long: 39.652207°, -123.039921°
Storage Capacity (Gal): Unknown
Storage Description: Hand dug pond using broken bladder as liner. Approximately 15 feet x 15 feet

Close -up broken bladder

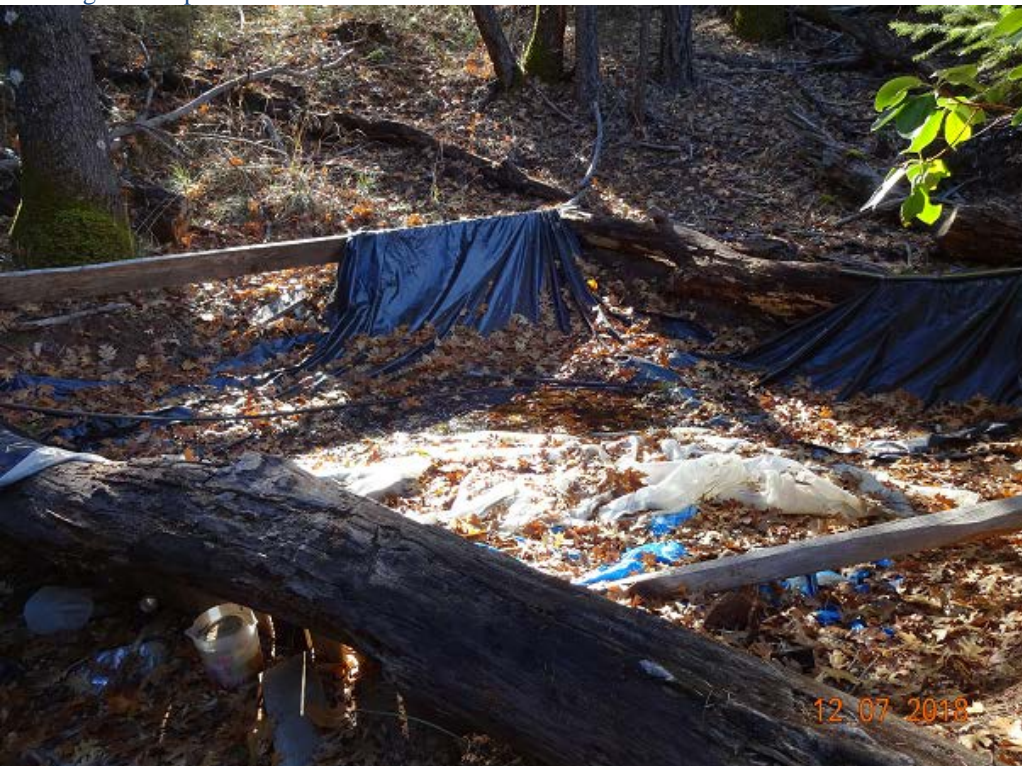
POD ID:	Rainwater
Storage ID:	5
Storage Type:	Pond/Broken Bladder
Storage Lat/Long:	39.652747°, -123.039204°
Storage Capacity (Gal):	Unknown
Storage Description:	Lumber structure with broken bladder as liner to catch rainwater. Used for POU2

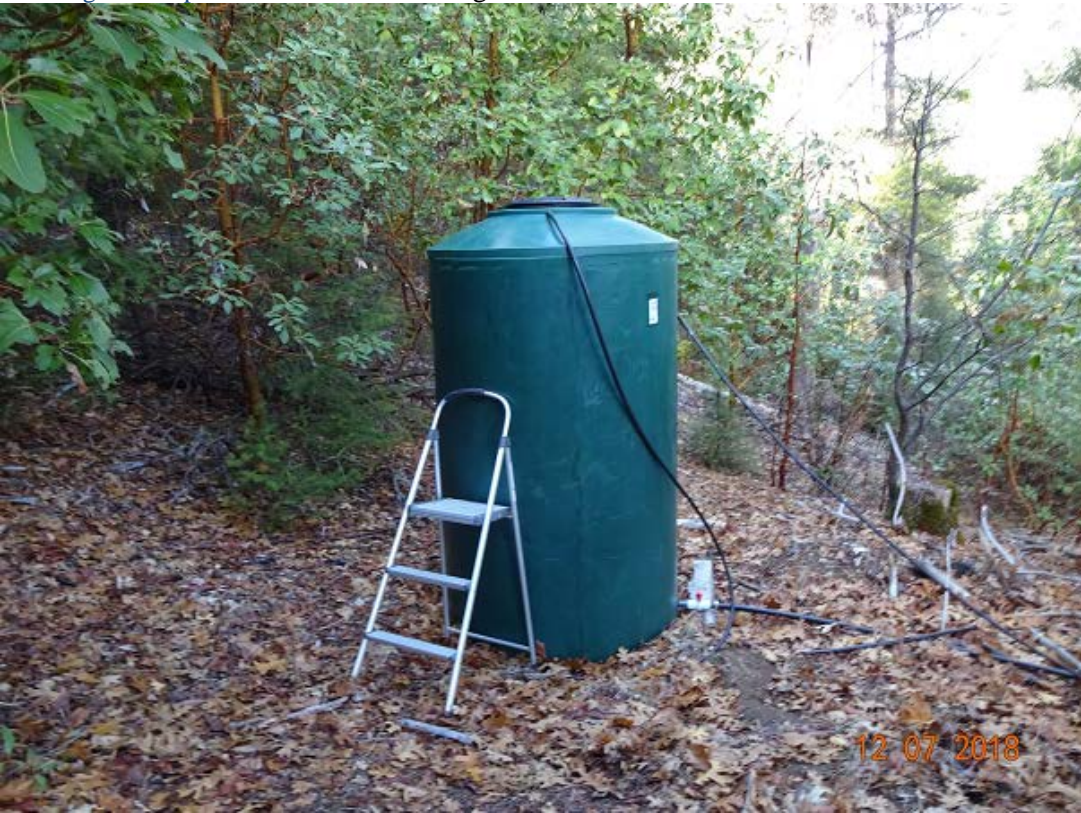
POD ID: 5
Storage ID: 6
Storage Type: 500-gallon tank
Storage Lat/Long: 39.651595°, -123.037796°
Storage Capacity (Gal): 500 gallons
Storage Description: Fullstorage tank for POU3

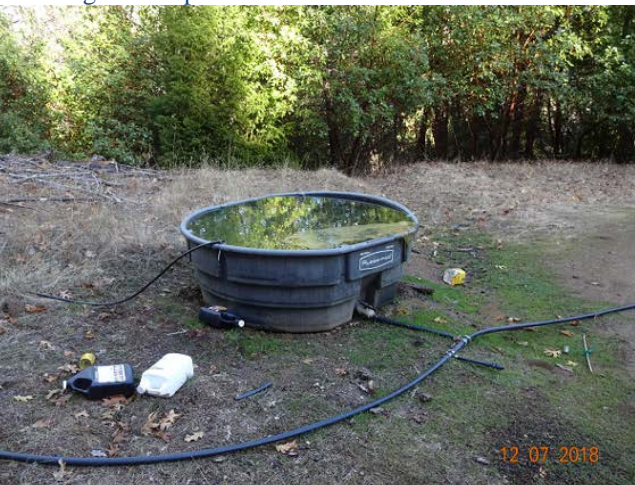
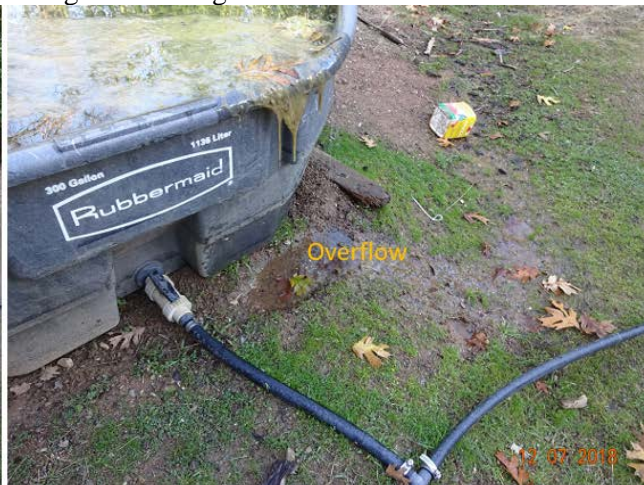
POD ID: 5
Storage ID: 7
Storage Type: Plastic Tub
Storage Lat/Long: 39.651442°, -123.037671°
Storage Capacity (Gal): 300 gallons
Storage Description: Overflow. Water was coming from Storage ID 6.

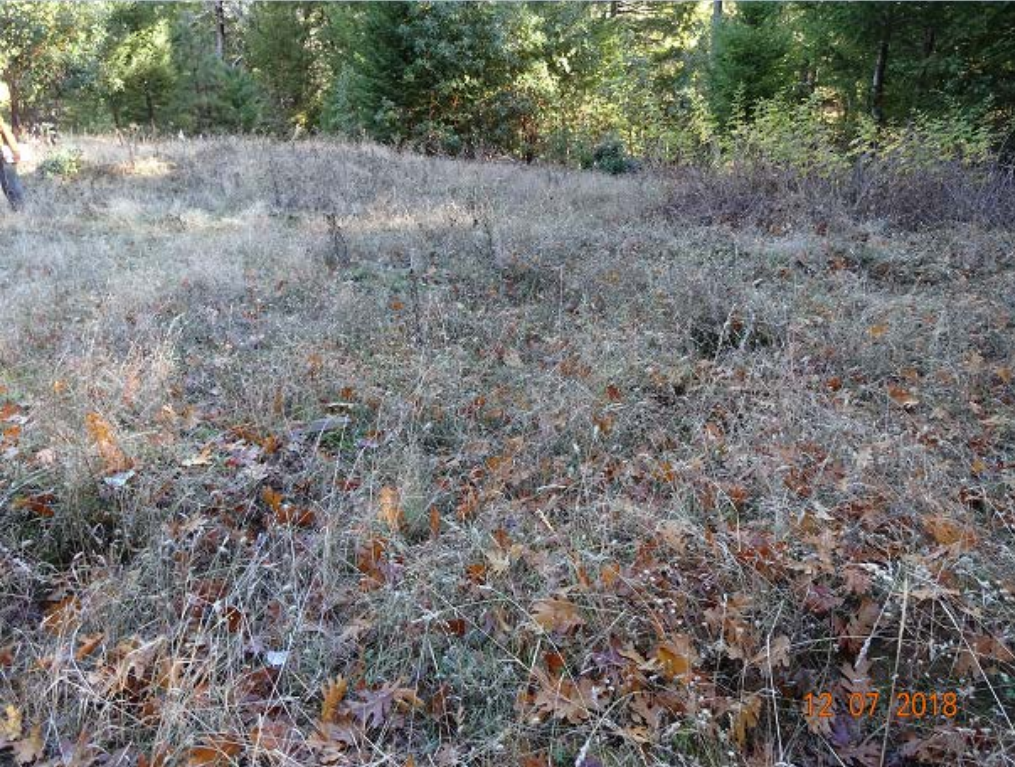
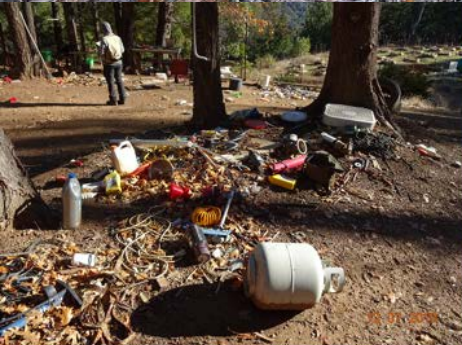
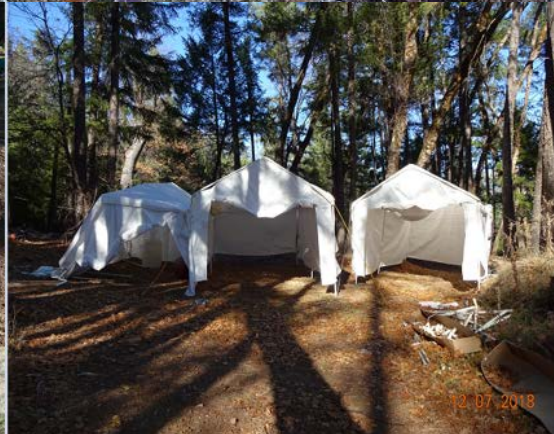
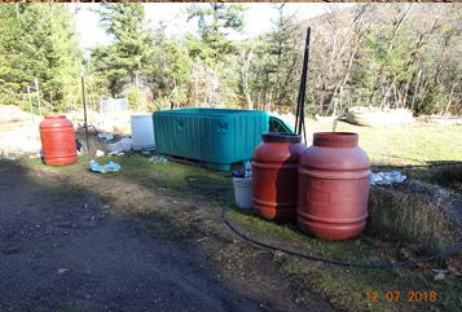
POD ID: 1
POU ID: Spring shows as blue dot on the detail map
POU Lat/Long: 39.652018°, -123.039711°
POU Type: Cannabis Grow,
POU Description: Counted approximately 90 holes from previous cultivation. Observed multiple fertilizer containers, trash, and 3 hoop houses
Number of Cannabis Plants 0
Grow Area 8640 sqft

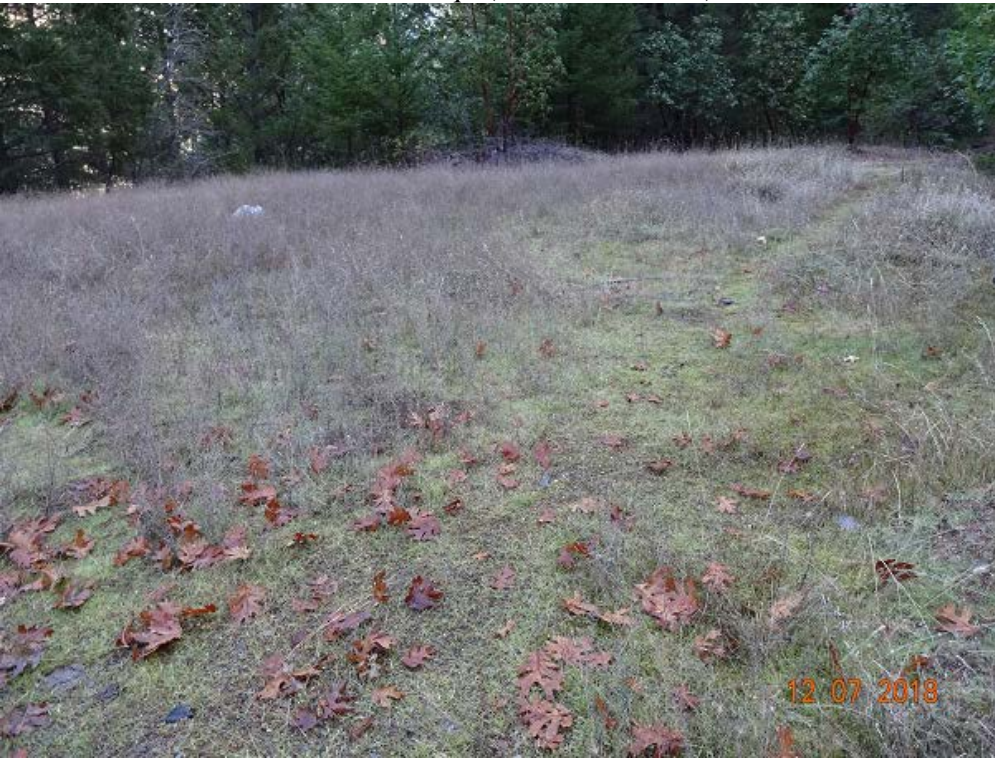
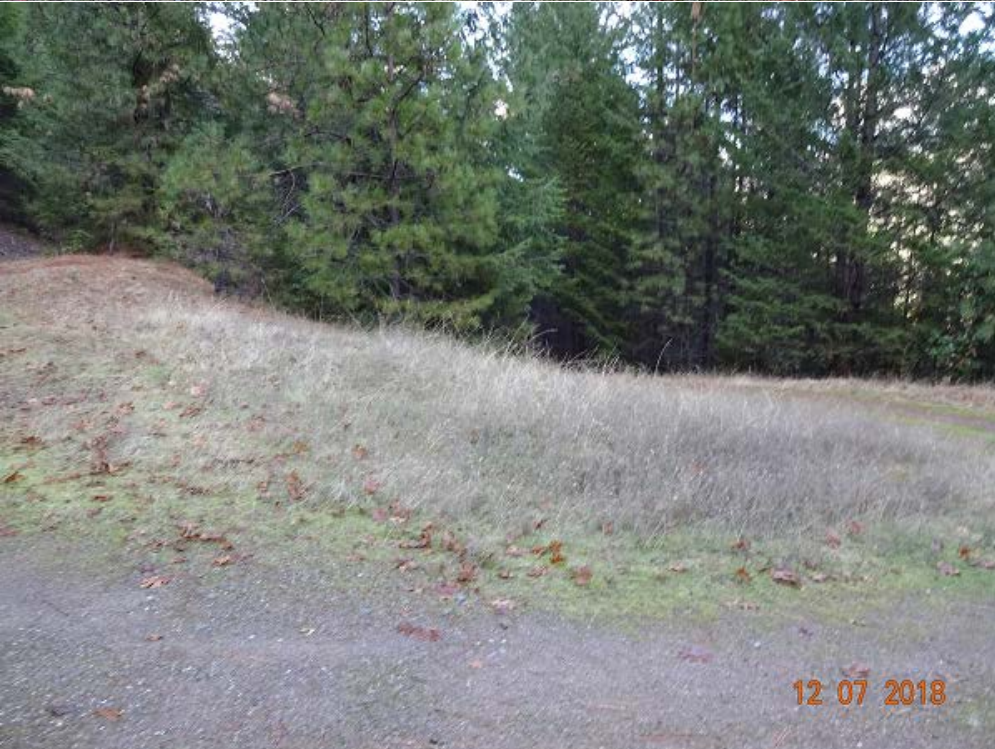
POD ID: 1
POU ID: 2
POU Lat/Long: 39.652865°, -123.039663°
POU Type: Cannabis grow site
POU Description: Counted approximately 15 holes from previous cultivation
Number of Cannabis Plants 0
Grow Area 8080 sqft (both sides of road)

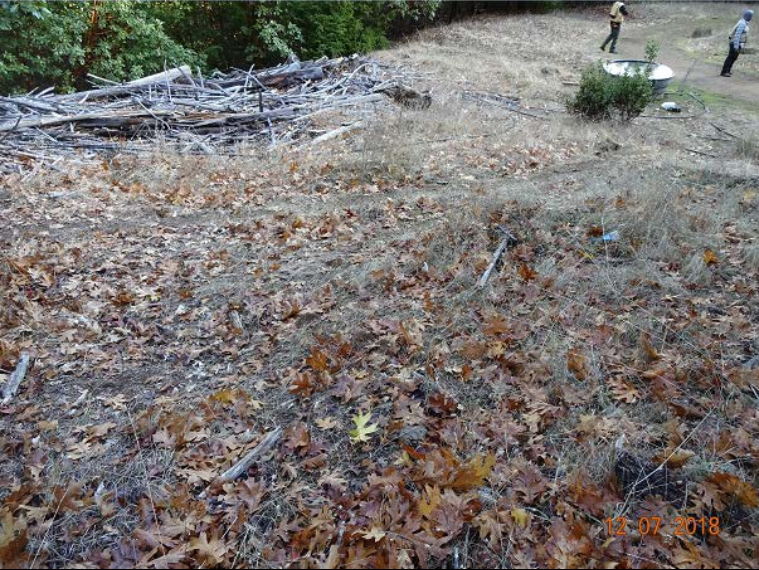
POD ID: 5
 POU ID: 3
 POU Lat/Long: 39.651425°, -123.037673°
 POU Type: Cannabis grow site
 POU Description: Counted approximately 90 holes from previous cultivation. Google Earth imagery date 8/12/2017 shows active cultivation.
 Number of Cannabis Plants 0
 Grow Area 4000 sqft (both sides of road)

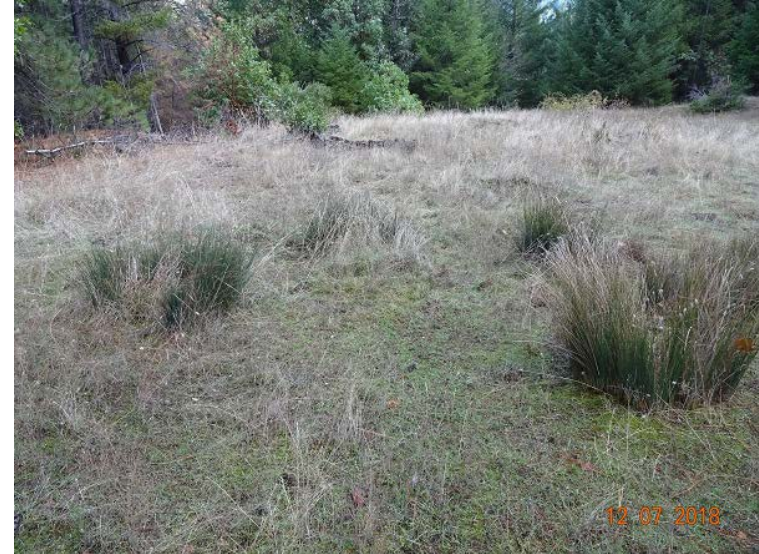
POD ID: 5
 POU ID: 4
 POU Lat/Long: 39.652338°, -123.035571°
 POU Type: Cannabis grow site
 POU Description: Counted about 39 holes from previous cultivation. Google Earth imagery date 8/12/2017 shows cultivation. This is not on his property. Site is on Mendocino National Forest
 Number of Cannabis Plants 0
 Grow Area 8300 sqft

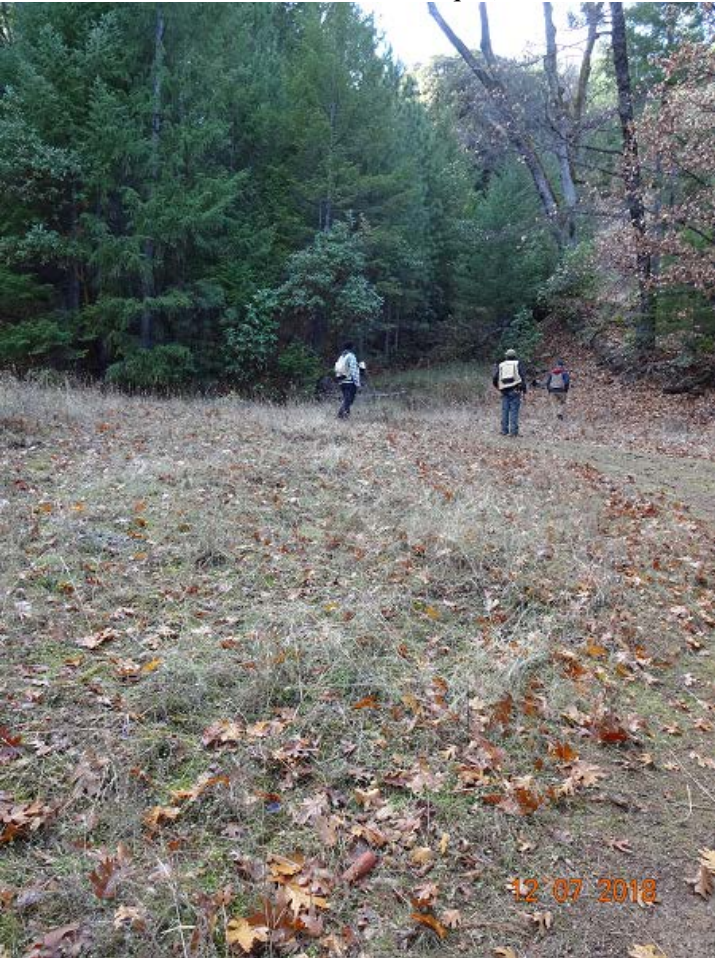
POD ID: 5
POU ID: 5
POU Lat/Long: 39.649662°, -123.034722°
POU Type: Cannabis grow site
POU Description: Old abundant truck remained. Counted about 49 holes from previous cultivation. Google Earth imagery date 8/12/2017 shows cultivation.
Number of Cannabis Plants 0
Grow Area 7800 sqft (both sides of road)

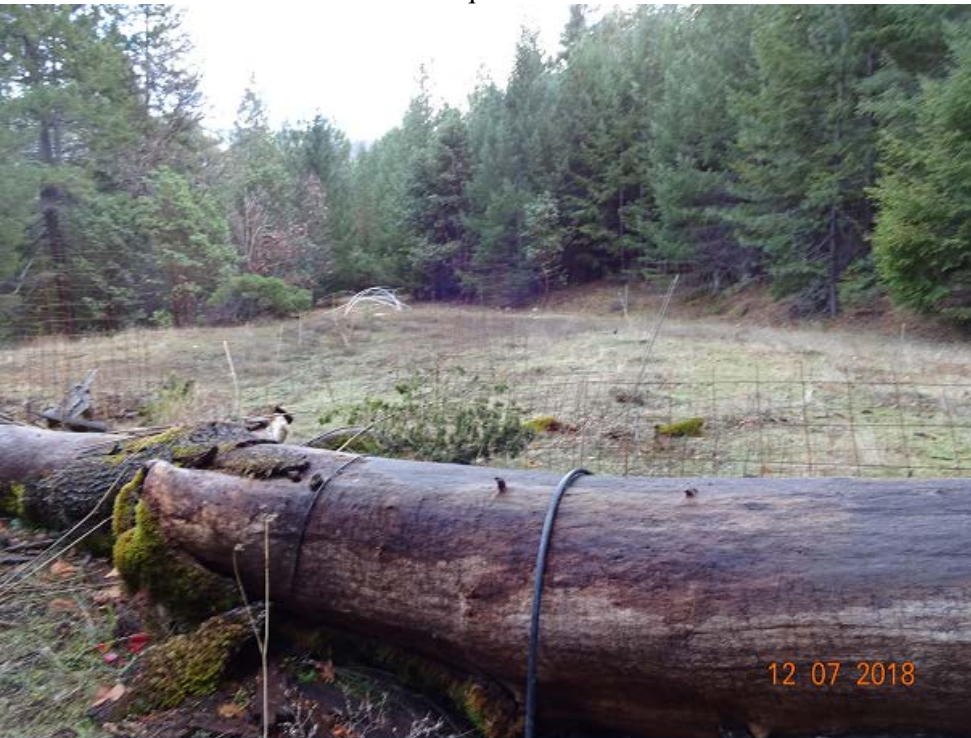
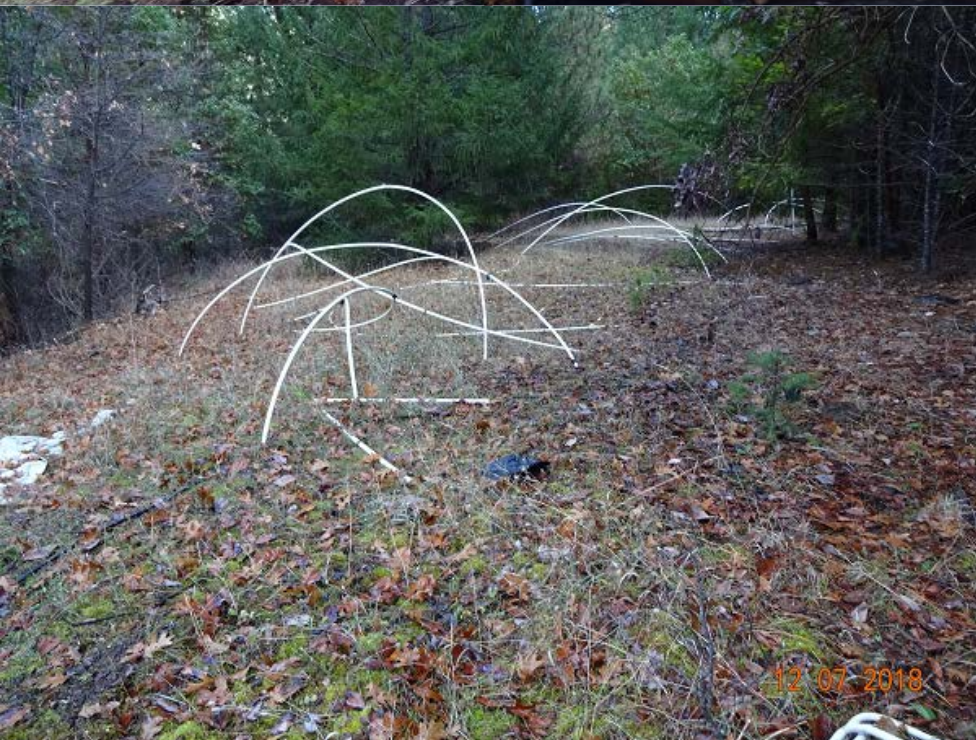
POD ID: UNK
POU ID: 6
POU Lat/Long: 39.649529°, -123.036656°
POU Type: Cannabis grow site
POU Description: Hoop house structure remained. Counted about 76 holes from previous cultivation. Google Earth imagery date 8/12/2017 shows cultivation.
Number of Cannabis Plants 1
Grow Area 10118 sqft

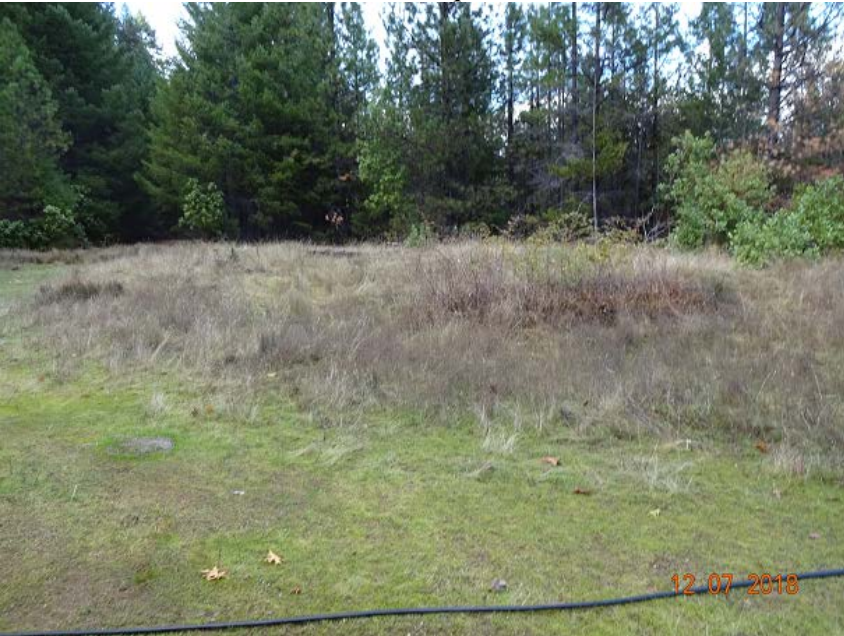
POD ID: Unknown
POU ID: 7
POU Lat/Long: 39.649180°, -123.037437°
POU Type: Cannabis grow site
Google
POU Description: Counted about 30 holes from previous cultivation. Earth imagery date 8/12/2017 shows cultivation.
Number of Cannabis Plants 0
Grow Area 7200 sqft

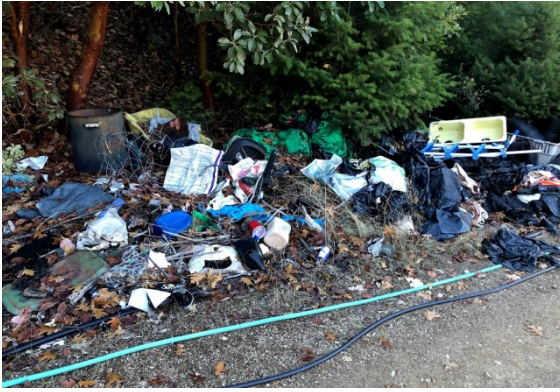
PHOTO 1

Non-Secure Garbage Storage

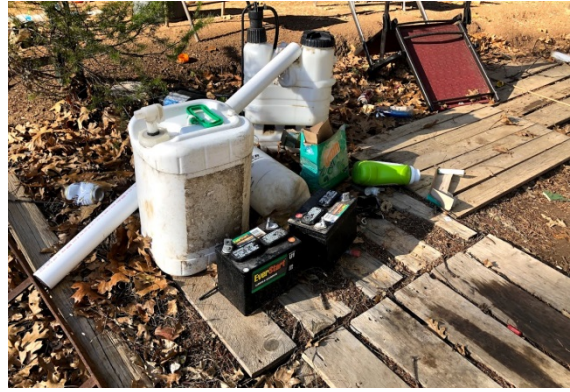
PHOTO 2

Exposed Batteries and Cleaning Materials

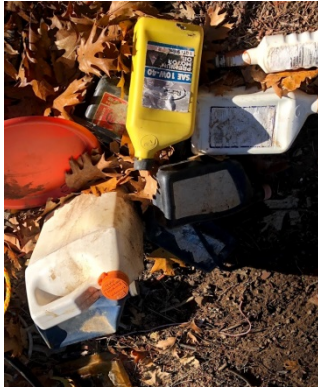
PHOTO 3

Garbage (Including Oil, Chemicals, Containers)

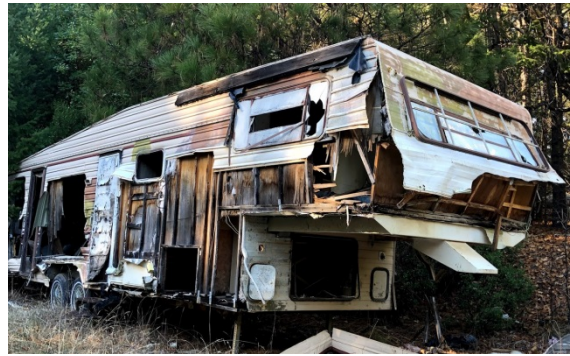
PHOTO 4

Abandoned Trailer

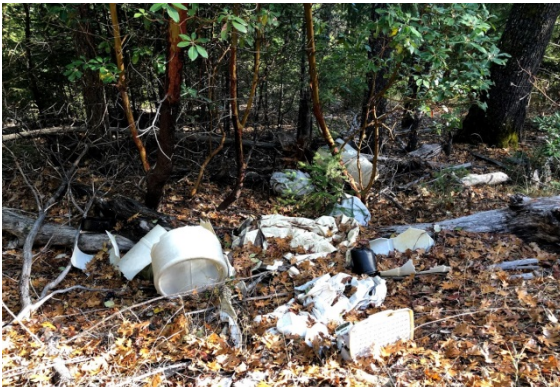
PHOTO 5

Non-Secure Garbage

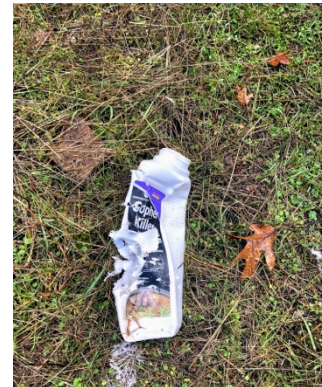
PHOTO 6

Animal Poison W/ Puncture Marks

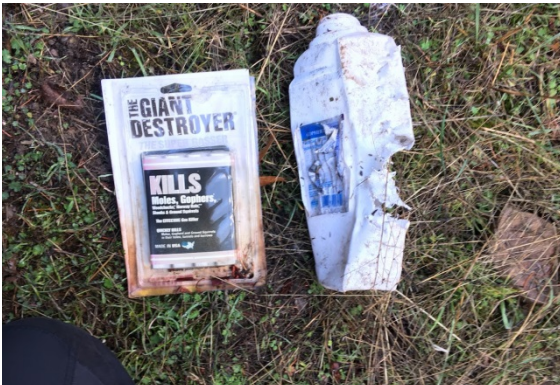
PHOTO 7

Animal Poison

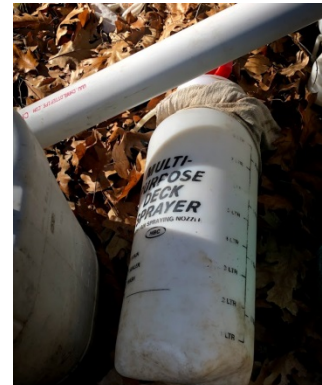
PHOTO 8

Non-Secure Chemical Sprayer

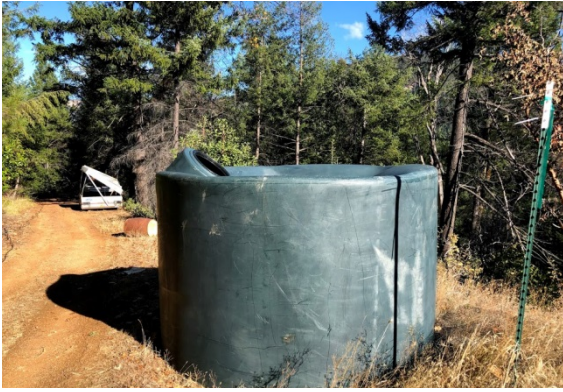
PHOTO 9

Damaged Water Tank

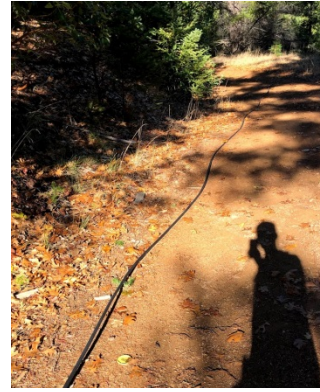
PHOTO 10

Exposed Irrigation Line
