**ZONING ADMINISTRATOR
STAFF REPORT- ADMINISTRATIVE**

**MARCH 14, 2019
AP_2018-0061**

REQUEST: Administrative Permit request for a large mixed light cannabis cultivation site (Type 2B (10000 ft²); AG_2017-0779) of no more than 10,000 ft² of canopy.

EXHIBIT Q: AP_2018-0061-Site Inspection Photographs

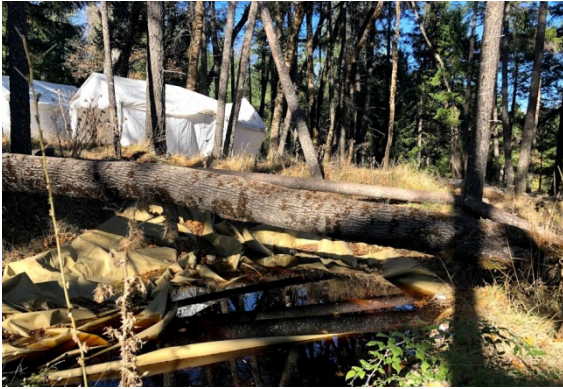
PHOTO 11

Water Bladder for Cultivation & Cut Trees

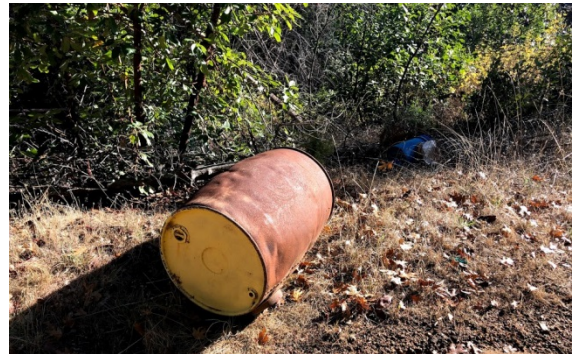
PHOTO 12

Empty Metal Barrel

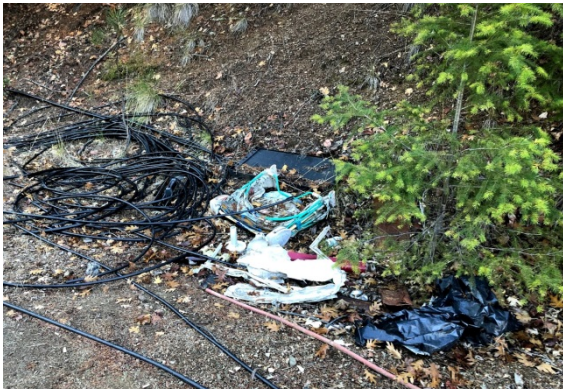
PHOTO 13

Exposed Irrigation Line and Trash

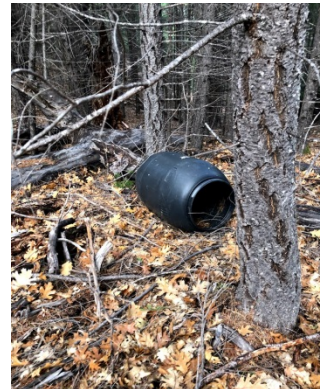
PHOTO 14

Empty Storage Container

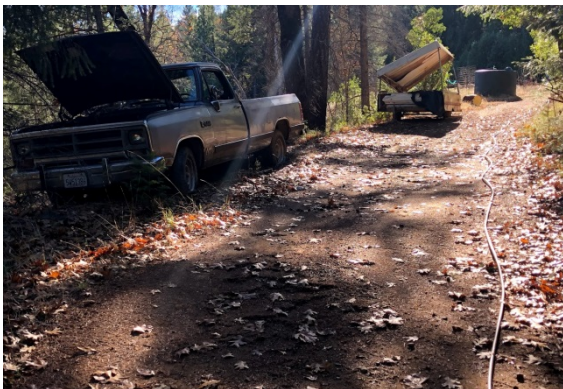
PHOTO 15

Abandoned Vehicles and Exposed Irrigation

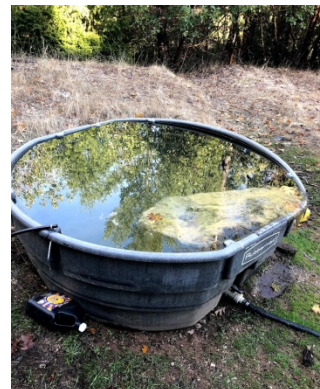
PHOTO 16

Overflowing Water Tank
