THE SECRETARY  
OF THE INTERIOR'S  
STANDARDS FOR  
REHABILITATION &

ILLUSTRATED  
GUIDELINES ON  
**SUSTAINABILITY**  
FOR  
REHABILITATING  
HISTORIC  
BUILDINGS

U.S. Department of the Interior  
National Park Service  
Technical Preservation Services

2011

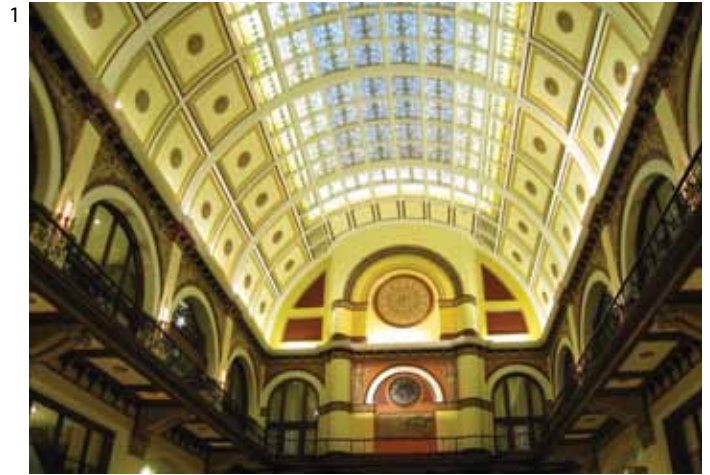
[1] Stained glass skylight provides natural light in a historic train station.

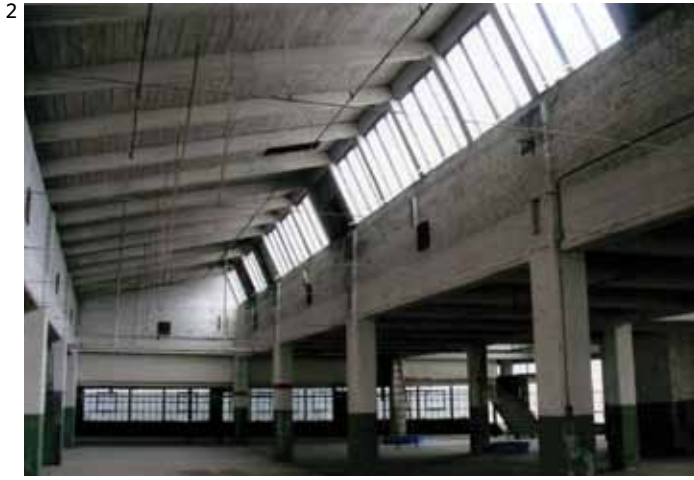
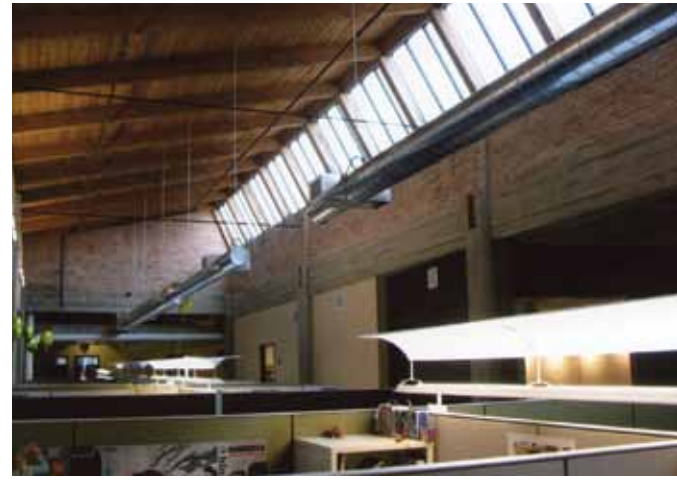
[2-3] Clerestory windows provide natural light in a historic industrial building: Before and after rehabilitation.

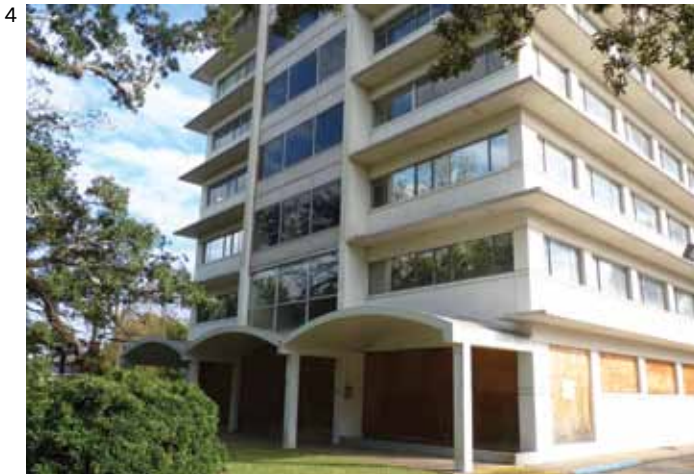
[4] Covered walkways and horizontal sun screens are distinctive and sustainable features in some mid-century modern office buildings.

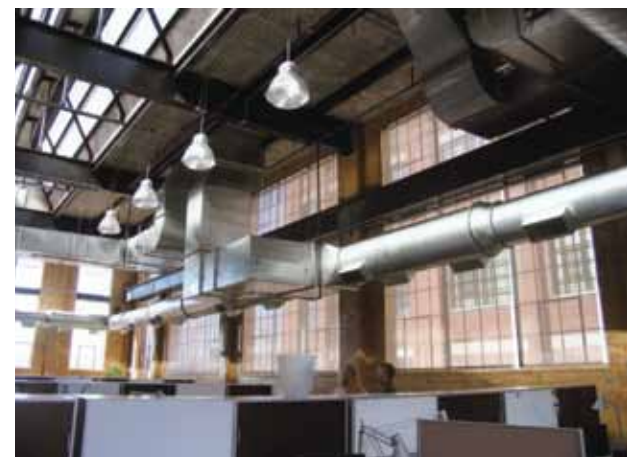
6

[5-6] Large windows and a roof monitor provide natural illumination in a historic industrial building.

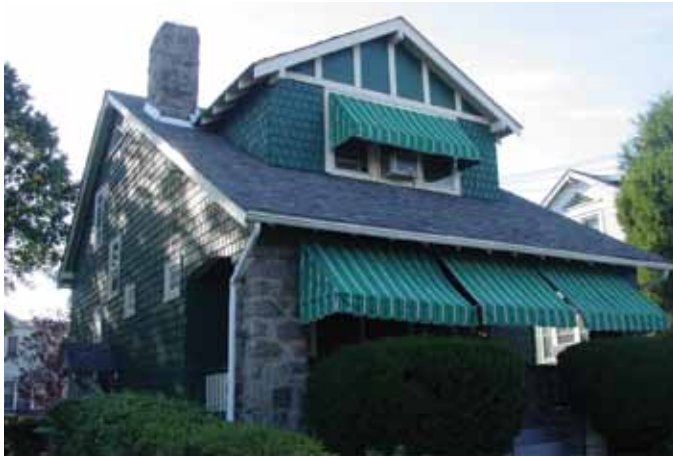
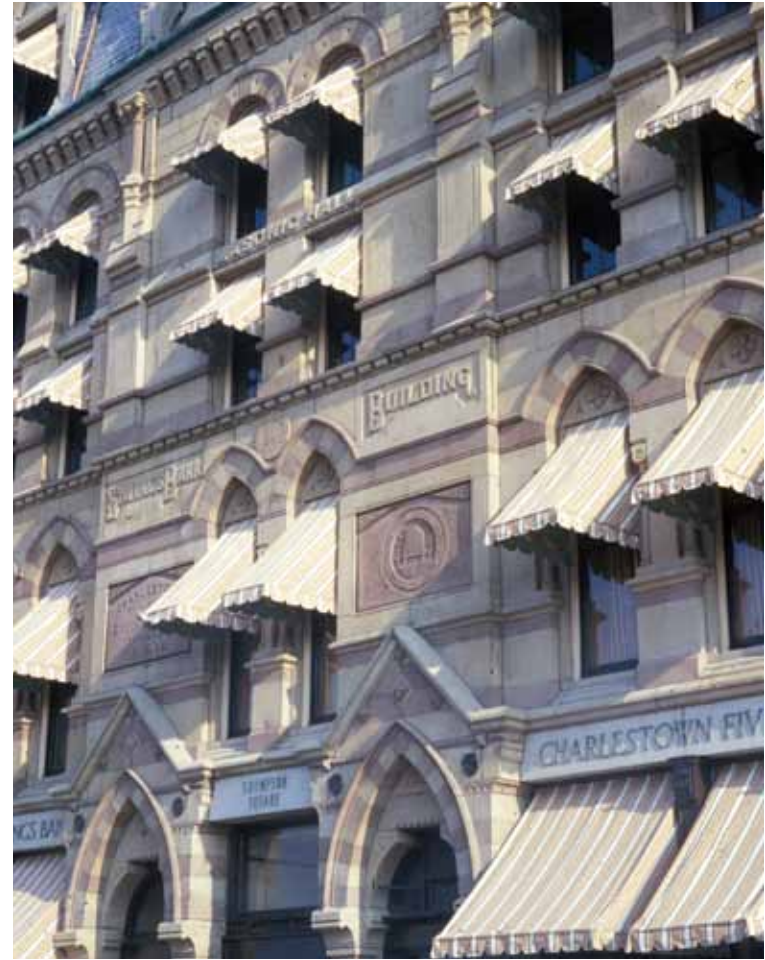
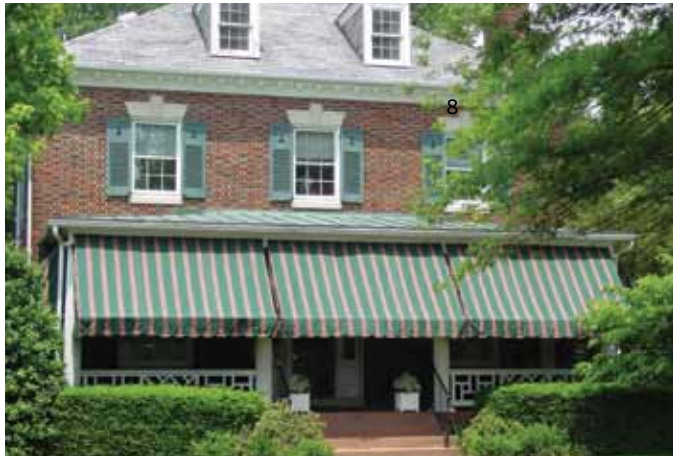
[7-9] Porches and canvas awnings provide shade and keep interiors cool in historic residential and commercial buildings.

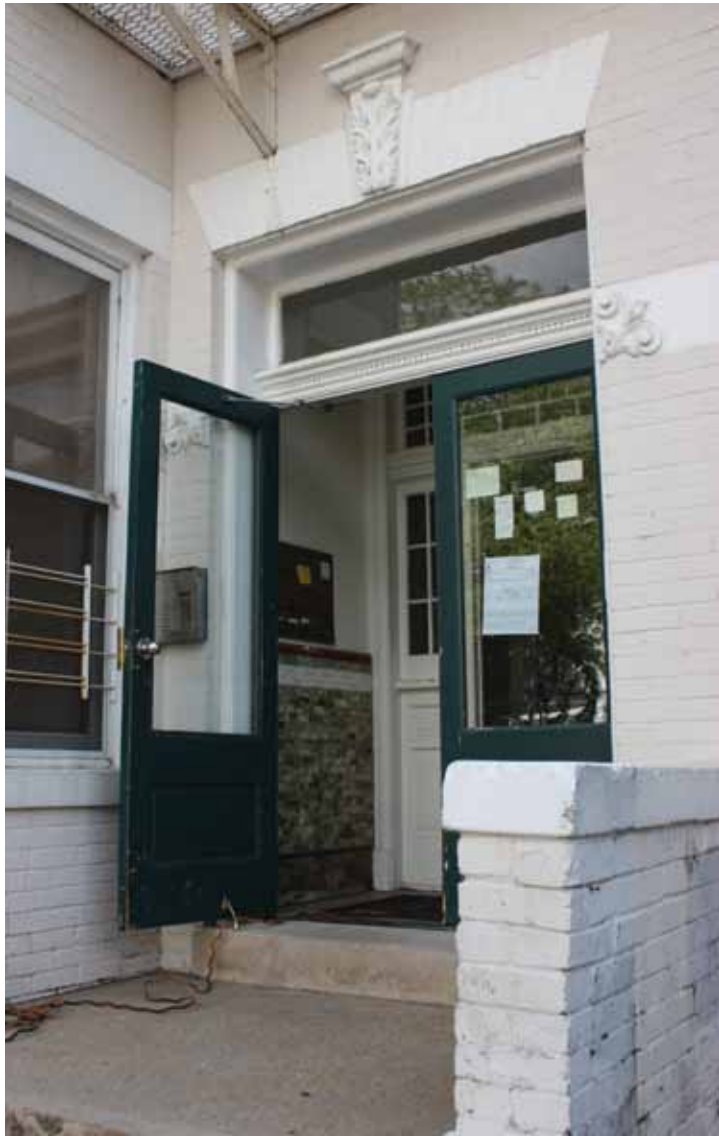
11

[11] A vestibule helps retain interior conditioned air in the living space in this historic row house.

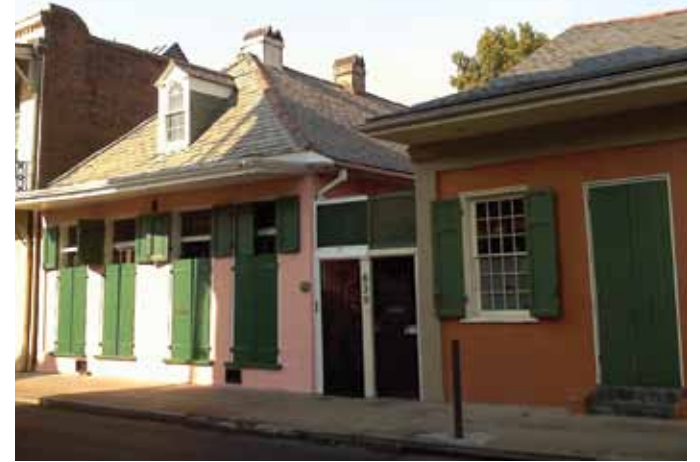
10

[10] Wood shutters provide natural light when open and keep interiors cool when closed in historic residential buildings.

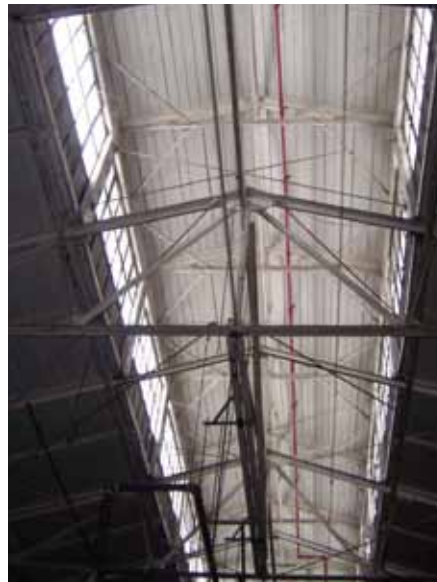
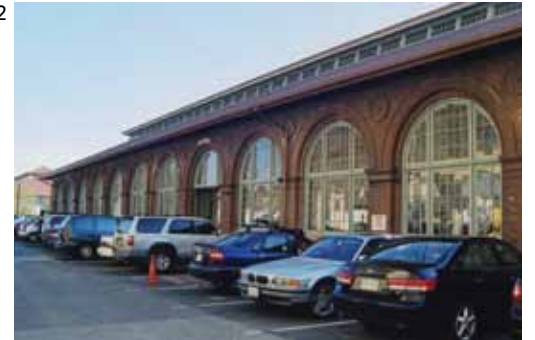
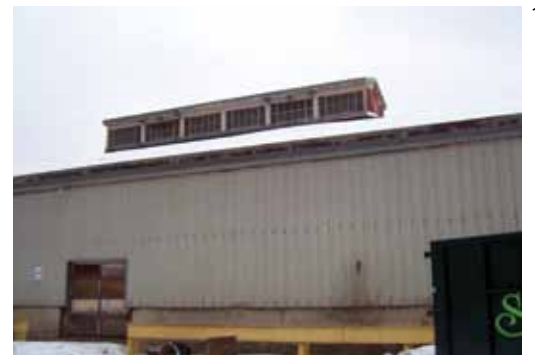
[12-14] Roof monitors provide natural light in historic industrial buildings

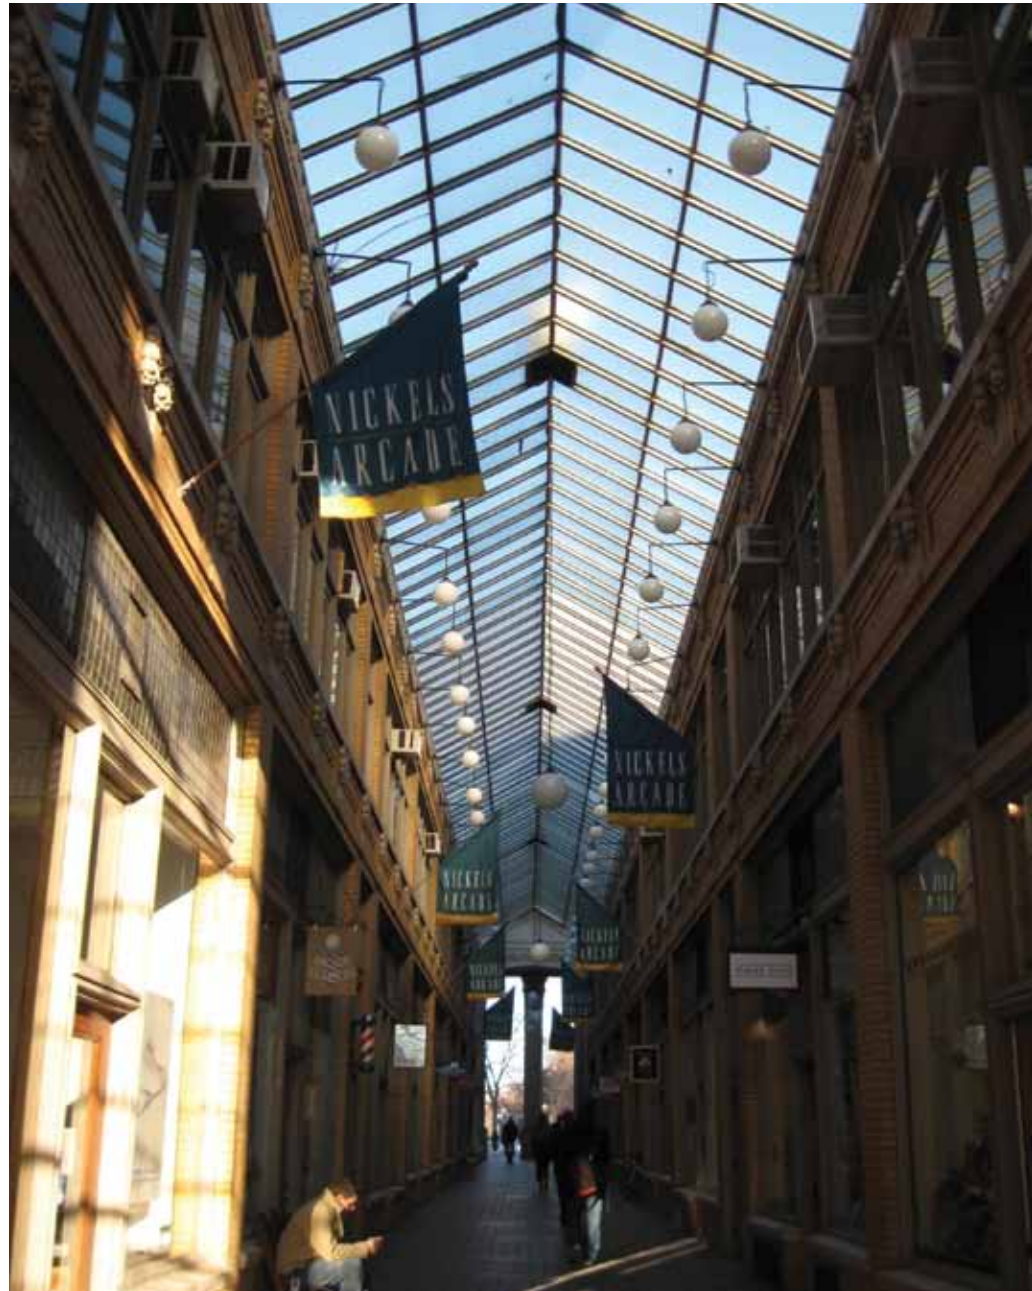
[15] Glass skylight illuminates historic shopping arcade.

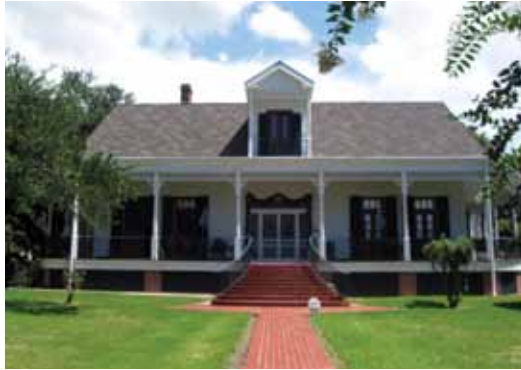
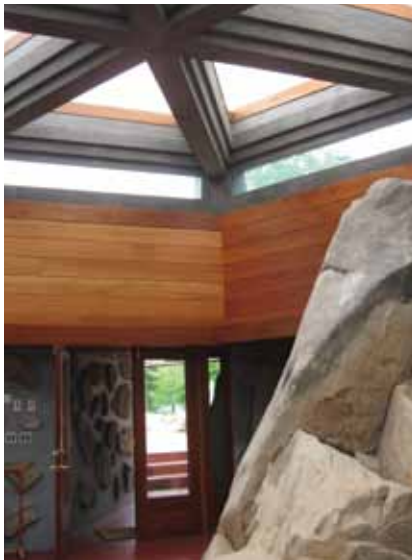
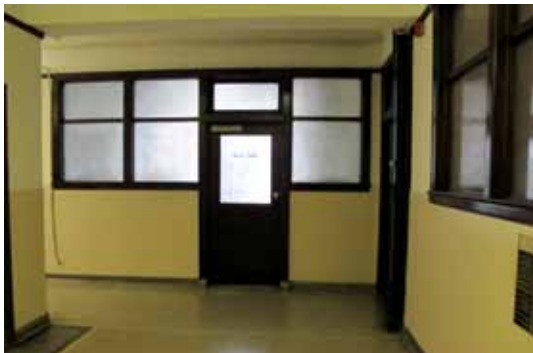
[16-18] Inherently sustainable features of historic buildings: Shutters and a deep porch keep the interior cool in a historic house in a warm climate (top); a skylight provides natural light to the interior of this mid-20th century house (center); partially glazed partitions and doors allow natural light into the corridor of a historic office building (bottom).

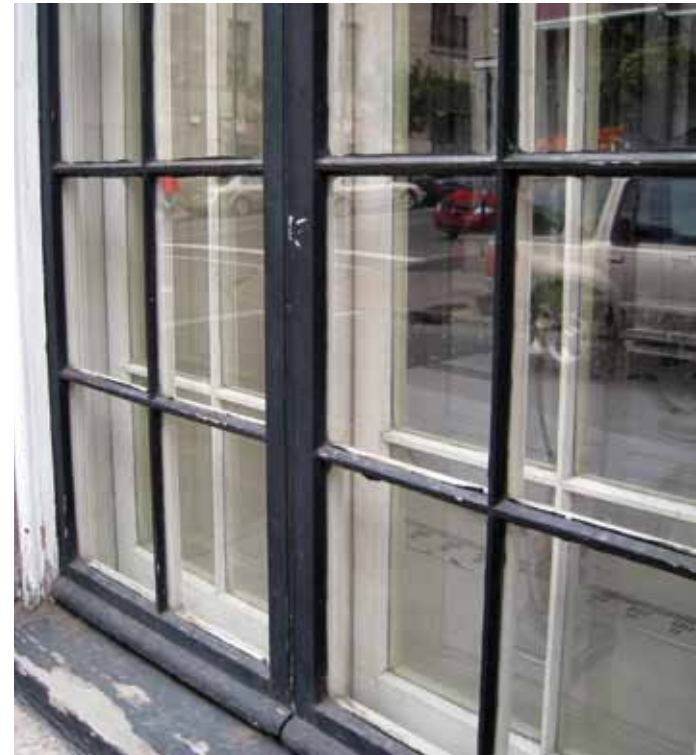
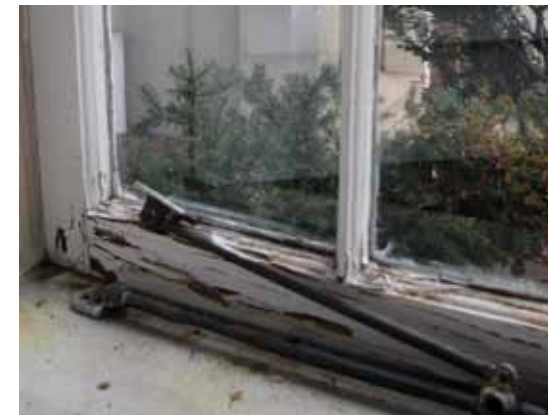
**Not Recommended:** [21-22] The peeling paint on an exterior window sill and on the interior of a window indicates that these features have not received regular maintenance. The broken casement window hardware also needs to be repaired to make the window operable.

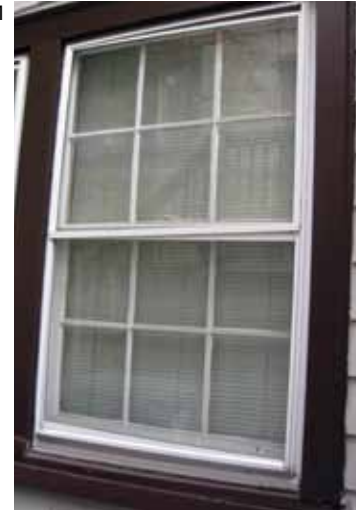
**Not Recommended:** [31-32] Ill-fitting exterior aluminum storm windows viewed from both inside and outside are clearly not energy efficient.

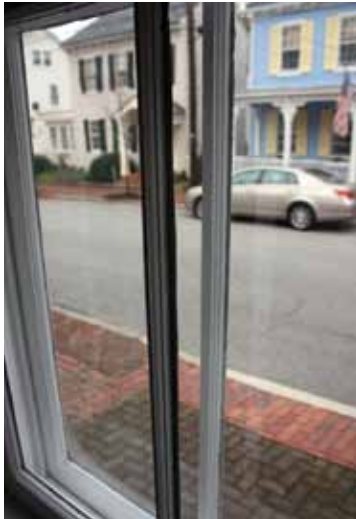
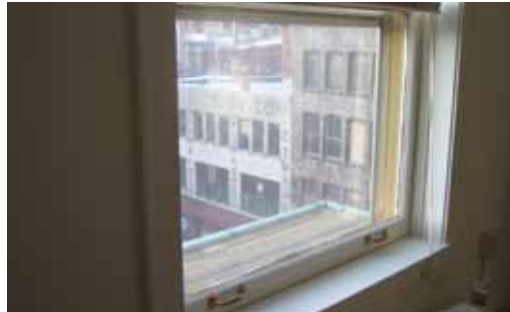
**Recommended:** [28-29] These exterior storm windows match the pane configuration of the historic interior windows in a residence and in a multi-story hotel building.

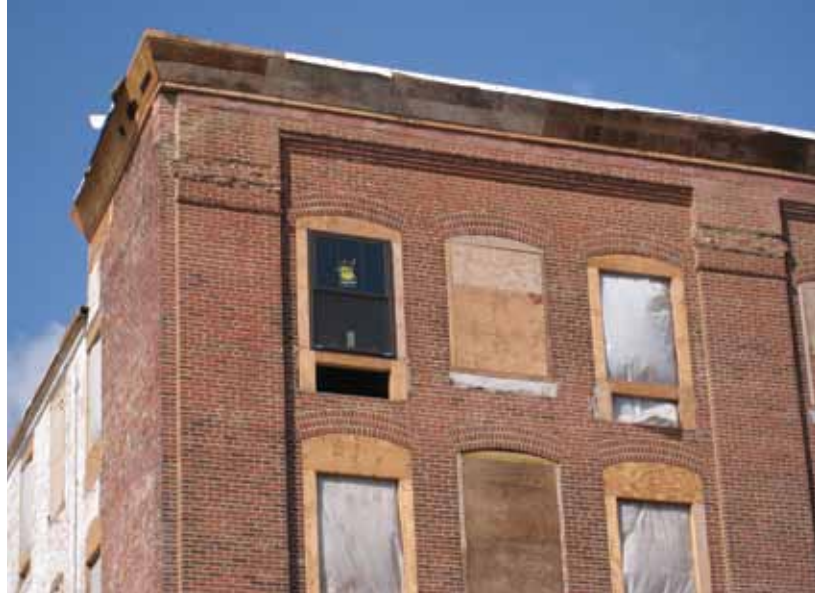
30

**Not Recommended:** [30] Not only have incompatible windows that do not fit the size and shape of the historic window openings been installed, but the original openings have also been shortened to install through-the-wall HVAC units.

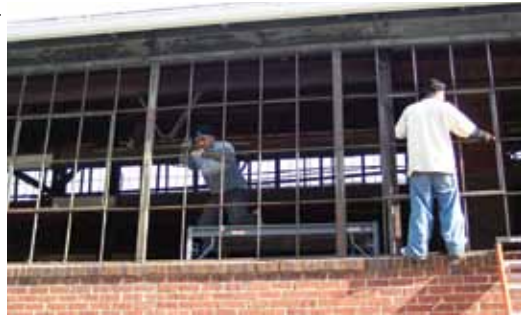
**Recommended:** [33-35] Original metal windows were appropriately repaired as part of the rehabilitation of this historic industrial building.

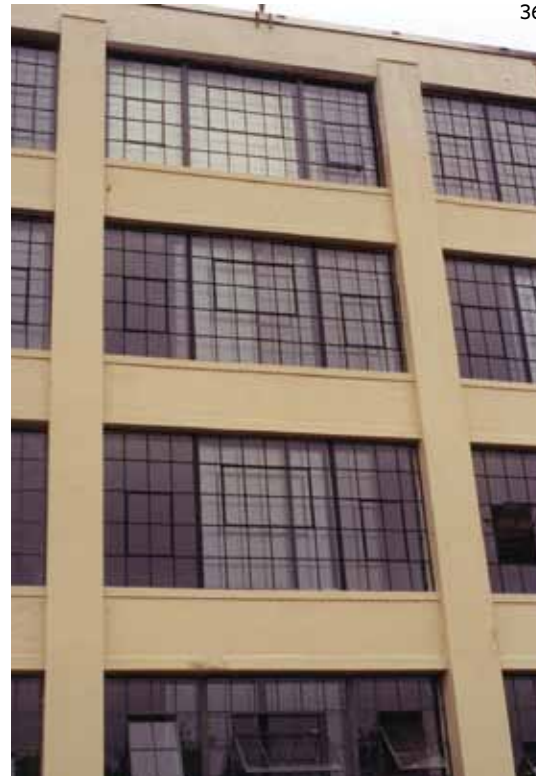
37

**Recommended:** [36-38] Original metal windows were retained and made operable during the rehabilitation of this historic mill complex. Installing patio slider doors as interior storm windows was a creative and successful solution to improve the energy efficiency of the existing windows.

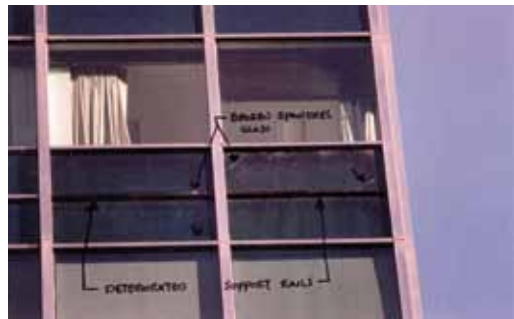
39  
**Recommended:** [39-40] The original windows, which were deteriorated beyond repair, featured a dark tint. They were replaced with a slightly lighter-tinted glazing to improve daylighting in this mid-century modern office building.

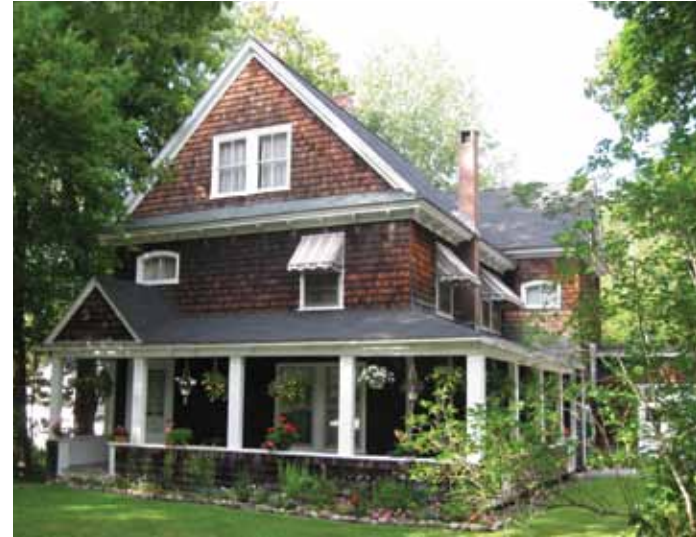
41  
**Recommended:** [41] Traditional canvas awnings should be retained when they exist on historic buildings.

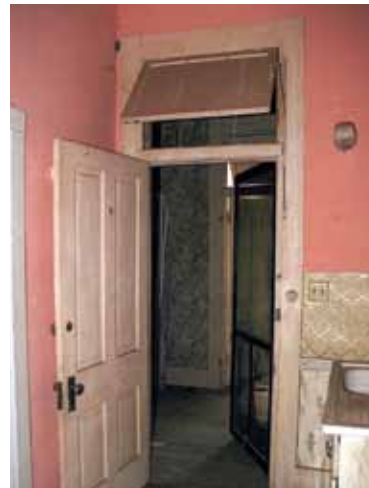
42  
**Recommended:** [43] The wall and door glazing ensures that the corridor receives natural daylight and the operable transom helps air to circulate in this historic office building.

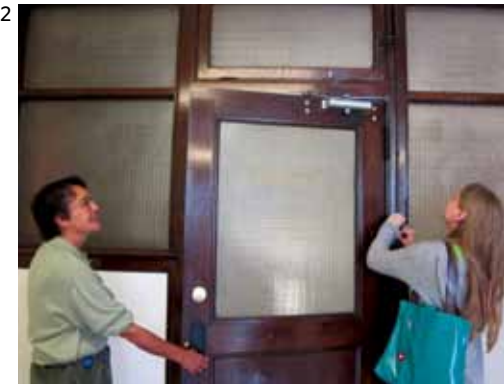
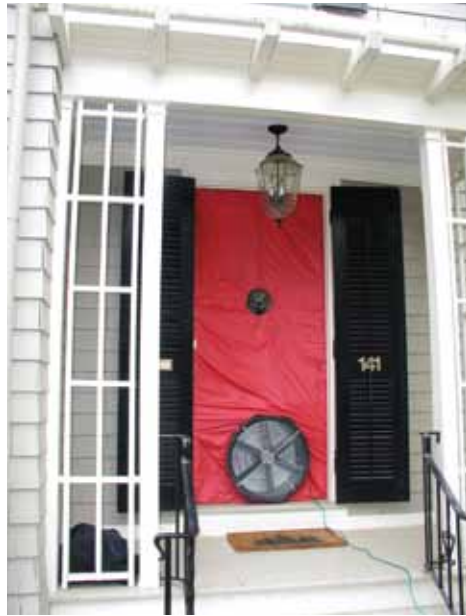
**Recommended:**  
[44-45] A blower door test is a useful tool to help identify air infiltration in a historic building before undertaking weatherization or retrofit treatments.  
*Top Photo: Robert J. Cagnetta, Heritage Restoration, Inc.*

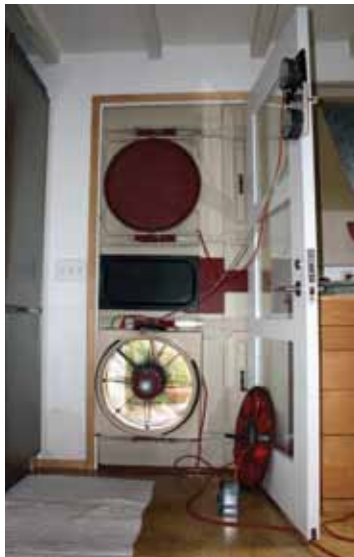
45

**Recommended:** [47-48] Insulation should be installed first in unfinished areas such as attics, crawl spaces and basements of residential buildings.

Understanding the inherent thermal properties of the historic building materials and the actual insulating needs for the specific climate and building type before adding or changing insulation.	
Insulating unfinished spaces, such as attics, basements and crawl spaces, first.	Insulating a finished space, which requires removing historic plaster and trim, before insulating unfinished spaces.

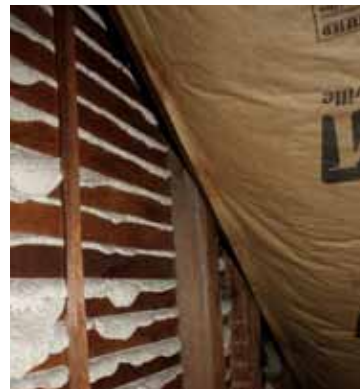
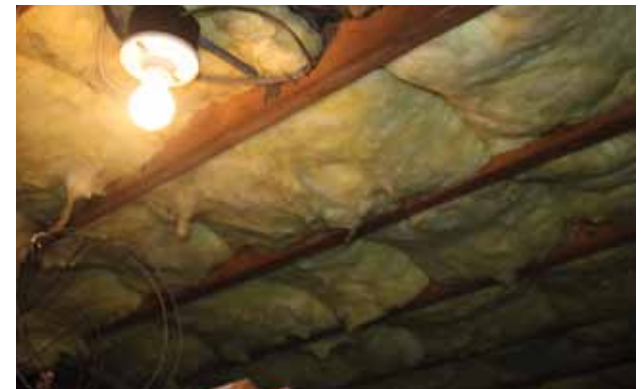
[50-51] When wall insulation was installed here the walls were furred out, which created deep, historically inappropriate window recesses. The repairable historic trim was also not reinstalled.

Replacing interior plaster—removed to install insulation—with plaster or gypsum board to retain the historic character of the interior, and in a manner that retains the historic proportion and relationship of the wall to the historic windows and trim.	Replacing interior plaster—removed to install insulation—with gypsum board that is too thick and that alters the historic proportion and relationship of the wall to the historic windows and trim.
Reinstalling historic trim that was removed to install insulation.	Replicating trim rather than retaining and reinstalling historic trim that is repairable.

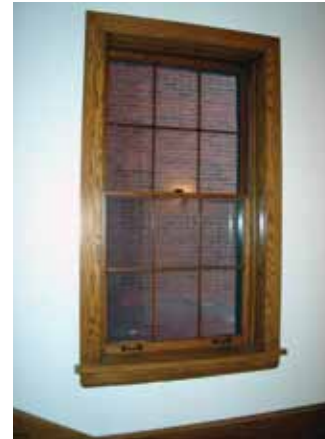
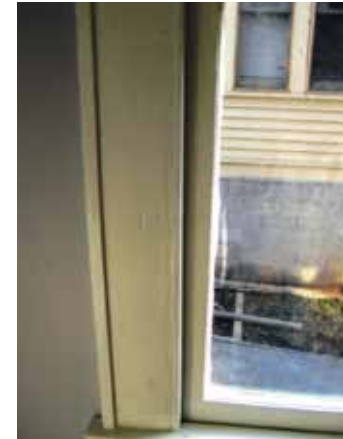
**Recommended:** [52-53] The original proportion and relationship of the wall to the windows and trim, which is important in defining the character of these historic interior spaces, has been retained here.

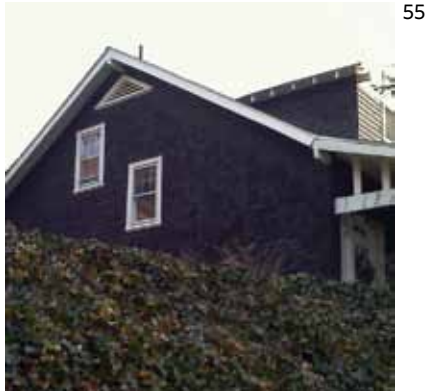
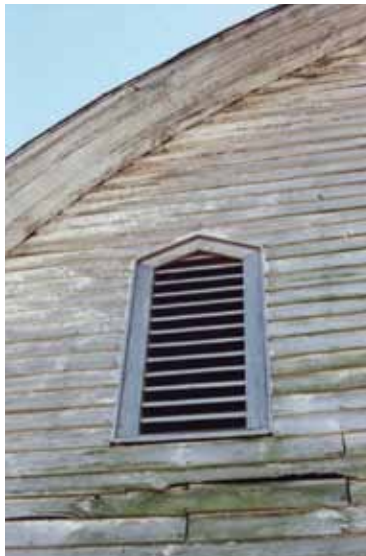
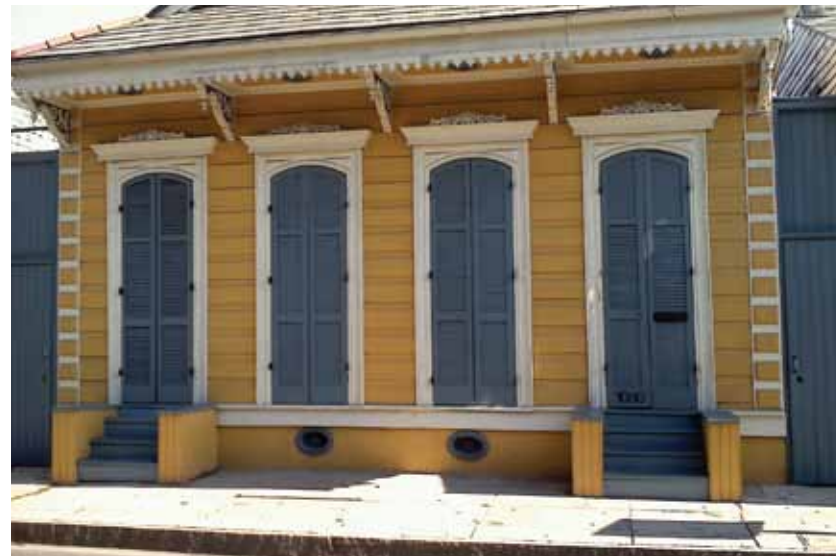
**Recommended:** [55-57]  
Wood vents in the gable ends of a historic house and a barn and cast-iron oval vents in a masonry foundation traditionally helped air circulate.

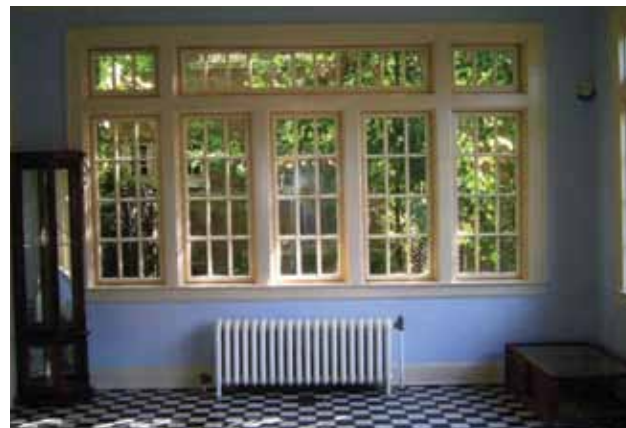
60

**Recommended:** [60] Original radiators that are still functional and efficient were retained in the rehabilitation of this historic house.

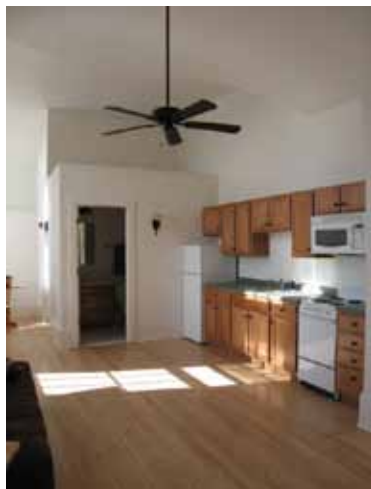
58

**Recommended:** [58] Ceiling fans enhance the efficiency of HVAC systems in historic buildings.

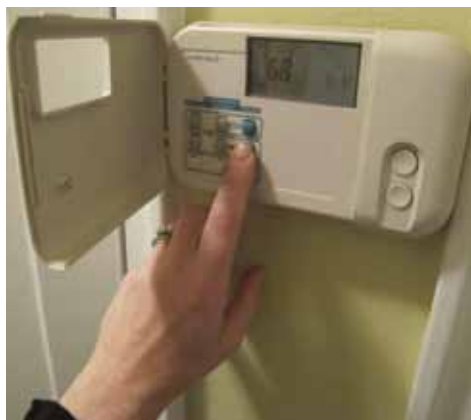
59

**Recommended:** [59] Installing a programmable thermostat can help existing systems to operate more efficiently.

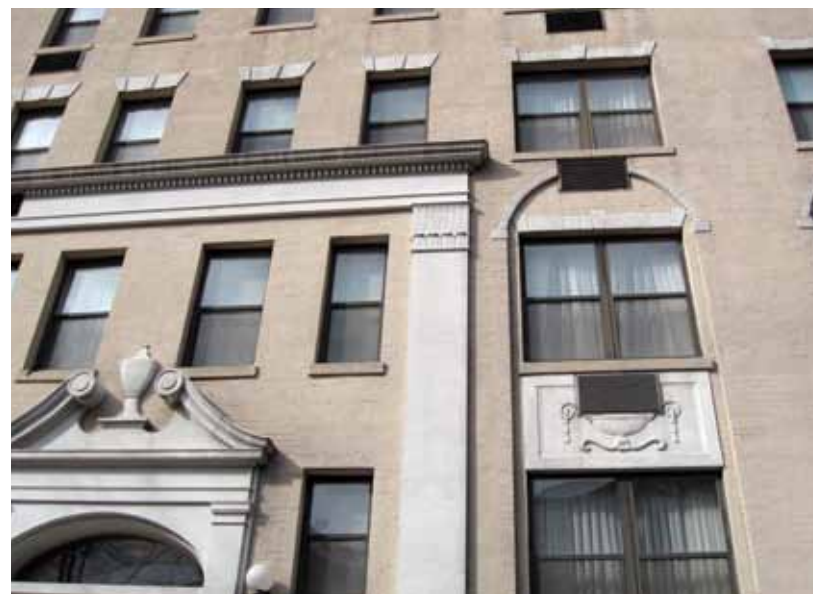
61

**Not Recommended:** [61] The cuts made in the brick and the decorative stone trim to install through-the-wall air conditioners have not only destroyed building material, but have also negatively impacted the character of this historic apartment building.

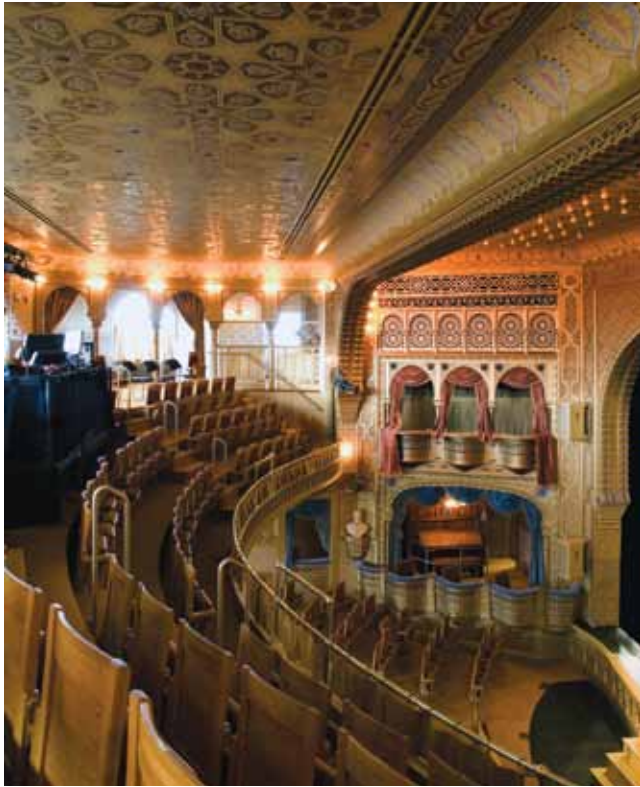
**Recommended:** [62-63] Carefully installed new mechanical ductwork is barely visible in the elaborately decorated ceiling of this historic theater.

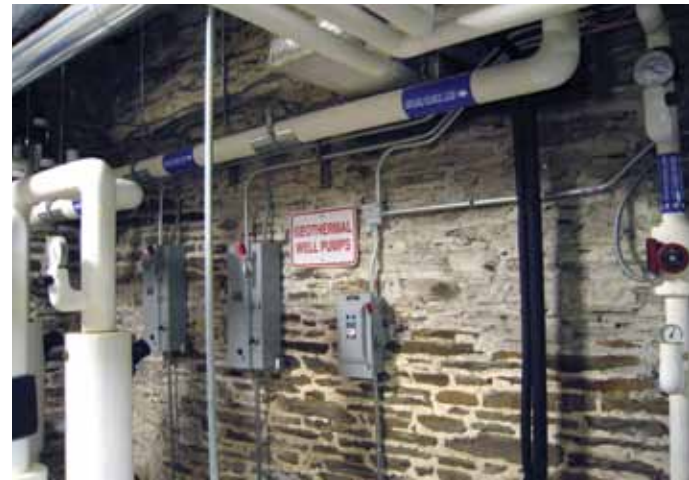
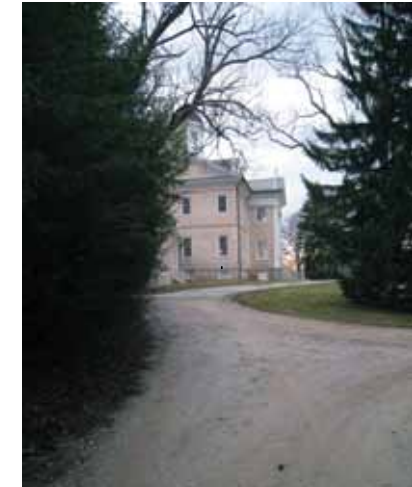
**Recommended:** [70-71] A geothermal system was installed on the property of this historic mansion, but only after an archeological investigation was conducted of the grounds.

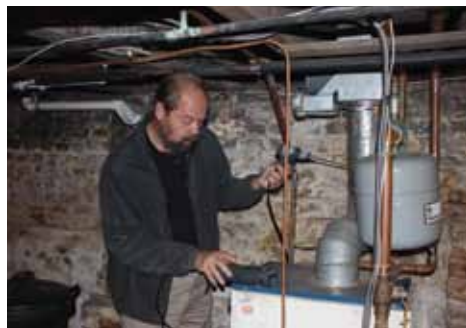
67

**Recommended:**[67] A professional energy auditor analyzes the performance of an existing furnace to ensure it is operating efficiently.

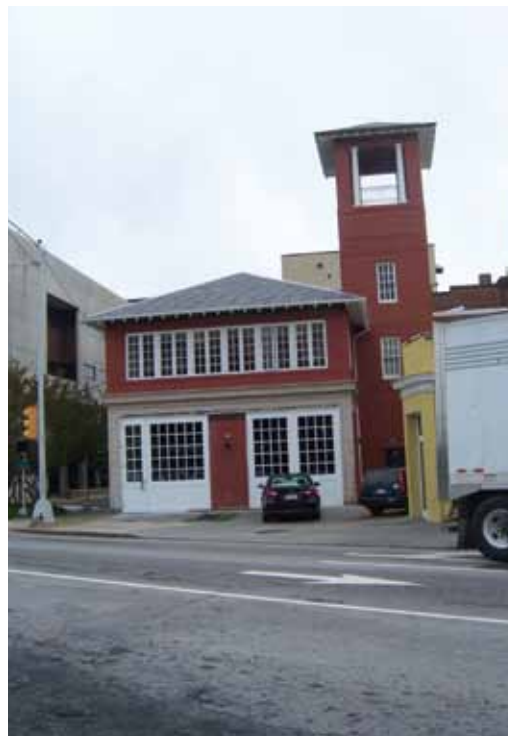
68

[68-69] A geothermal system, evidenced by a panel in the sidewalk, was installed on the site of this historic firehouse during rehabilitation.

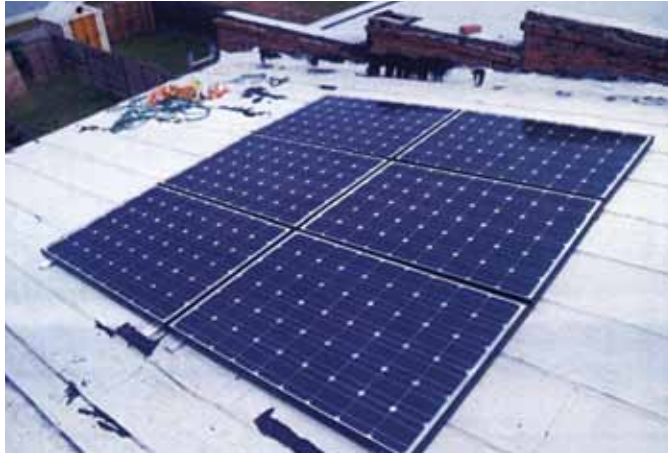
72

**Recommended:** [72-73] Solar panels were installed appropriately on the rear portion of the roof on this historic row house that are not visible from the primary elevation.

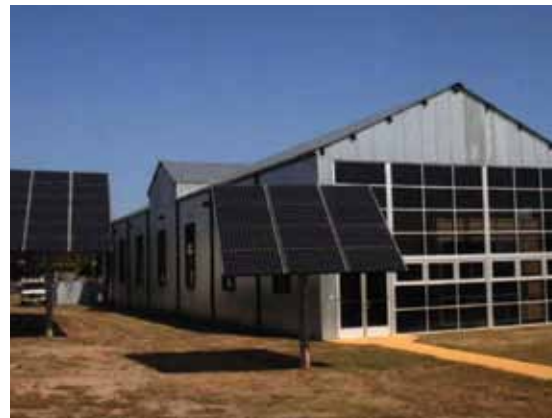
74

**Recommended:** [74] Free-standing solar panels have been installed here that are visible but appropriately located at the rear of the property and compatible with the character of this industrial site.

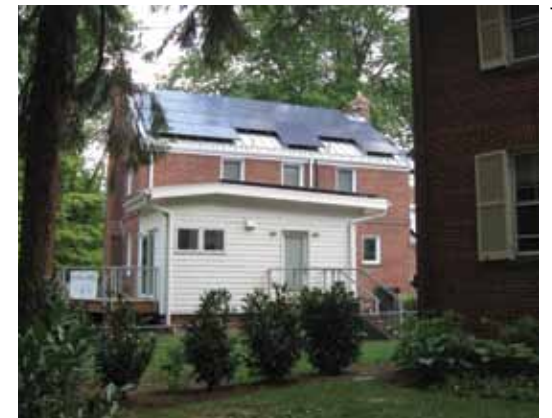
75

**Not Recommended:** [75] Solar roof panels have been installed at the rear, but because the house is situated on a corner, they are highly visible and negatively impact the character of the historic property.

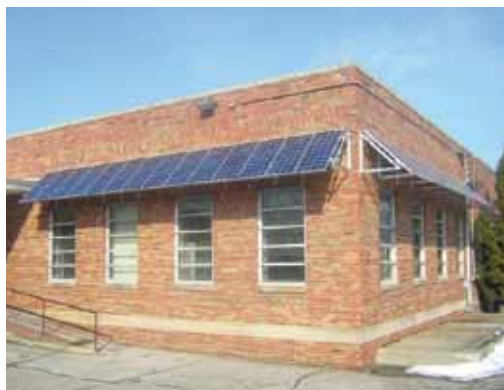
76

**Recommended:** [76-77] Solar panels, which also serve as awnings, were installed in secondary locations on the side and rear of this historic post office and cannot be seen from the front of the building. [78] Solar panels placed horizontally on the roof of this historic building are not visible from below.

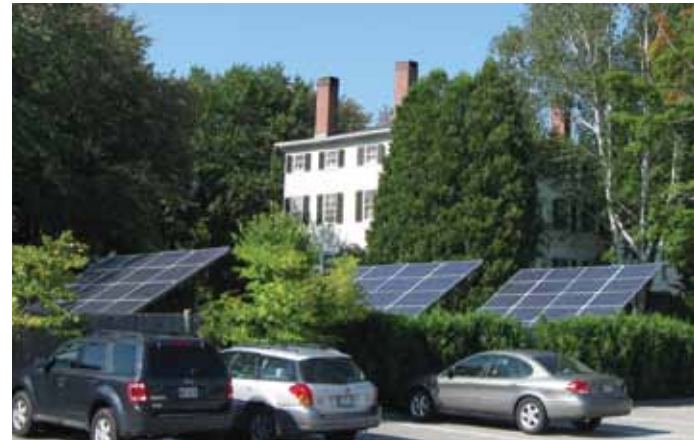
79

**Not Recommended:** [79] Although installing solar panels behind a rear parking lot might be a suitable location in many cases, here the panels negatively impact the historic property on which they are located.

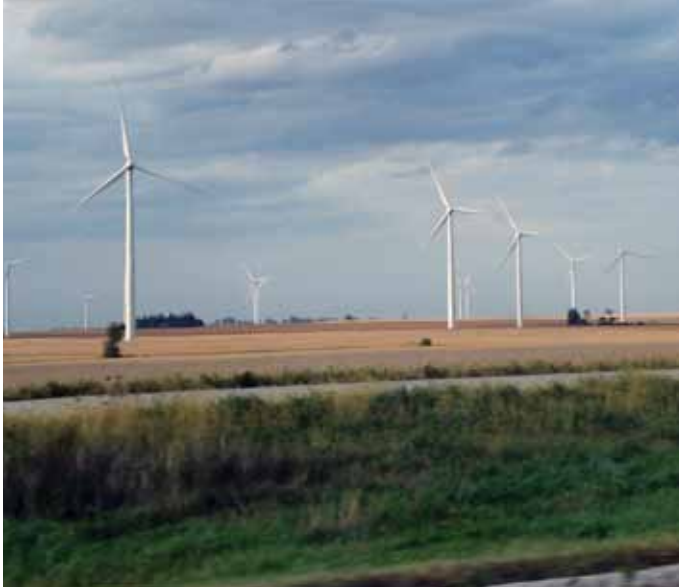
80

**Recommended:** [80] It is often best to install wind-powered equipment in off-site, rural locations to avoid negatively impacting a historic building and its site.

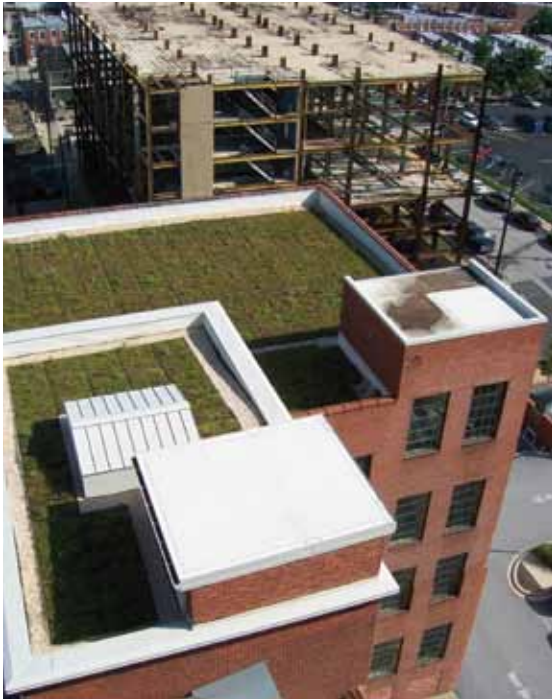
85

**Recommended:** [85-86] A cool or green roof is best installed on a flat roof where it cannot be seen from the public right of way and will not negatively impact the character of the historic building.

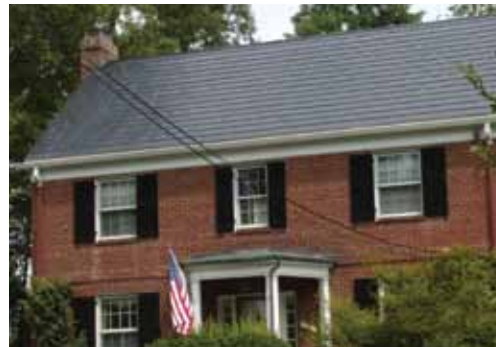
87

**Not Recommended:** [87] Historic roofing materials in good condition should be retained rather than replaced with another material perceived as more sustainable, such as, in this case, solar roofing shingles.

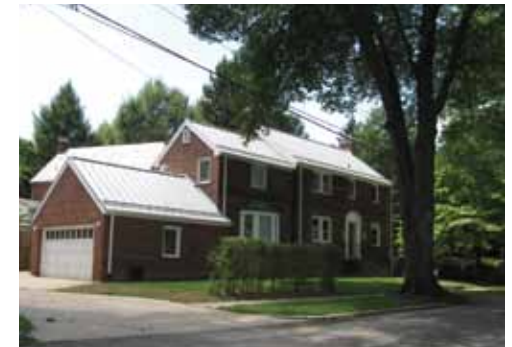
88

**Not Recommended:** [88] This new, cool white metal roof is not an appropriate material or color for this historic mid-20th century house.

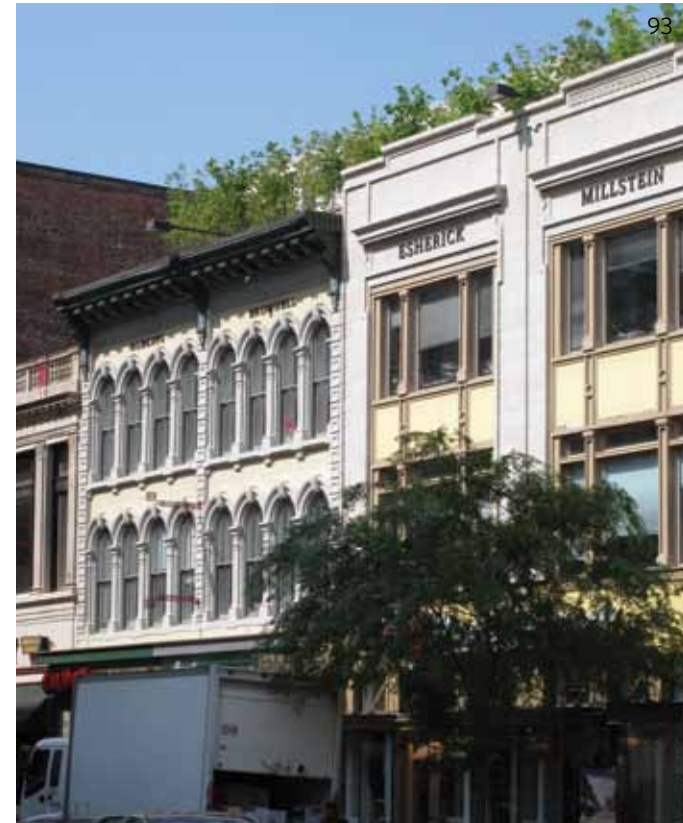
93

**Not Recommended:** [93] The vegetation on these green roofs has grown too tall and negatively impacts the character of these historic commercial buildings.

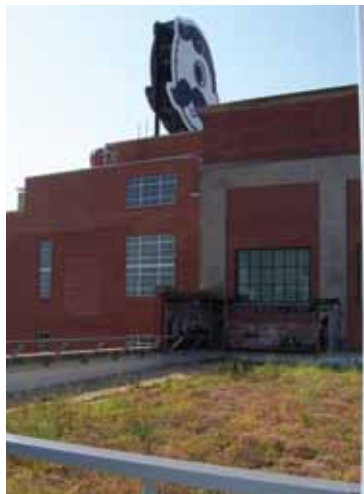
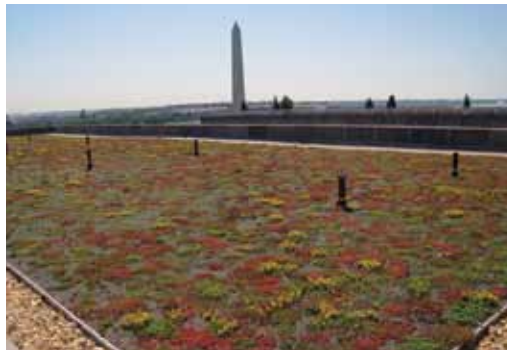
**Recommended:** [89-92] Low-scale and sustainable native plants are appropriate for these roof gardens on historic buildings.

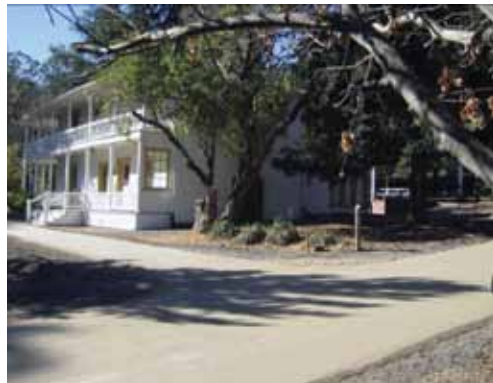
95

**Recommended:** [94-95] Permeable pavers were used at this historic residential property for a driveway and parking (above) and a hard-packed, construction aggregate provides environmentally-friendly paths for visitors at this historic site (below).

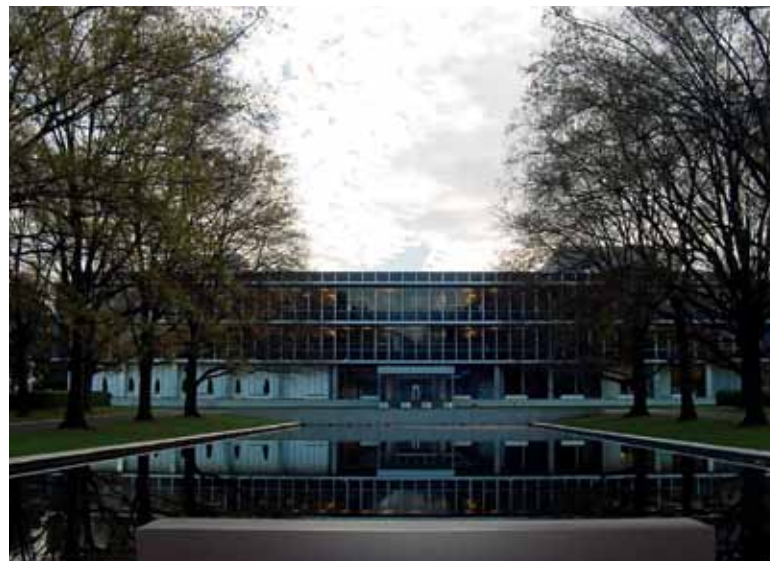
96

[96] Mature trees and a water feature contribute to the sustainability of this mid-twentieth century property.

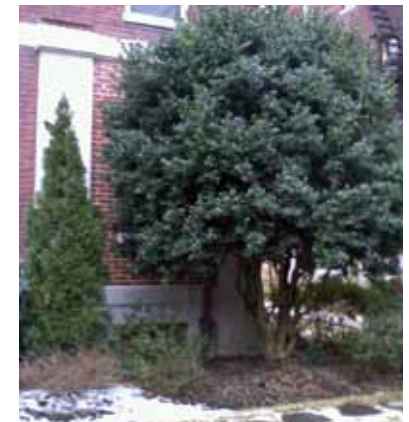
97

**Not Recommended:** [97] This tree, which was planted too close to the building, has caused the masonry wall to retain moisture that damaged the mortar and required that the brick be repointed in this area.

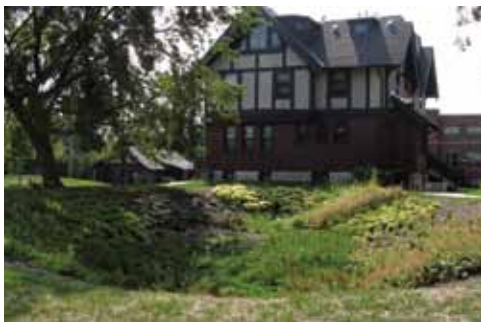
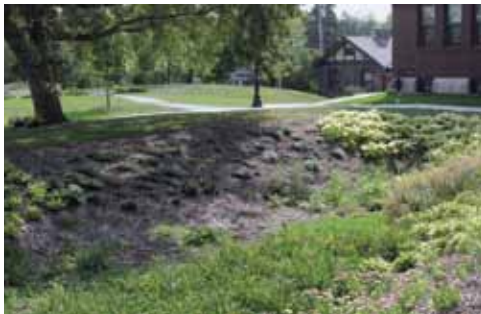
**Recommended:** [98-100] Rain gardens and rain-water collection tanks are features that may be added to a historic property to improve storm-water management and increase on-site water use.

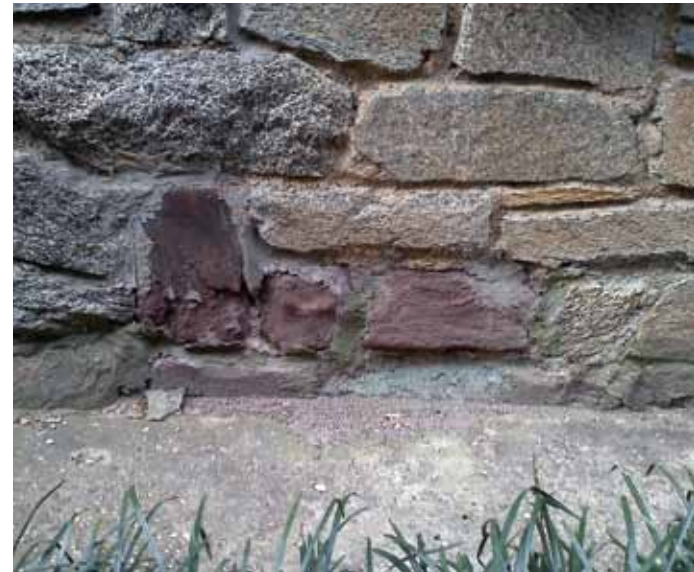
101

**Not Recommended:** [101] Splash back from the impermeable concrete paving next to the foundation is damaging these stones.

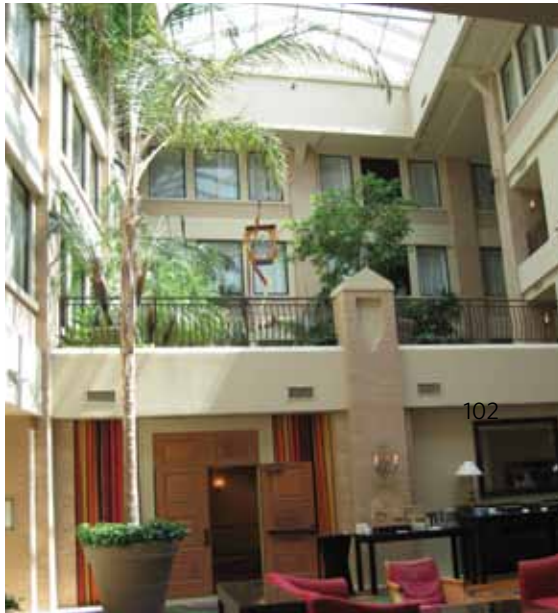
102

**Recommended:** [102-103]  
Small, covered atriums that are compatible with the character of these historic warehouses have been inserted to light the interior.

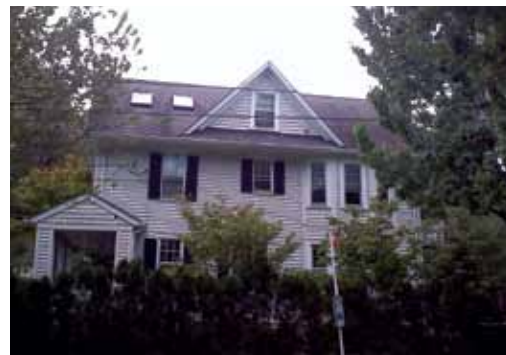
104

**Not Recommended:** [104-106]  
Skylights added on a primary roof elevation negatively impact the character of these historic houses.

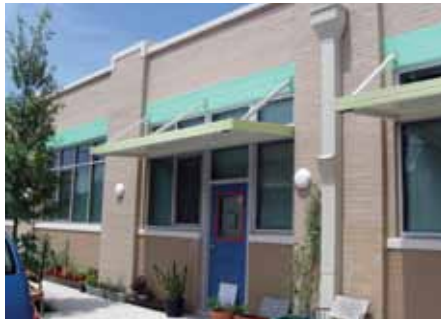
107

**Recommended:** [107] Traditional canopies compatible with the industrial character of this former factory building were installed when it was converted for residential use.
