THE SECRETARY  
OF THE INTERIOR'S  
STANDARDS FOR  
REHABILITATION &

ILLUSTRATED  
GUIDELINES ON  
**SUSTAINABILITY**  
FOR  
REHABILITATING  
HISTORIC  
BUILDINGS

U.S. Department of the Interior  
National Park Service  
Technical Preservation Services

2011

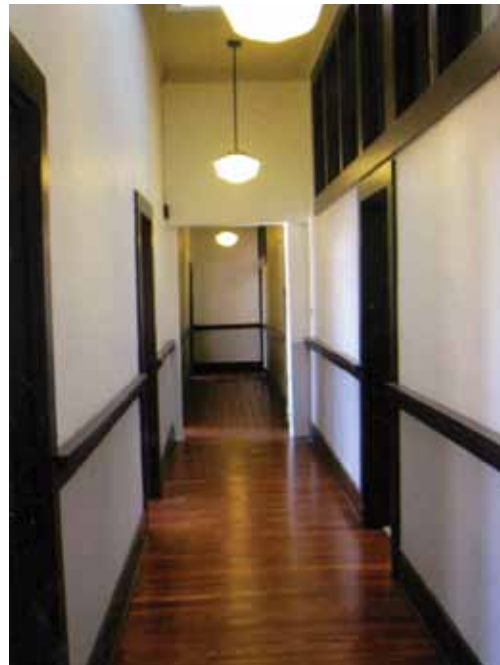
108

[108-109] The original, partially-glazed doors and office partitions, as well as skylights, that let natural light into the corridors were retained as part of the rehabilitation of this early-20th century building.
