COUNTY OF MENDOCINO
DEPARTMENT OF PLANNING AND BUILDING SERVICES

CASE#: CDP_2020-0003

REQUEST: Coastal Development Permit to resolve code violations including: removing vegetation (29 Bishop Pine Trees) within a presumed Bishop Pine Tree Forest ESHA; constructing a ground-mounted solar array and other accessory structures within a presumed ESHA or its buffer; and removing a second, unpermitted kitchen and establishing that the number of bedrooms equal the permitted septic capacity.

LOCATION: In the Coastal Zone, on the west side of Iversen Drive, 0.2± mile south of its intersection with Iversen Road; located at 46801 Iversen Dr, Gualala; APN: 142-033-17-05.

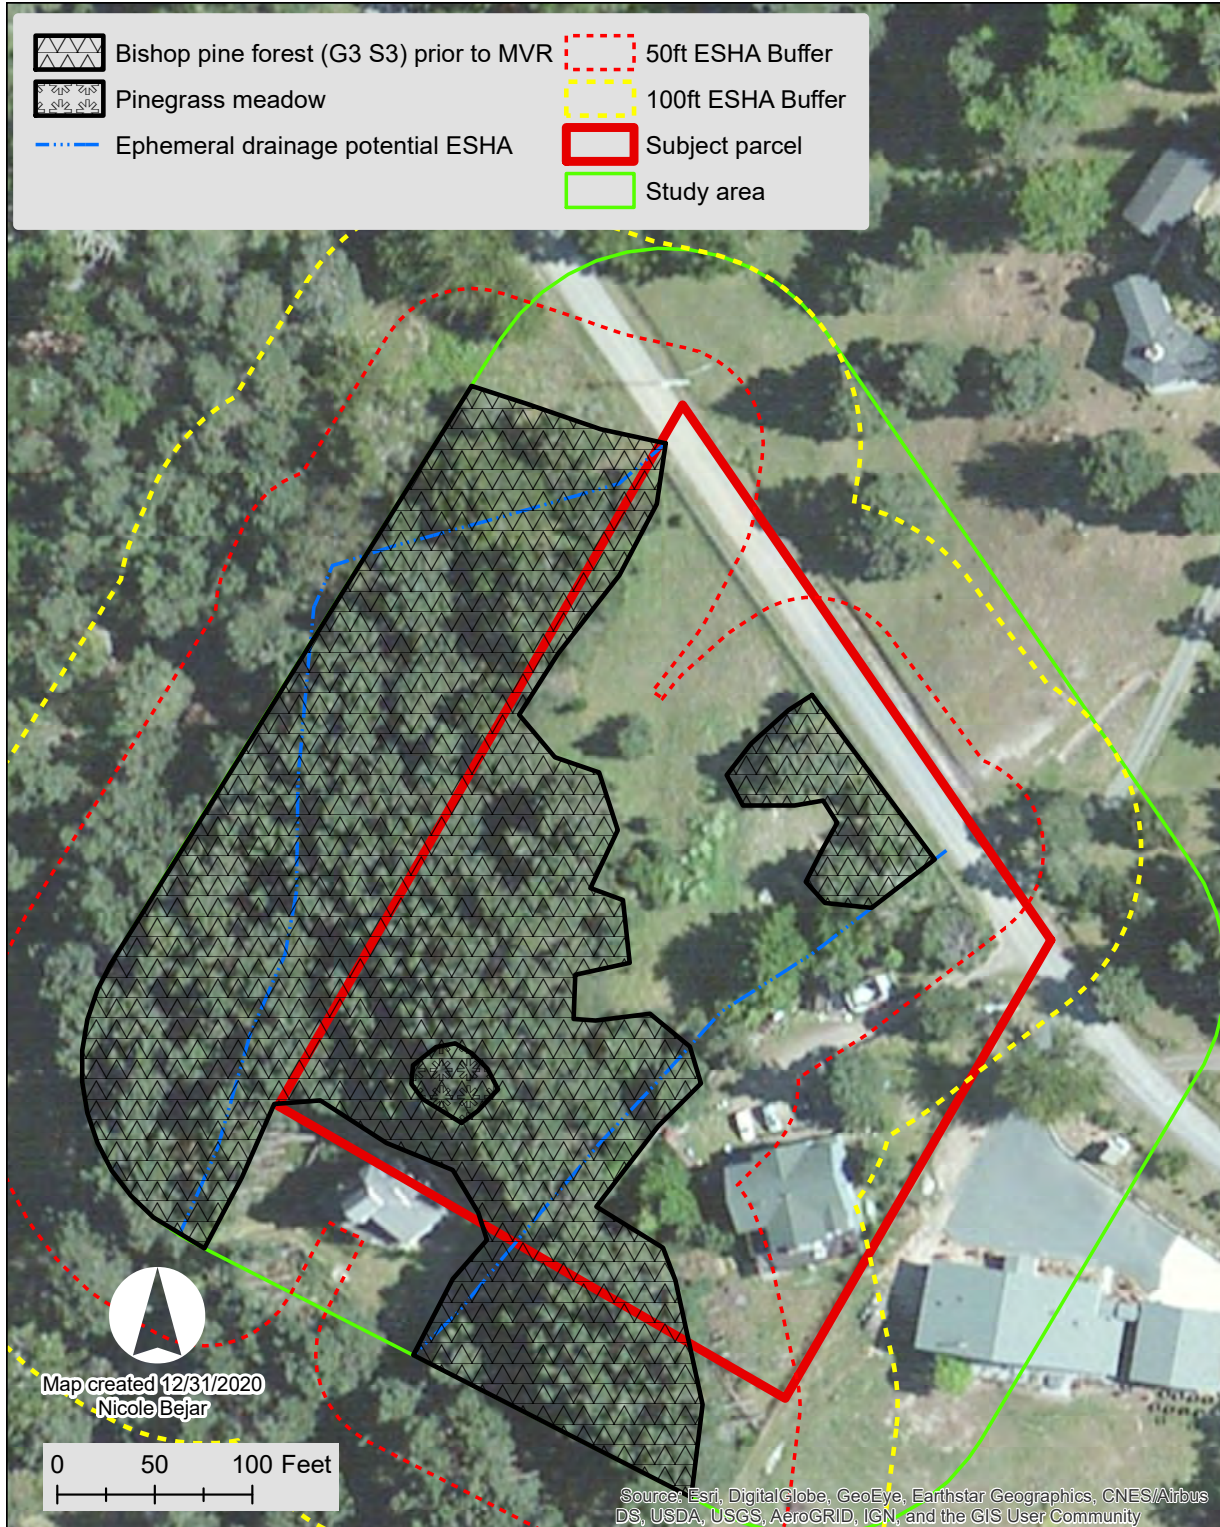
Pre-Major Vegetation Removal ESHA Map

Figure 5. Map displaying presumed ESHAs identified in the study area with 50ft and 100ft buffers prior to major vegetation removal.

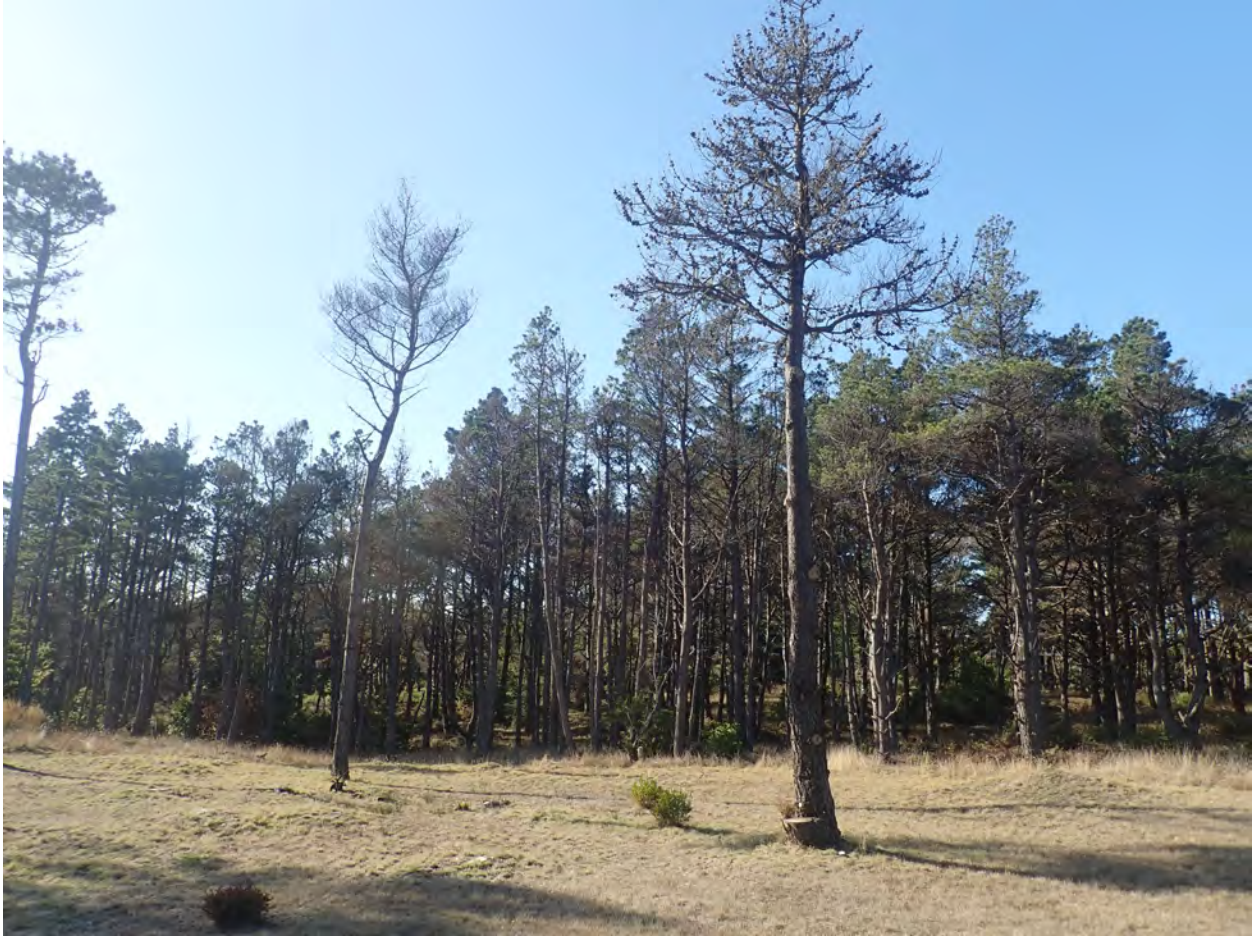
Figure 7. Edge of Bishop pine forest presumed ESHA.

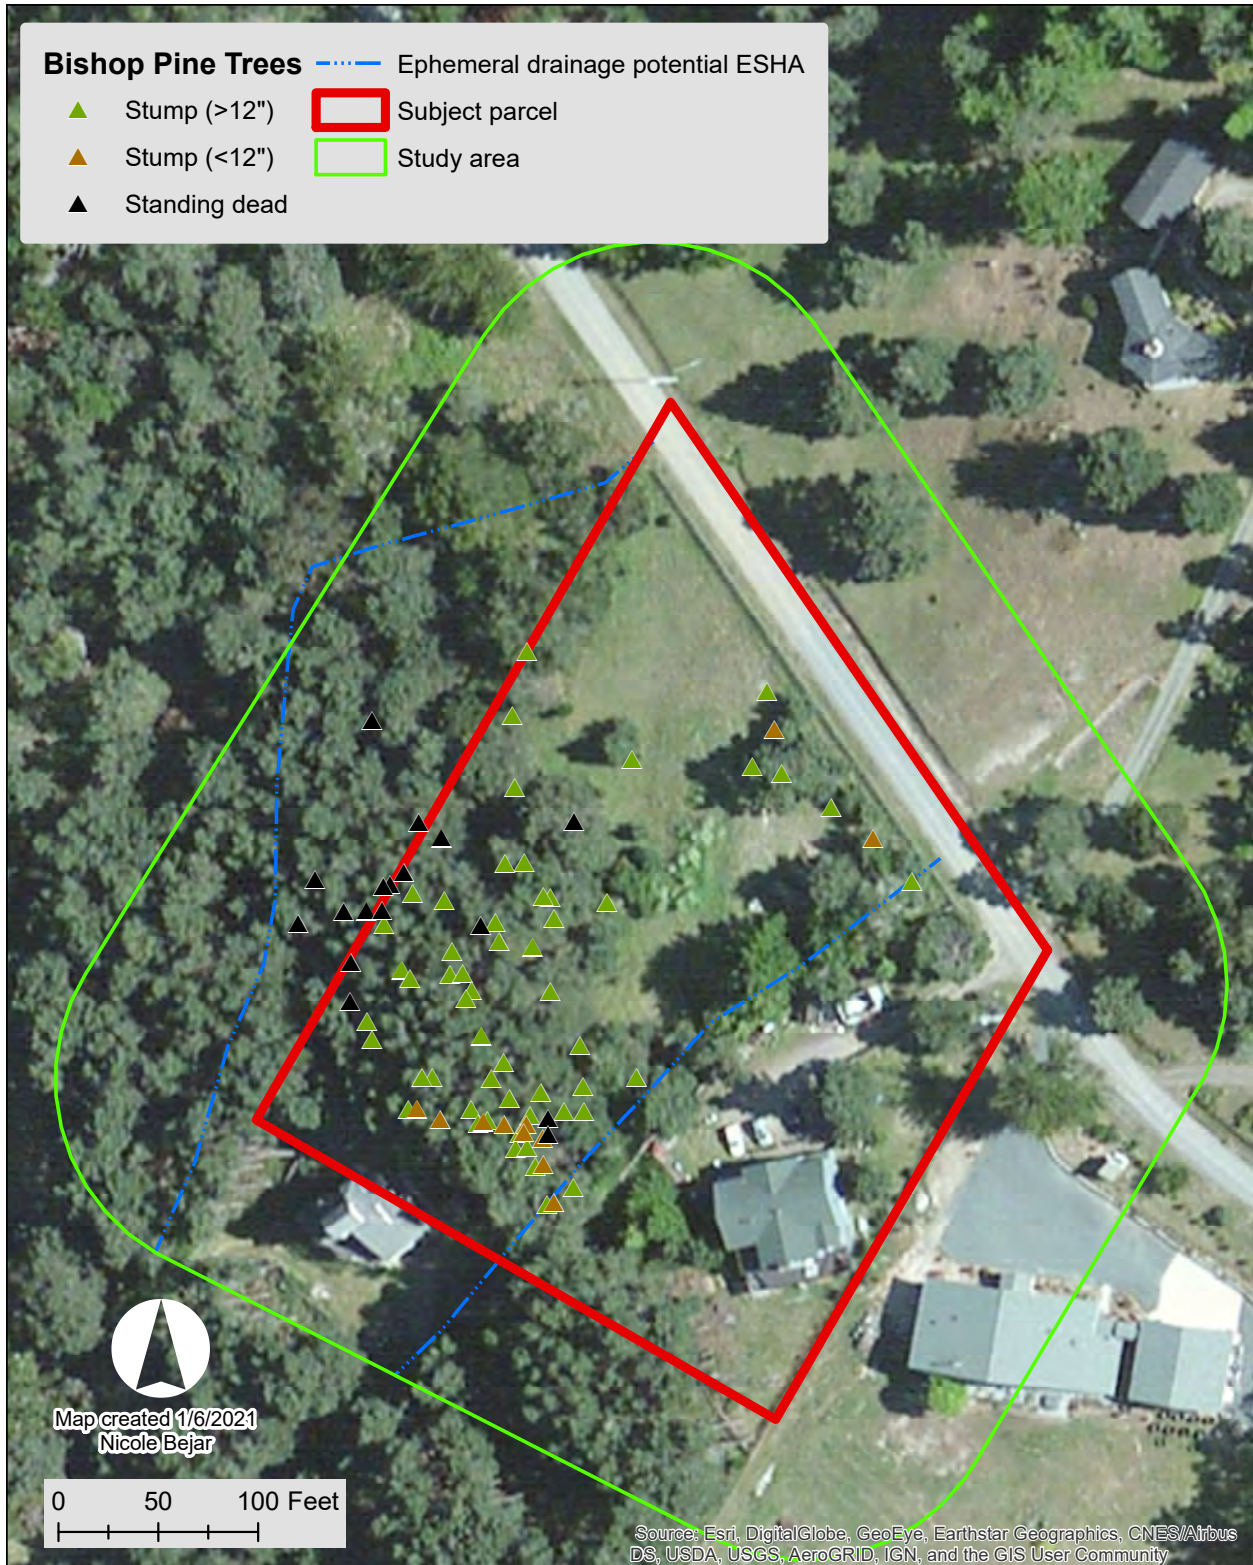
Pre-Major Vegetation Removal

Figure 8. Aerial imagery depicting the Bishop pine forest prior to major vegetation removal.

Prior to MVR, the Bishop pine forest (***Pinus muricata* Forest and Woodland Association G3? S3?**) presumed ESHA dominated the area north of the southern drainage. In June 2018, most of the Bishop pine trees within the parcel boundary were removed without benefit of a Coastal Development Permit due to the potential hazards posed by the trees that were dying from disease and other factors (**Figure 5 & Figure 6**). Aerial imagery comparing the bishop pine forest before and after vegetation removal illustrates that most of the forest was cleared to the property edge (**Figure 8 & Figure 9**). Tree stumps and mounds that contained multiple tree stumps were observed throughout the property (**Figure 10**). Based on aerial imagery prior to MVR it is presumed that many of these stumps are from Bishop pine trees. A handful of trees were left standing near the southern property boundary, along the southern stream drainage, and sporadically throughout the area. It is important to note that the most recent aerial imagery taken from the drone depicts a significant increase in the amount of a dead Bishop pine trees indicating that the forest is declining most likely due to pathogens, drought, and/or other causes. Western gall rust, veiled polypore (*Cryptoporus volvatus*), and resinosis were all observed on the Bishop pine trees in the study area reinforcing that the Bishop pine trees are unhealthy and dying (**Figure 11**). Other trees present in the plant community included: Monterey pine (*Pinus radiata*), blue gum eucalyptus (*Eucalyptus globulus*), and tanoak (*Notholithocarpus densiflorus*). Tan oak sapling and Monterey pine seedlings were regenerating under the canopy layer. The understory was thick with shrubs in places and more sparse with only duff and patches of grass sticking through the ground in other places (**Figure 12**). The shrub layer was dominated by California blackberry (*Rubus ursinus*). Other species present included: Cascara buckthorn (*Frangula purshiana*), thimbleberry (*Rubus parviflorus*), California wax myrtle (*Morella californica*), coyote brush (*Baccharis pilularis*), cotoneaster (*Cotoneaster franchetii*), and pink honeysuckle (*Lonicera hispidula*). Herbaceous vegetation present included: sweet vernal grass (*Holcus lanatus*), western sword fern (*Polystichum munitum*), bracken fern (*Pteridium aquilinum*), lady fern (*Athyrium filix-femina*), blue wildrye (*Elymus glaucus*), bull thistle (*Cirsium vulgare*), and dune goldenrod (*Solidago spathulata*). The total vascular cover of the intact portions of the plant community, considering porosity, was estimated to be around 55%.

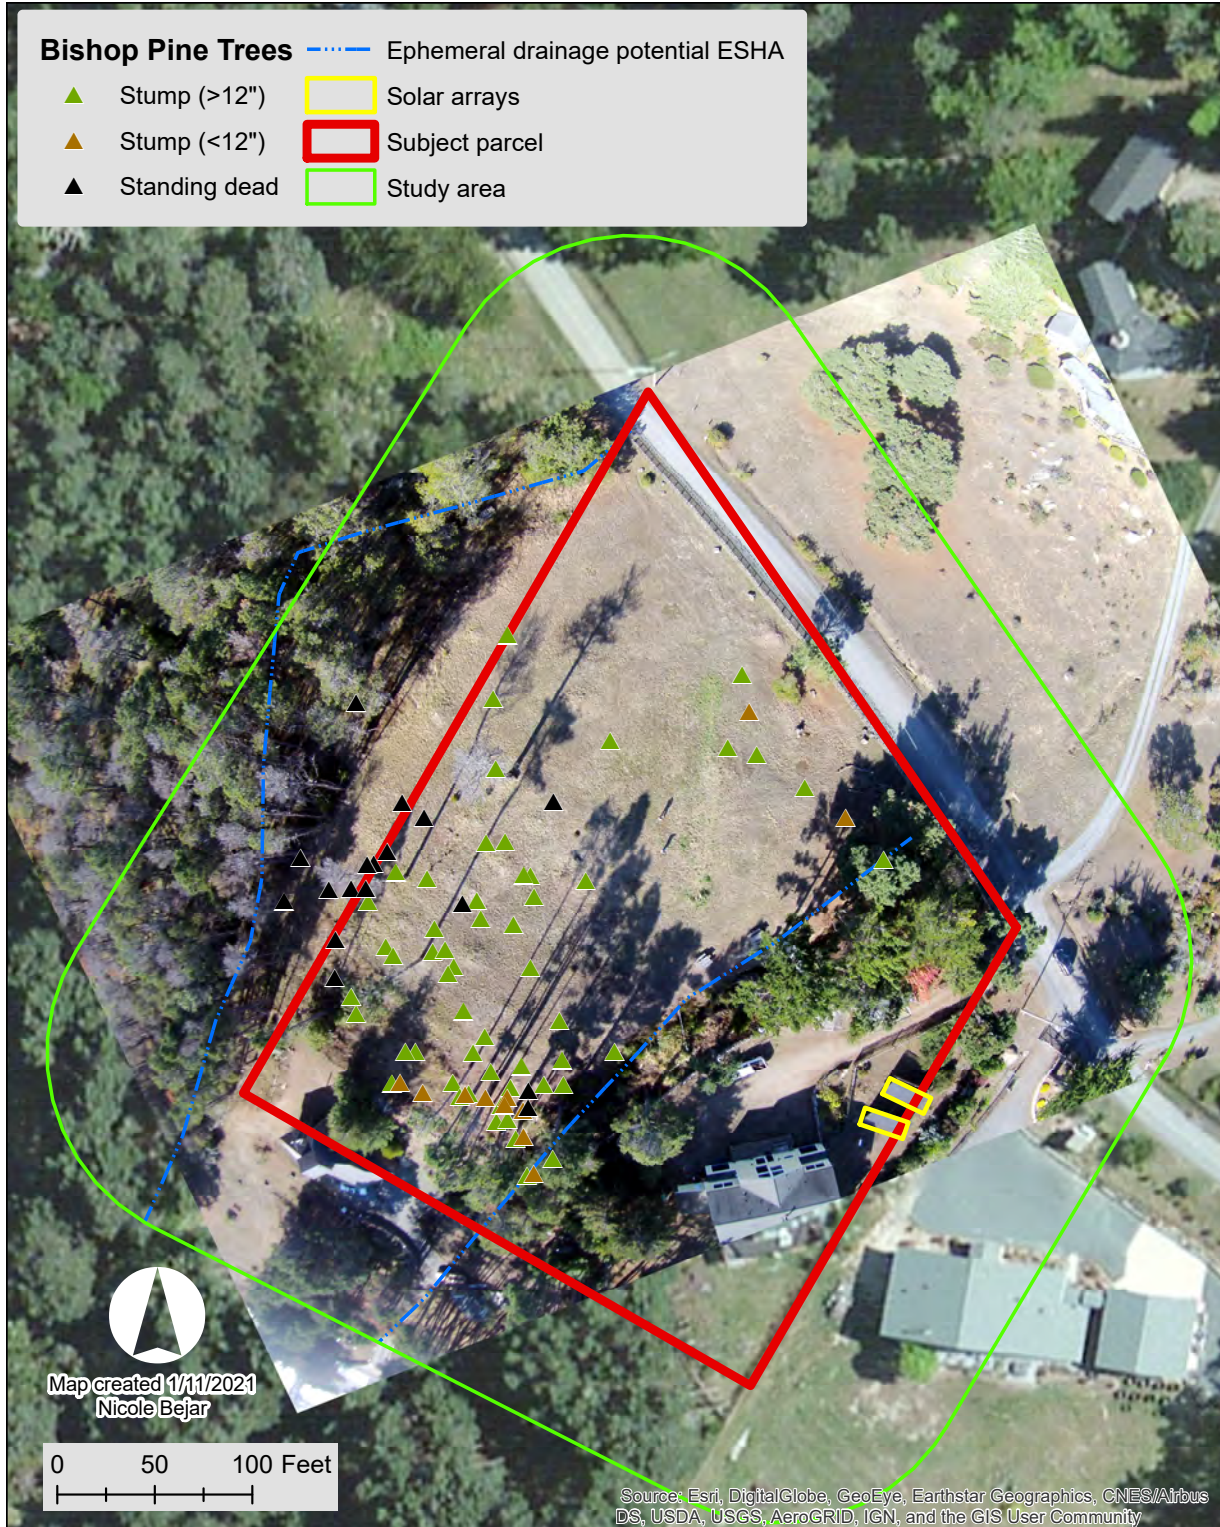
Post-Major Vegetation Removal

Figure 9. Aerial imagery depicting the Bishop pine forest after major vegetation removal. Please note that background image is slightly warped due to curvature from drone image.

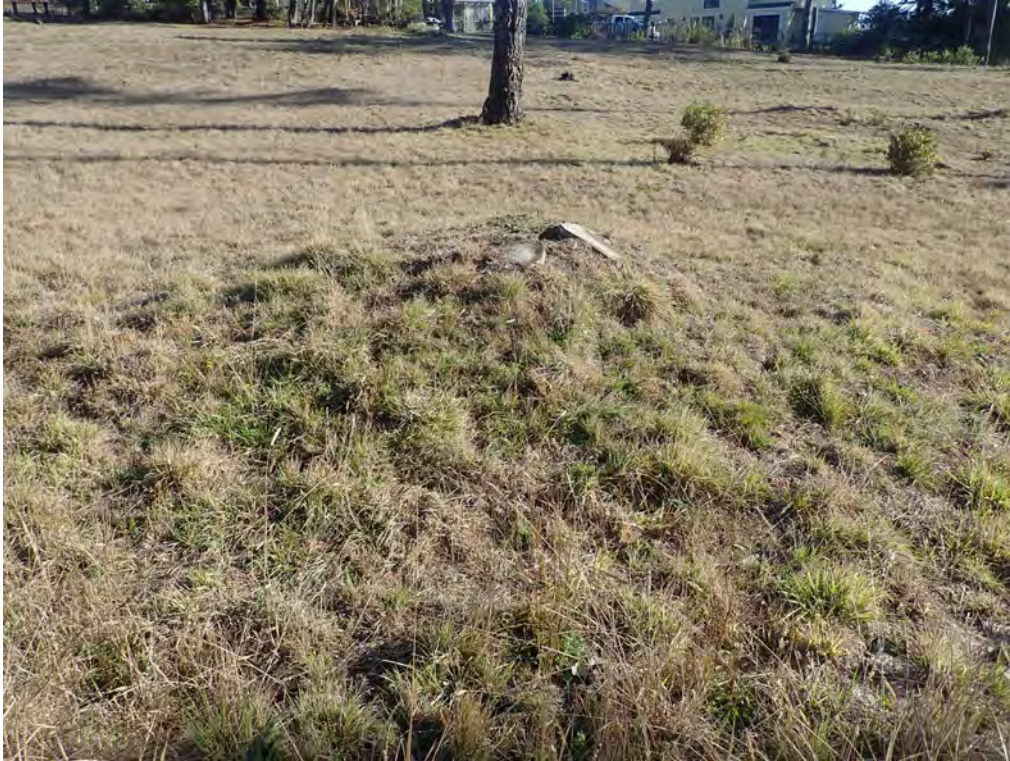
Figure 10. Earthen mound made up of several stumps within grassland.

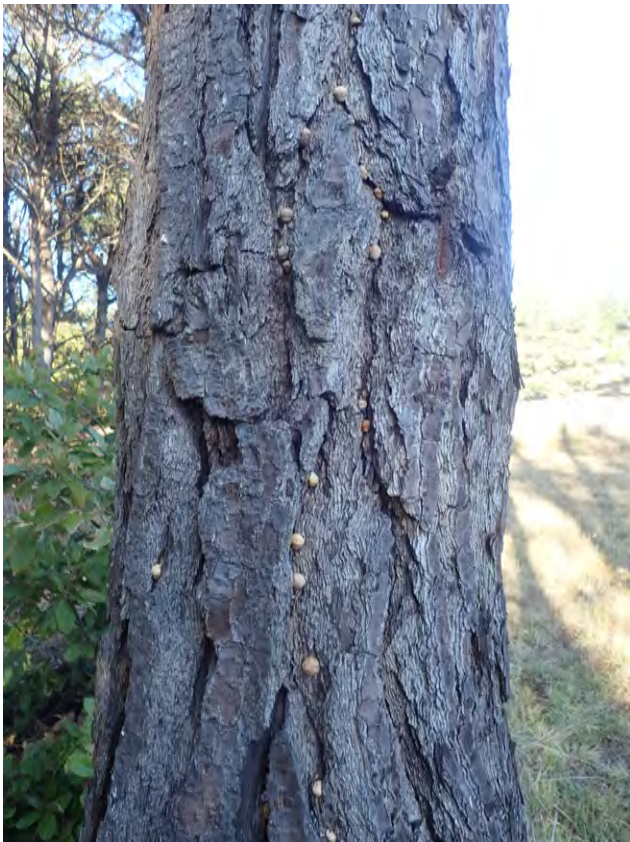
Figure 11. Veiled polypore fungus on Bishop pine tree.

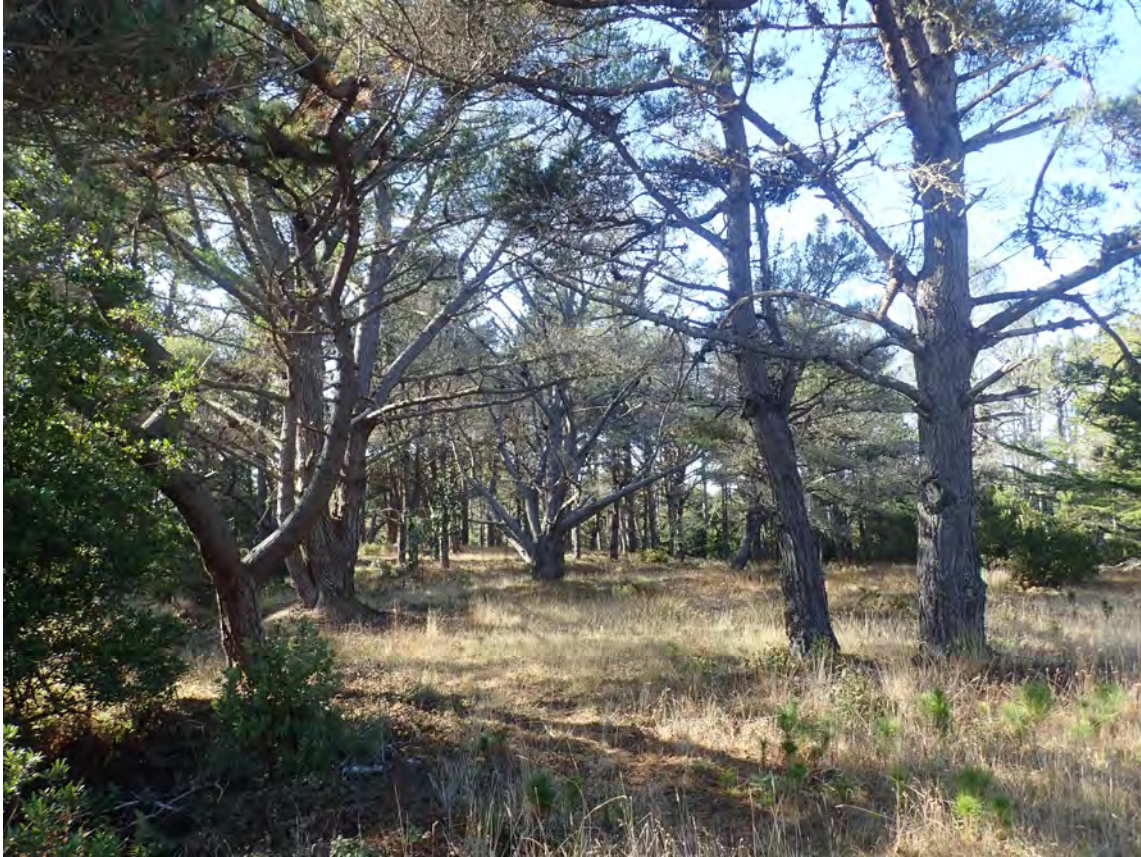
Figure 12. Bishop pine forest understory.

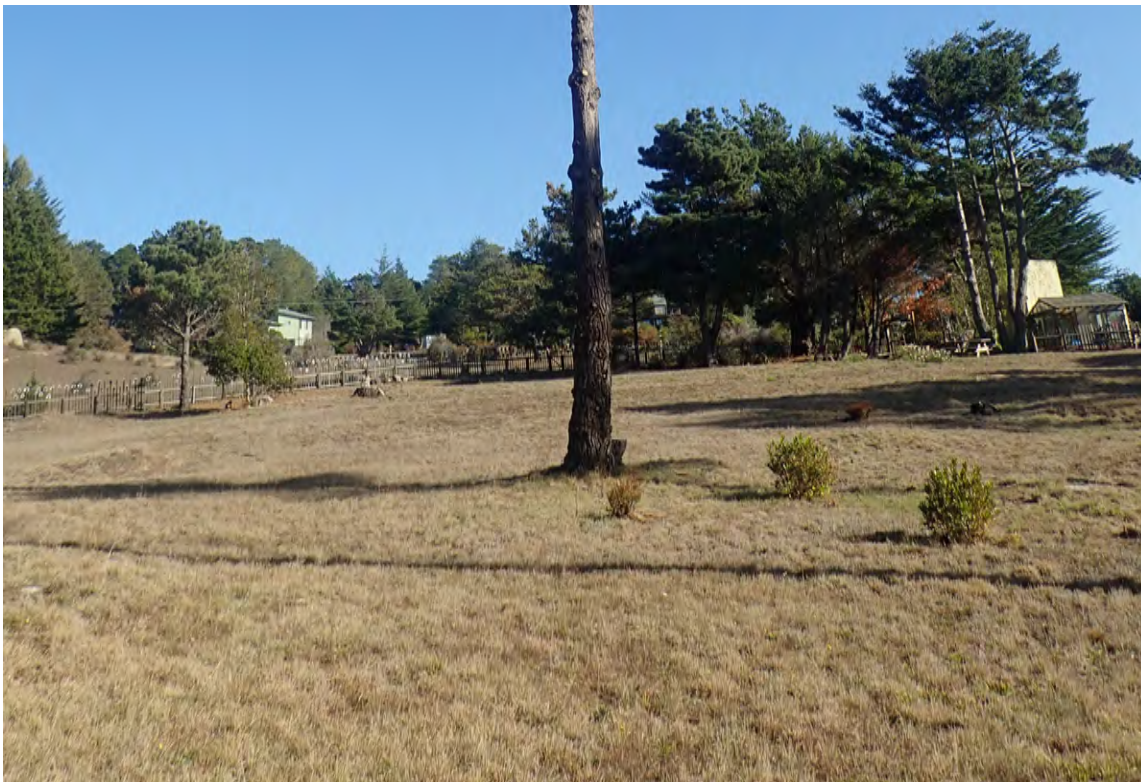
Figure 13. Non-native common velvet grass meadow.

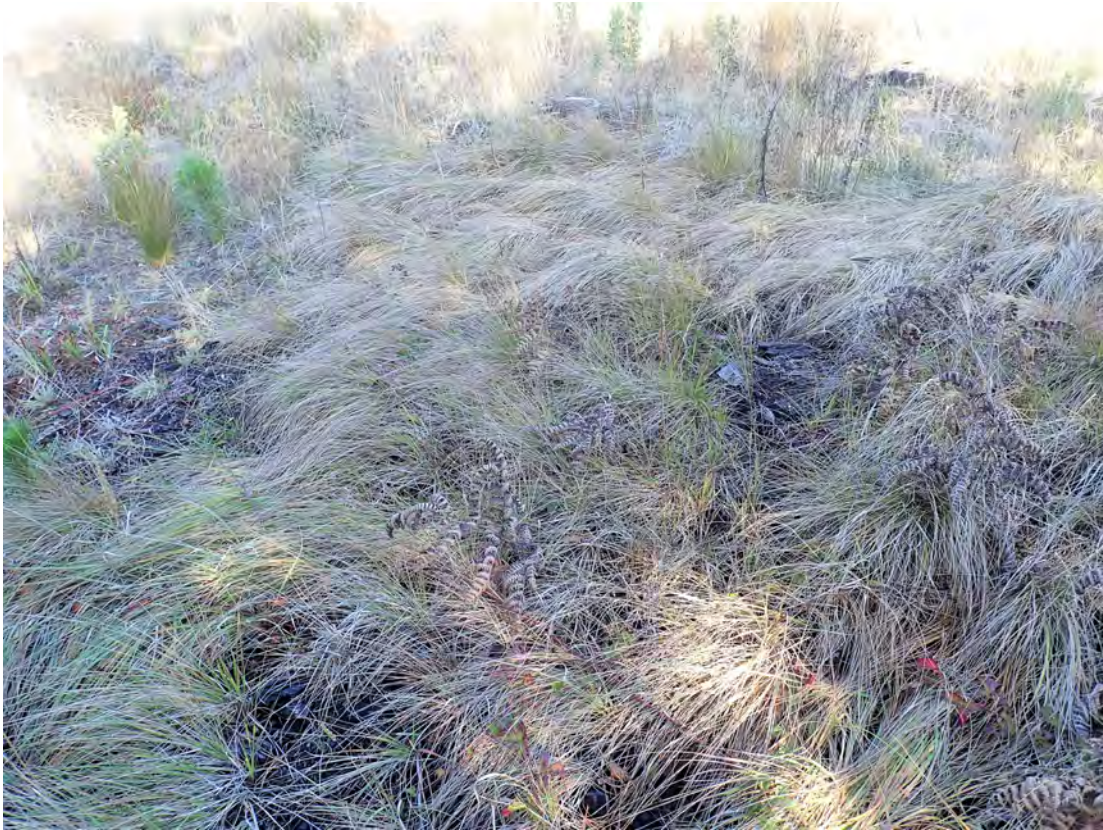
Figure 14. Pinegrass meadow.

A small patch (~1,150ft²) of pinegrass (*Calamagrostis rubescens*) was identified on the southern property line adjacent to the neighbor's house (**Figure 14**). The species composition in this small patch differed from the surrounding non-native common velvet grass meadow. Pinegrass dominated this community, while other species observed included: soft rush (*Juncus effusus*), spreading rush (*J. patens*), Douglas iris (*Iris douglasiana*), foxglove (*Digitalis purpurea*), Pacific reedgrass (*Calamagrostis nutkaensis*), California blackberry, iceplant, pampas grass (*Cortaderia jubata*), and dune goldenrod. Monterey pine and tanoak seedlings were also regenerating in this area. *Calamagrostis rubescens* Herbaceous Association is not listed in the California Natural Communities List but could be used to describe this area in its current state and this name is used in this report and for the purpose of vegetation mapping. Pinegrass is likely more often present as an understory species, in which case it would probably have been part of the *Pinus muricata* Forest Association prior to the tree removal. The area mapped is notable for its predominance of native grasses.

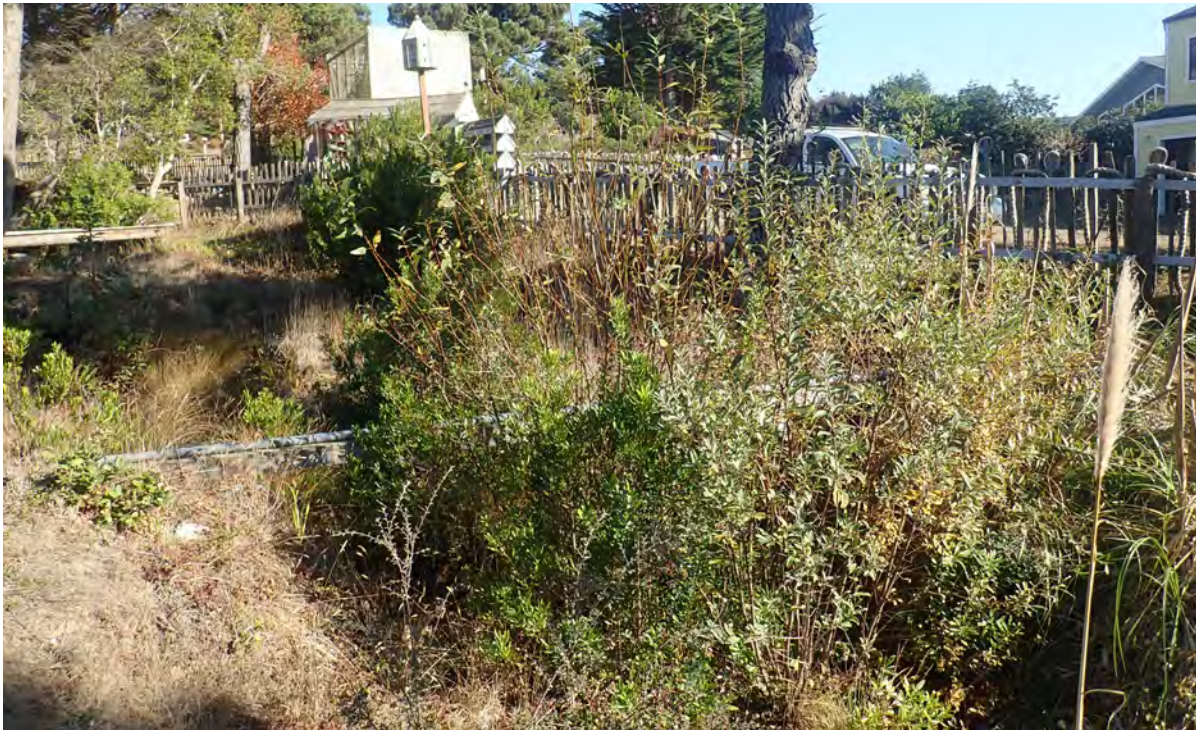
Figure 15. Southern drainage.

The southern ephemeral drainage just north of the driveway was primarily vegetated with California wax myrtle (*Morella californica*) and western sword fern (*Polystichum munitum*) (**Figure 15**). The overstory vegetation running along the stream consisted of Douglas fir (*Pseudotsuga menziesii*) and Bishop pine trees. Other species present included: cow parsnip (*Heracleum maximum*), tall flatsedge (*Cyperus eragrostis*), California blackberry, soft rush, evergreen huckleberry (*Vaccinium ovatum*), giant chain fern (*Woodwardia fimbriata*), Sitka willow (*Salix sitchensis*), salal (*Gaultheria shallon*), pampas grass, and cascara buckthorn. The northern ephemeral drainage was vegetated similarly to the southern drainage, however, vegetation was denser with a high percentage of thimbleberry in patches (**Figure 16**).

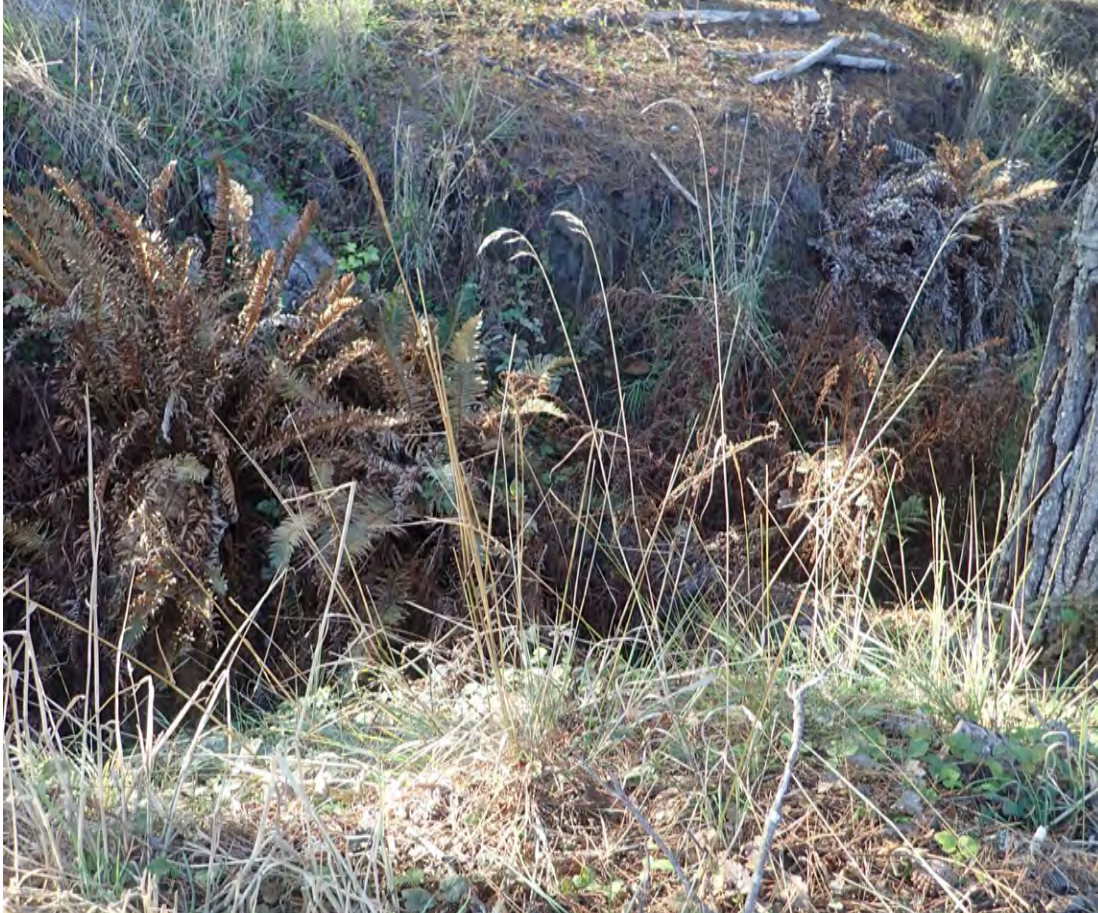
Figure 16. Northern drainage.

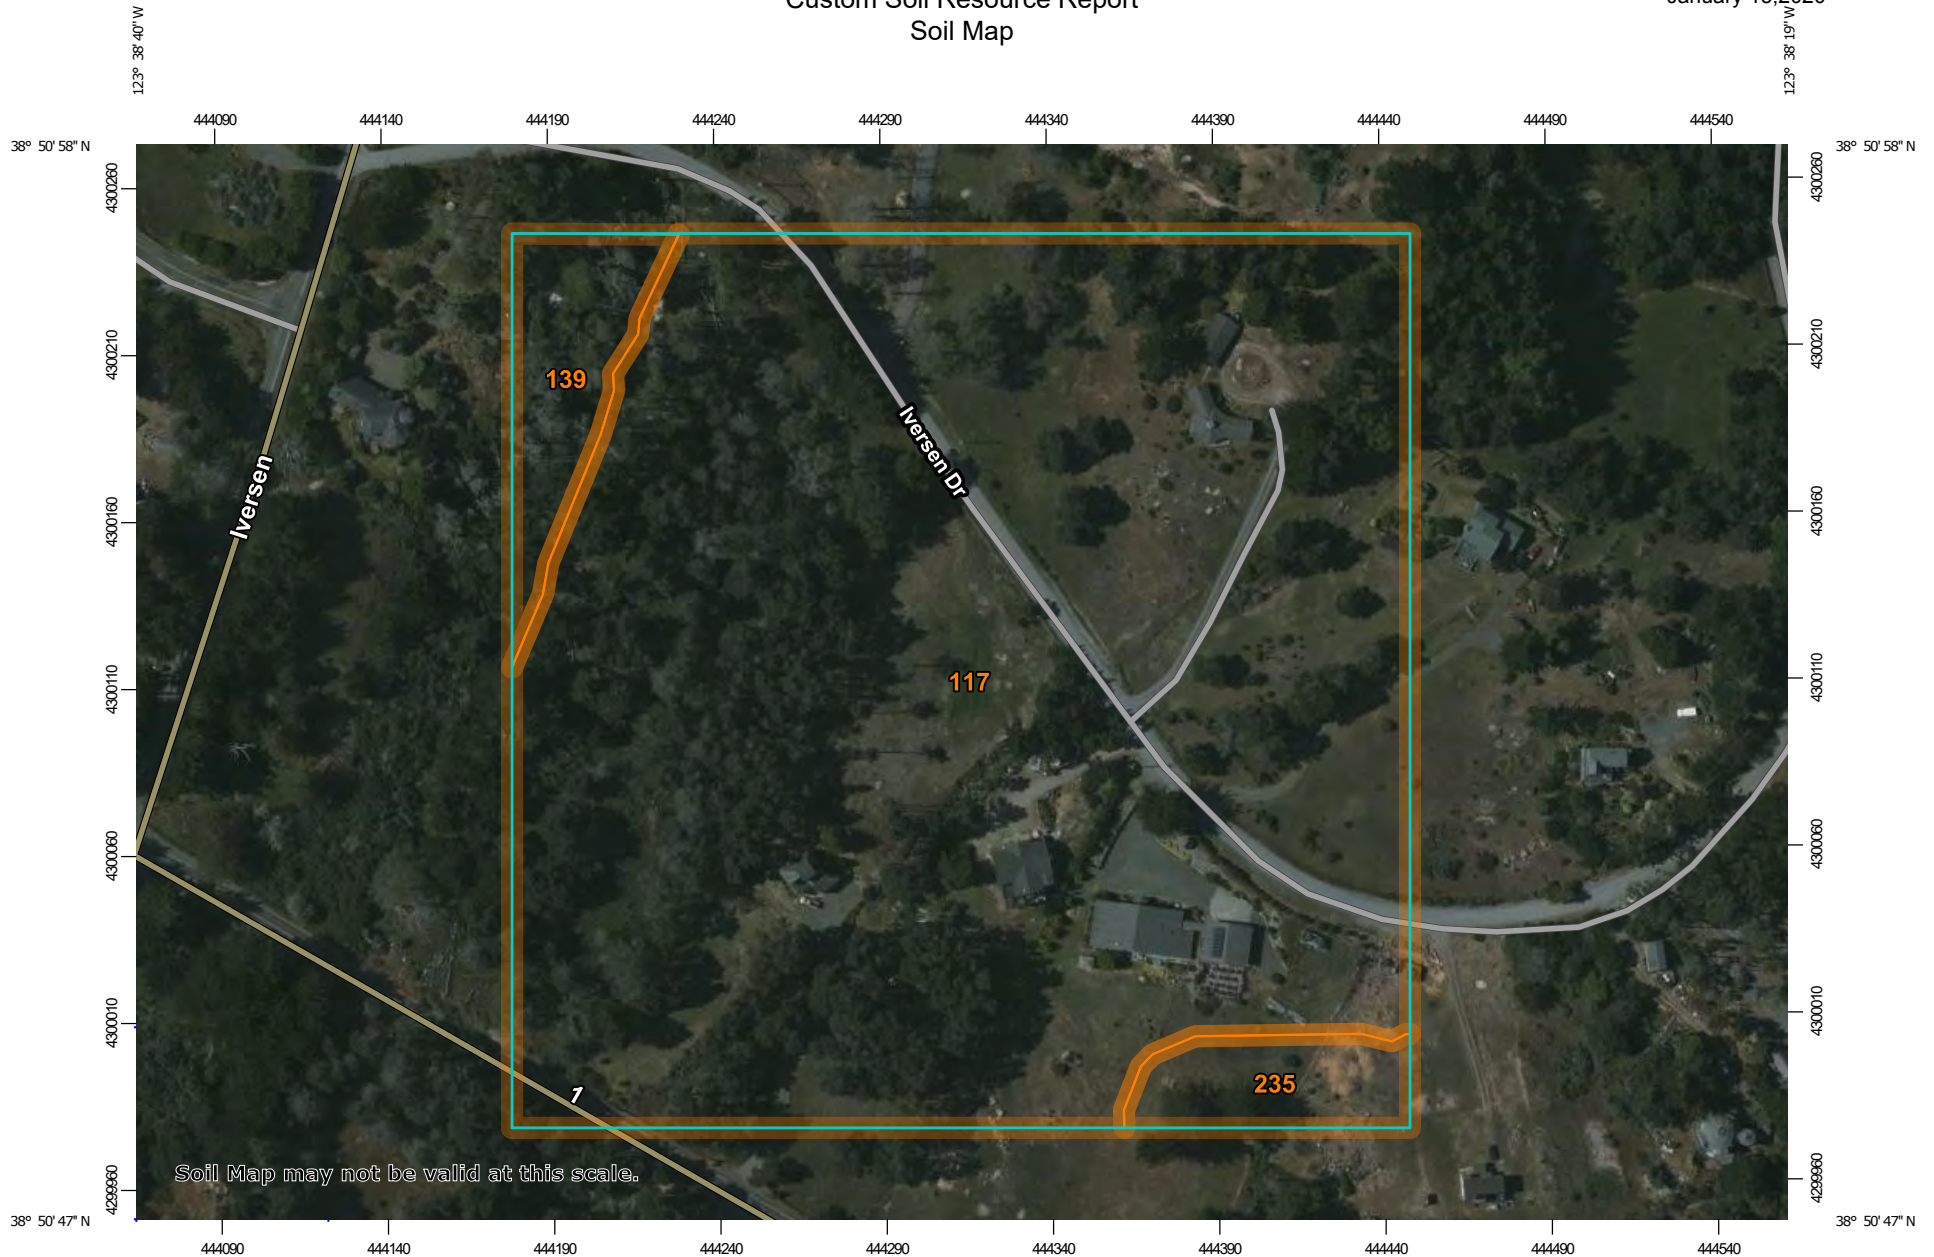
Custom Soil Resource Report
Soil Map

Holberg-Olsen Biological Scoping Survey
January 15, 2020

Map Scale: 1:2,270 if printed on A landscape (11" x 8.5") sheet.

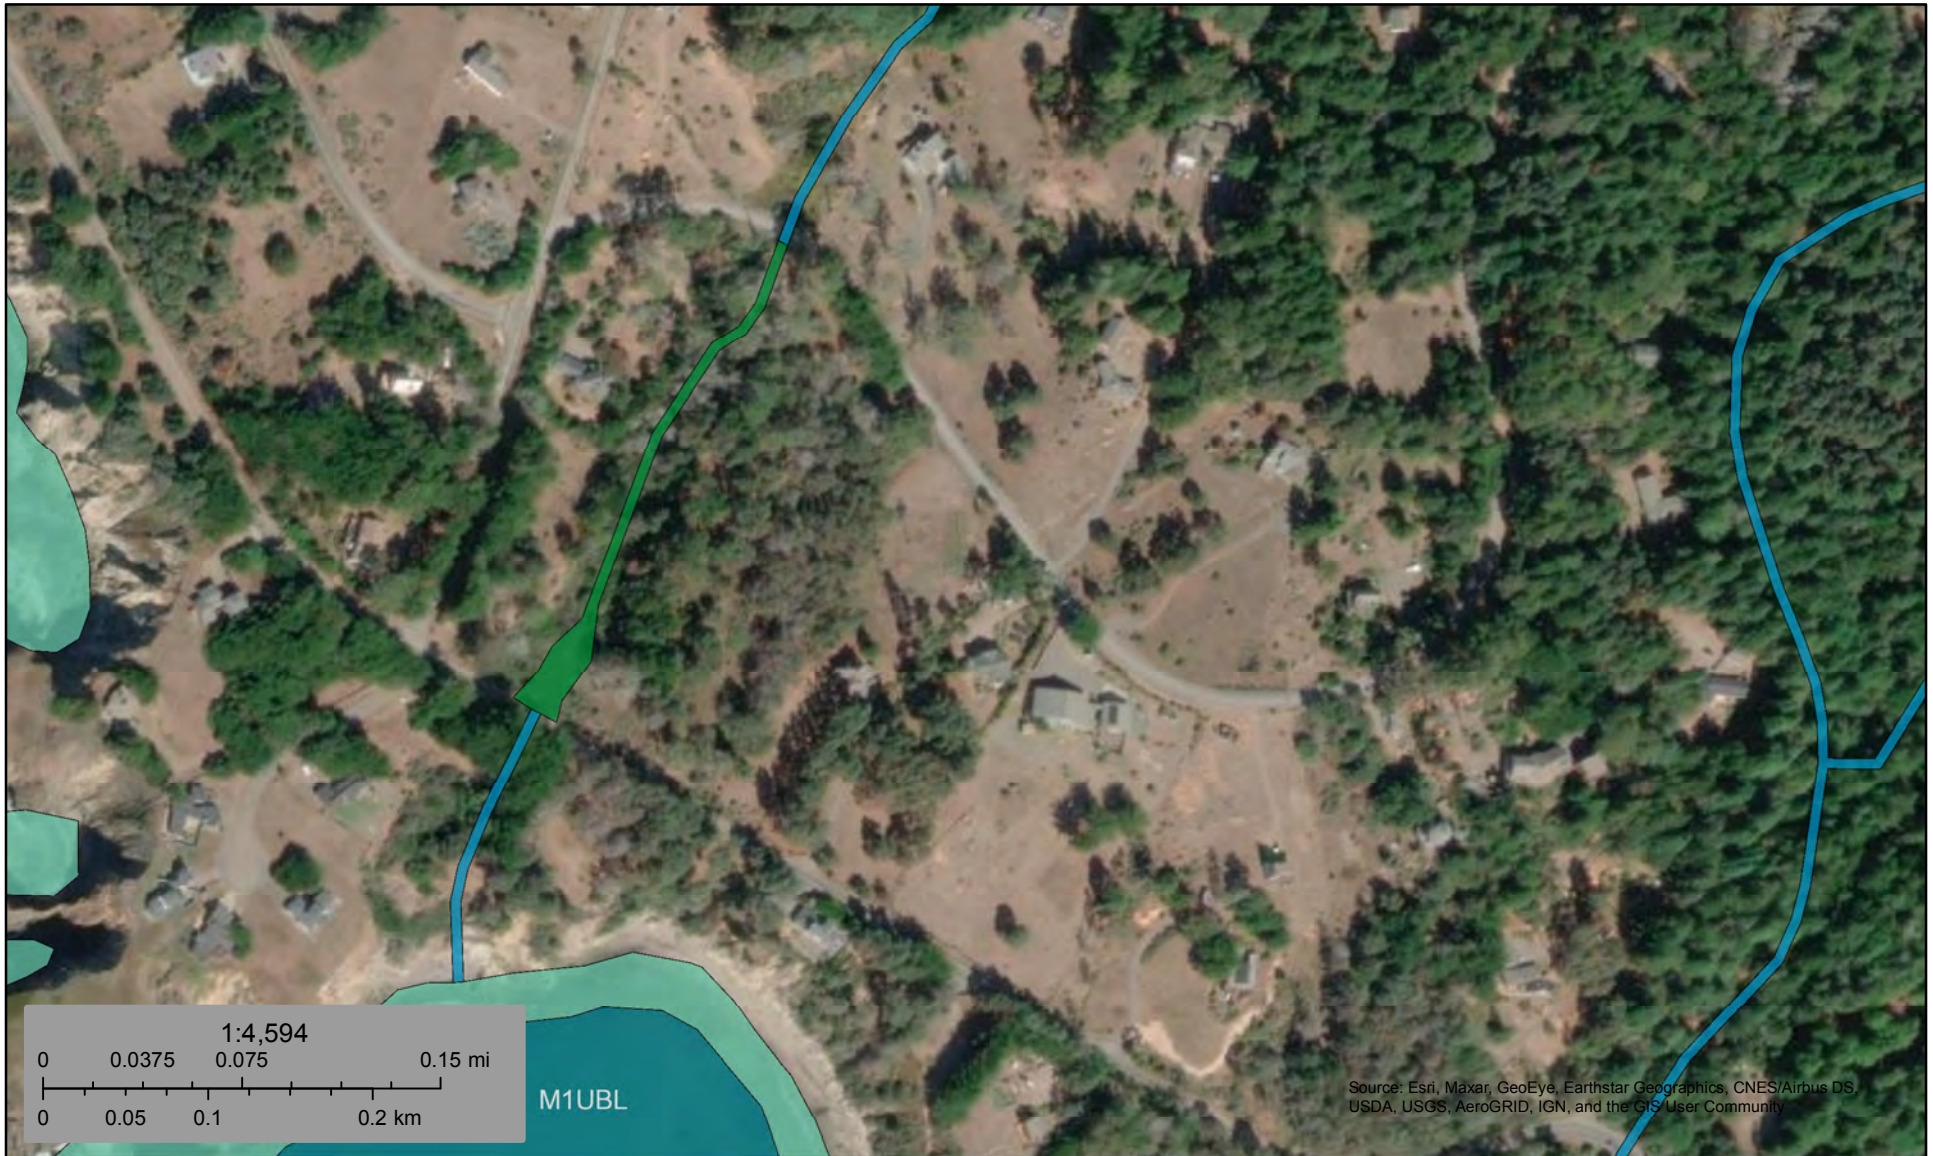
This map is for general reference only. The US Fish and Wildlife Service is not responsible for the accuracy or currentness of the base data shown on this map. All wetlands related data should be used in accordance with the layer metadata found on the Wetlands Mapper web site.

There are no known records of the previous ecological conditions of the two ephemeral drainages. A USFWS National Wetlands Inventory (NWI) map was generated for the study area and did not depict any wetlands within the area.

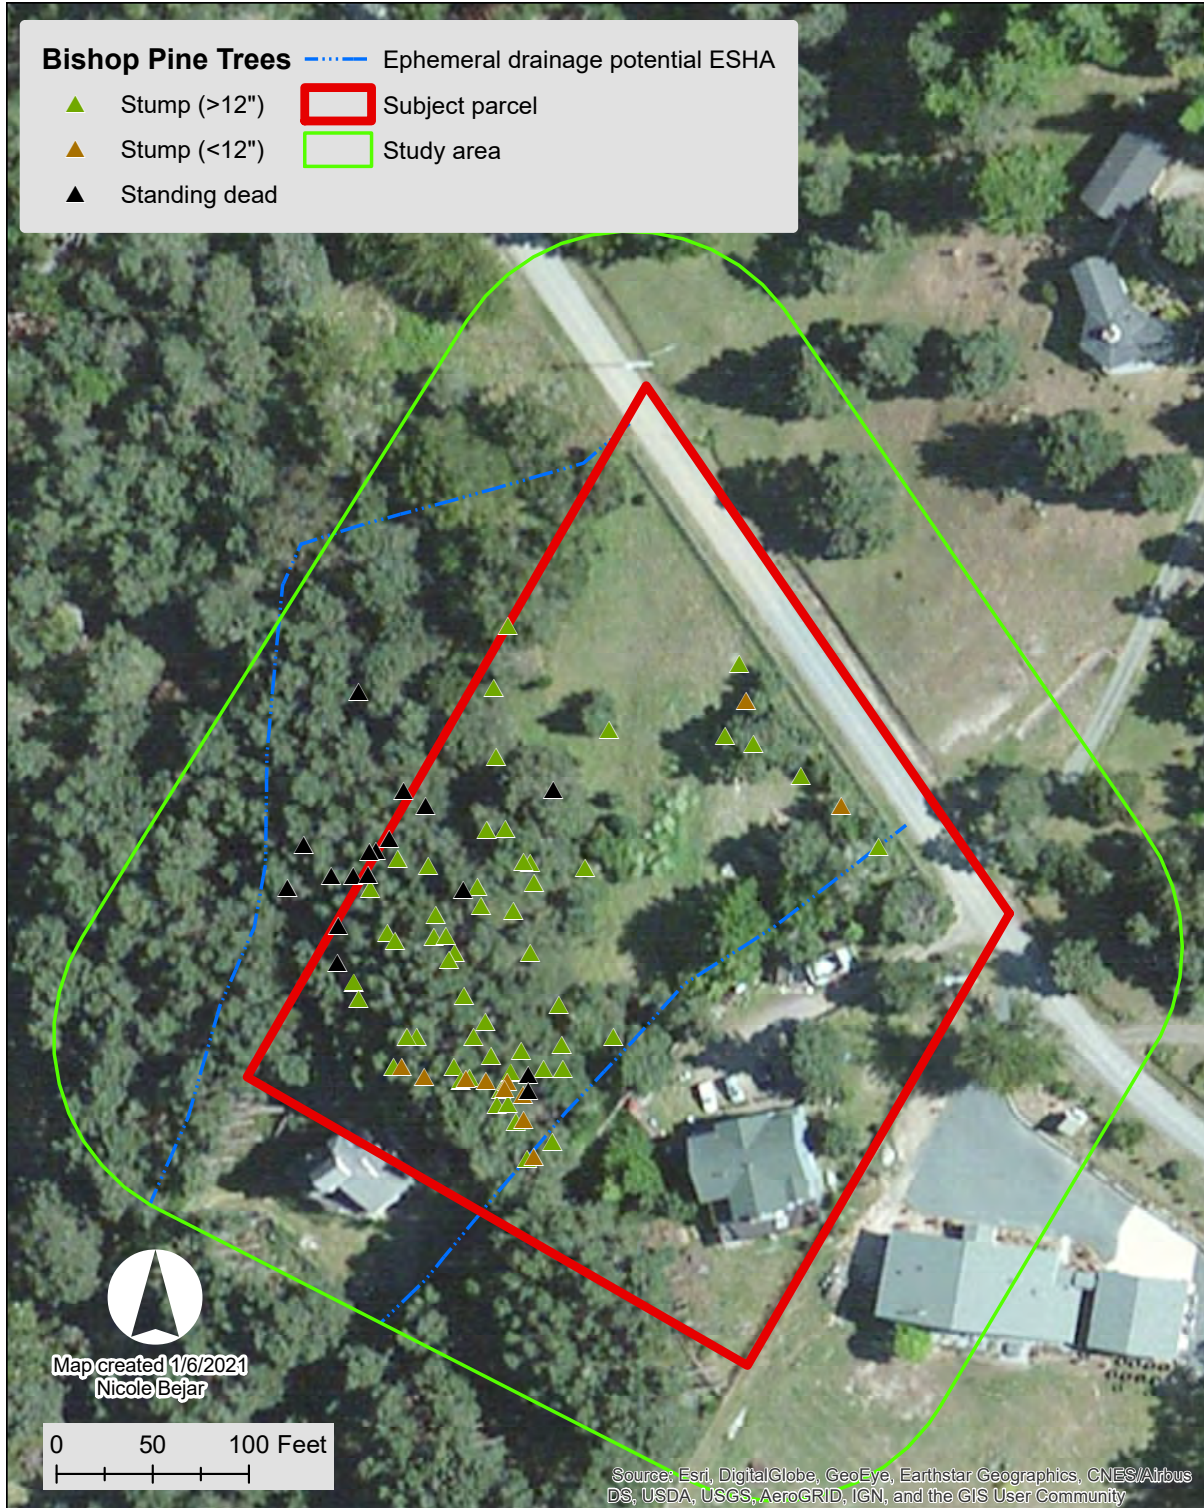
Pre-Major Vegetation Removal

Figure 3. Aerial imagery taken before 2017 showing the extent of the Bishop pine forest prior to Major Vegetation Removal.

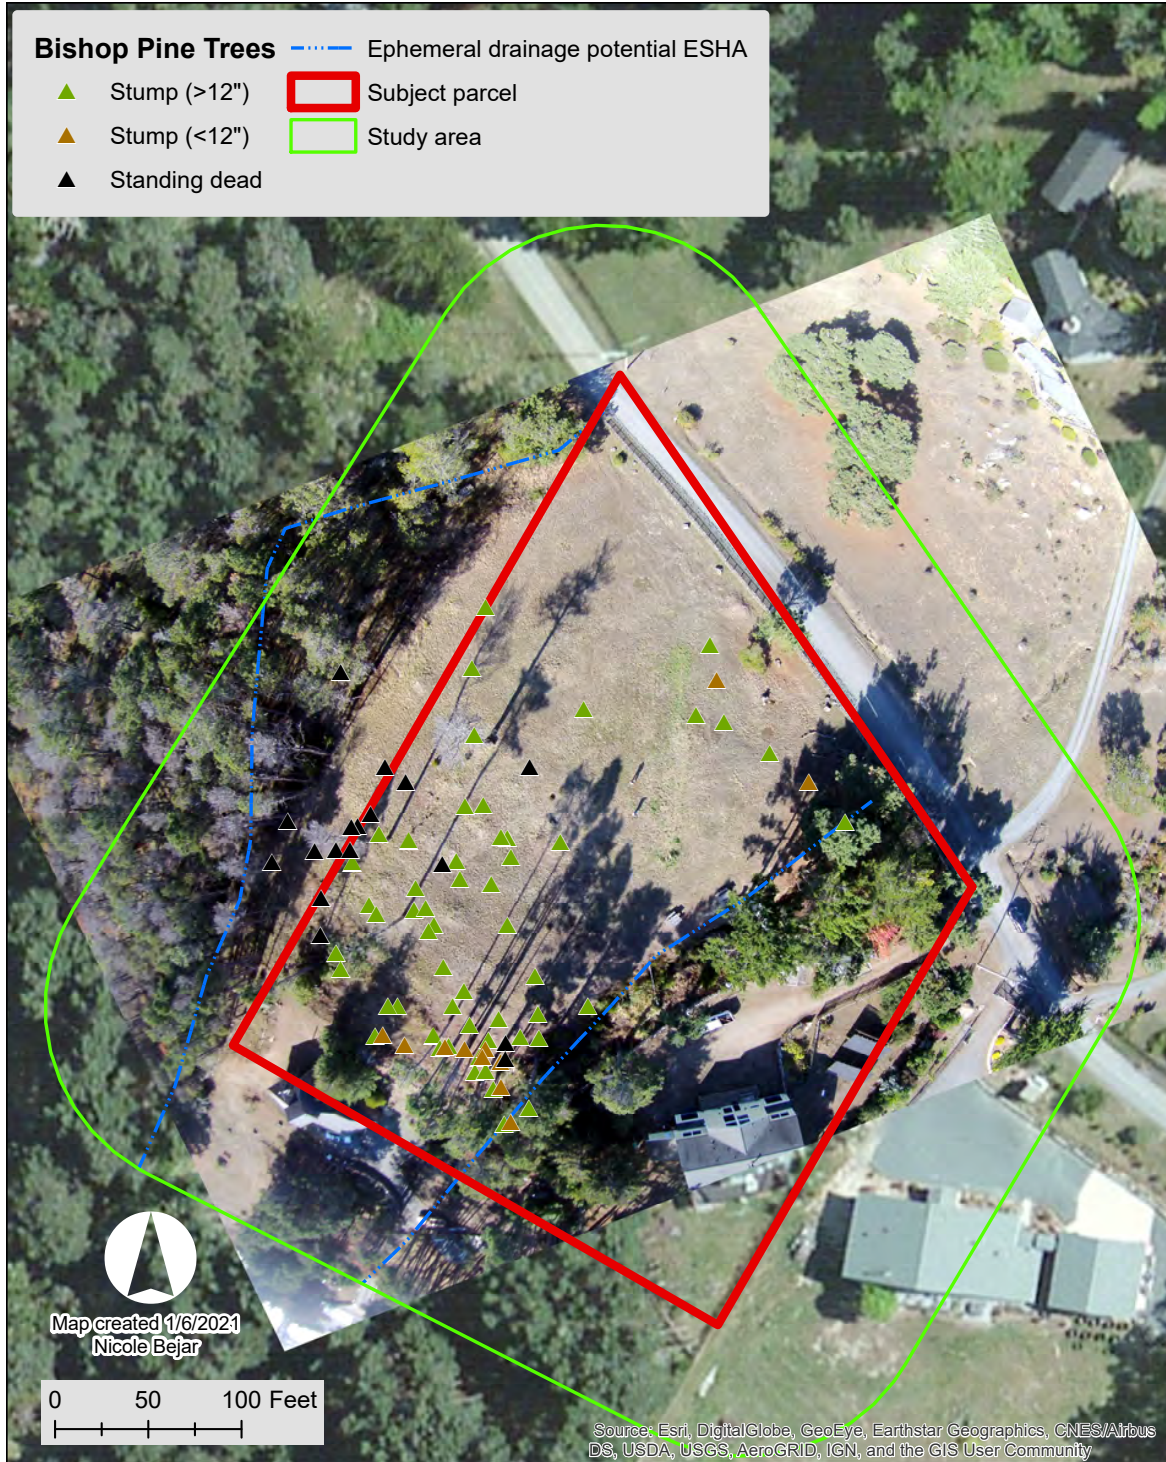
Post-Major Vegetation Removal

CLIENT: Holberg-Olsen
APN: 142-033-17-05
ADDRESS: 46801 Iversen Drive
Gualala, CA
