COUNTY OF MENDOCINO
DEPARTMENT OF PLANNING AND BUILDING SERVICES

CASE#: CDP_2020-0003

REQUEST: Coastal Development Permit to resolve code violations including: removing vegetation (29 Bishop Pine Trees) within a presumed Bishop Pine Tree Forest ESHA; constructing a ground-mounted solar array and other accessory structures within a presumed ESHA or its buffer; and removing a second, unpermitted kitchen and establishing that the number of bedrooms equal the permitted septic capacity.

LOCATION: In the Coastal Zone, on the west side of Iversen Drive, 0.2± mile south of its intersection with Iversen Road; located at 46801 Iversen Dr, Gualala; APN: 142-033-17-05.

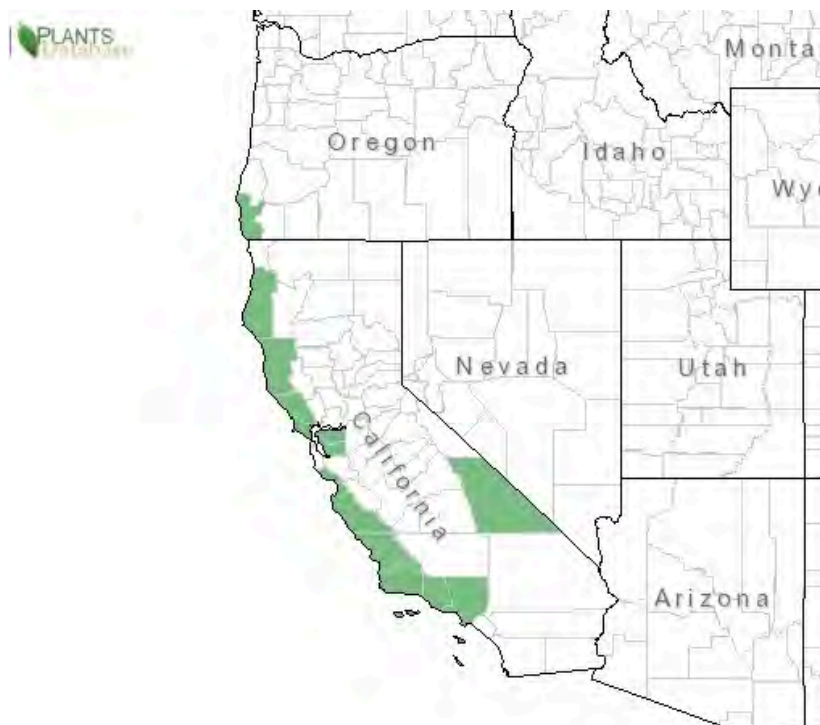
Figure 6. USDA Bishop pine range (USDA 2019).

Bishop pine forest has a ranking of G3 S3, which indicates that the community is rare globally and throughout California. According to both the *Manual of California Vegetation* and USDA, Bishop pine forests typically occur in disjunct coastal populations from southern Oregon to Santa Barbara California (Sawyer 2009 & USDA 2018) (**Figure 5 & Figure 6**). Bishop pines are also located on Santa Cruz and Santa Rosa islands as well as Baja California, Mexico (Sawyer 20019 & USDA 2018). Populations of Bishop pines are typically located in Mediterranean climates between sea level and 400 meters in elevation (NPS 2015).

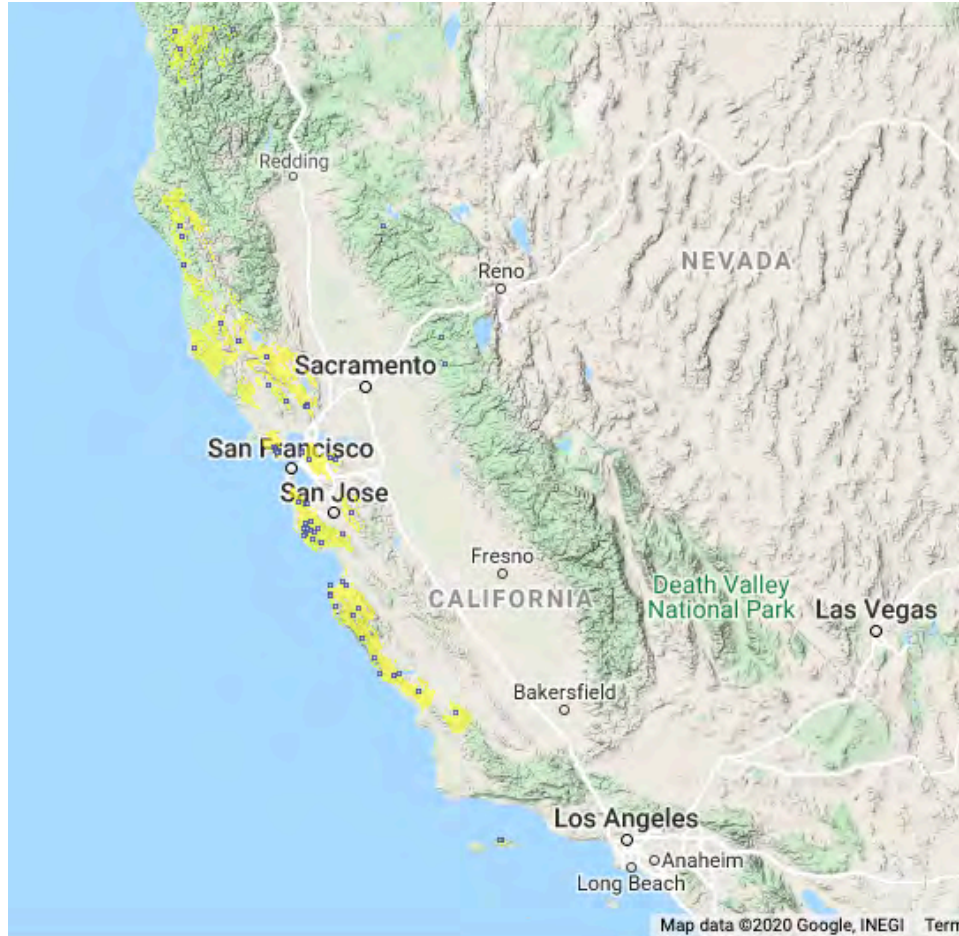
Figure 7. Calscape pinegrass estimated plant range.

Pinegrass is unranked; however, due to it being a native grassland and the unique, high quality habitat in this patch, WCPB biologists determined it to be a plant community that warrants protection. According to the California Native Plant Society, pinegrass is found in Canada and the western United States. In the United States, it ranges from California to Colorado and is usually found in forests and woodlands (CNPS 2020) (**Figure 7 & Figure 8**).
