**CC: CDP 2019-044 Archeological
Recommendations**

FROM
Genevieve Marsh,
Representative of Elisabeth Brinton and Bob Utley
Parcel #1182300800
45640 Cypress Drive
Mendocino, CA 95460

Property Description:

Archaeology:

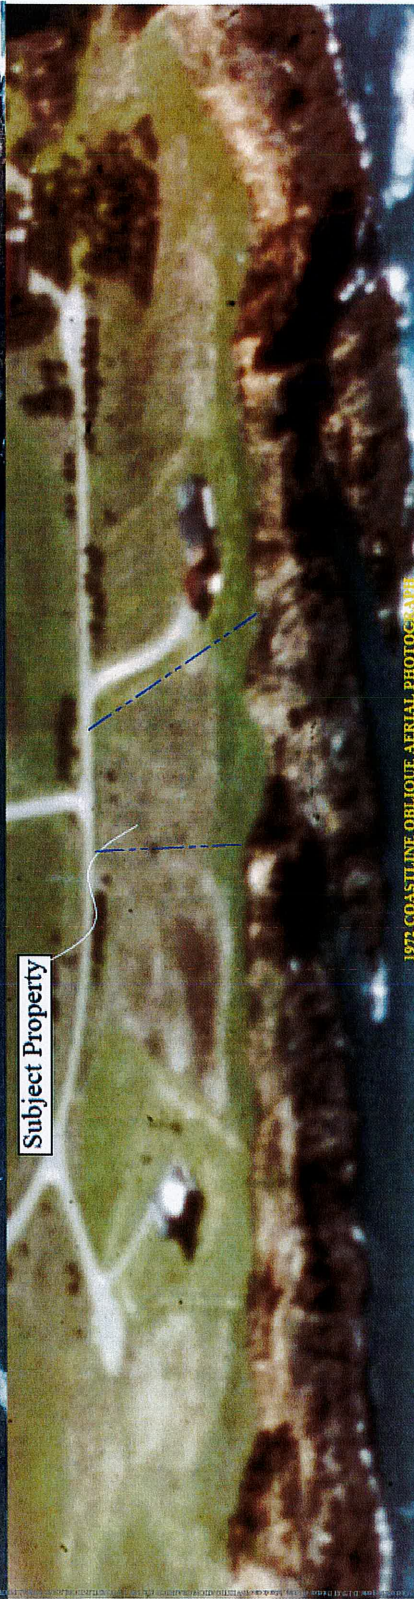
Date: 03/06/20	1973 and 2013 COASTLINE OBLIQUE AERIAL PHOTOGRAPHS BRENTON AND UTILEY RESIDENCE 45640 Cypress Drive Menlo Park, California	PLATE 2
---	---	---	---	-------------------

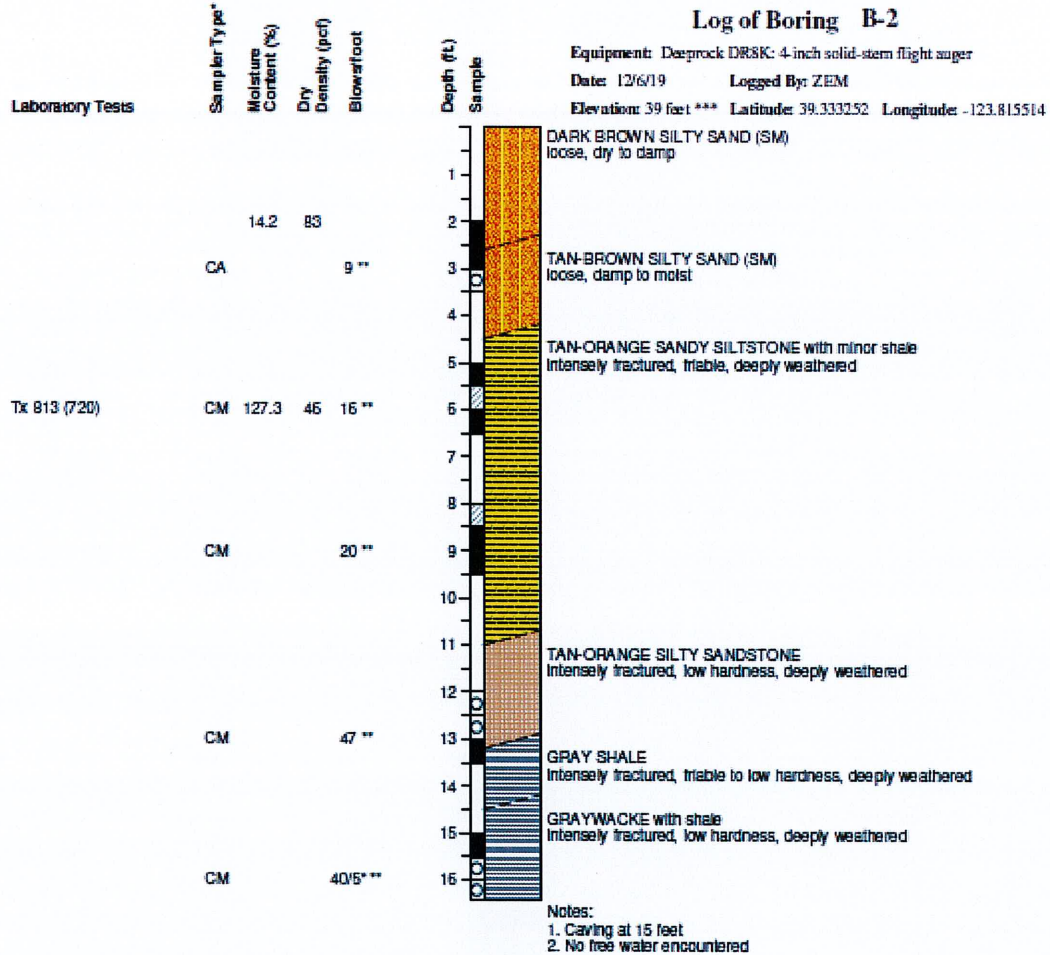
<p>Brunsing Associates, Inc. 5468 Skyline Blvd., Suite 201 Santa Rosa, California 95403 Tel: (707) 528-6108</p>	Job No.: 13155.DI Appr: EEO Date: 03/09/20	<p>LOG OF BORING B-2 BRINTON AND UTLEY RESIDENCE 45640 Cypress Drive Mendocino, California</p>	PLATE 5 SHEET 1 of 1
---	---	--	-----------------------------------
