ONSITE REVEGETATION PLAN  
for the  
MEN 1 WIDEN SHOULDERS PROJECT

**Mendocino County, State Route 1, Post Miles 65.13/65.49  
EA 01-0G600 / EFIS 0117000026**

**February 2021**

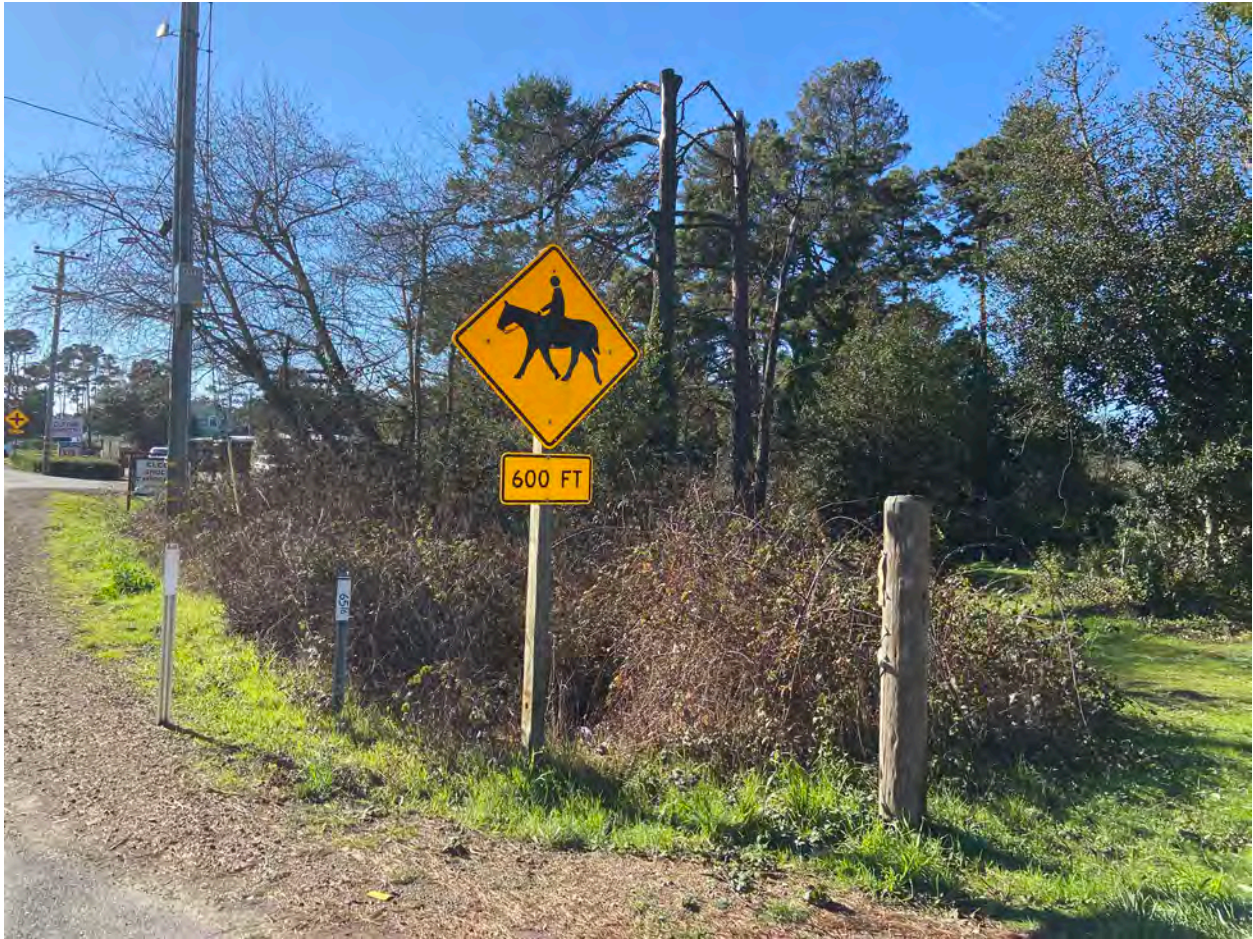
**Photo Point 1. View of culvert outlet and associated riparian vegetation, looking southwest.  
Date of Photo: February 4, 2021.**

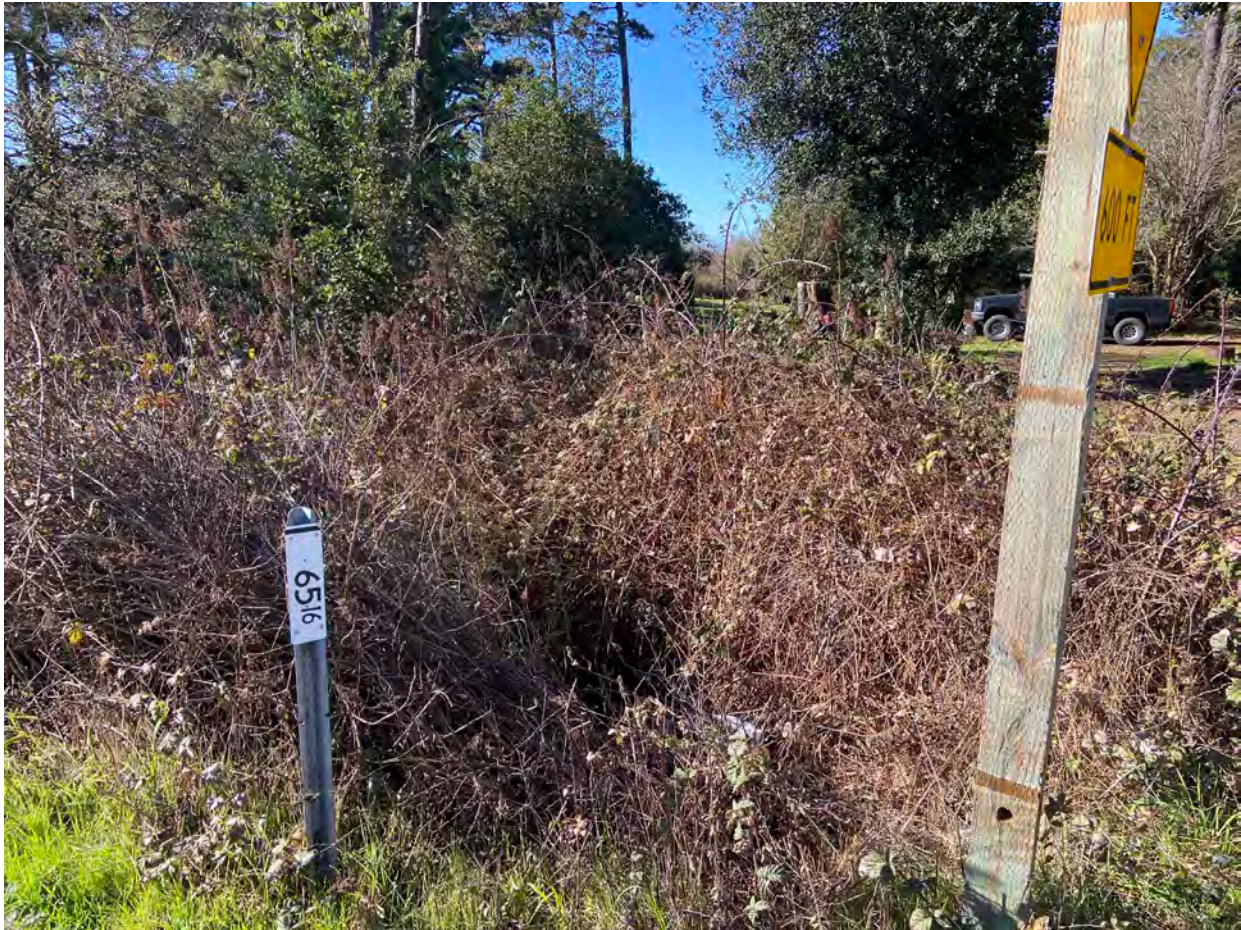
**Photo Point 2.** View of riparian vegetation at culvert outlet, looking west.  
Date of Photo: February 4, 2021.

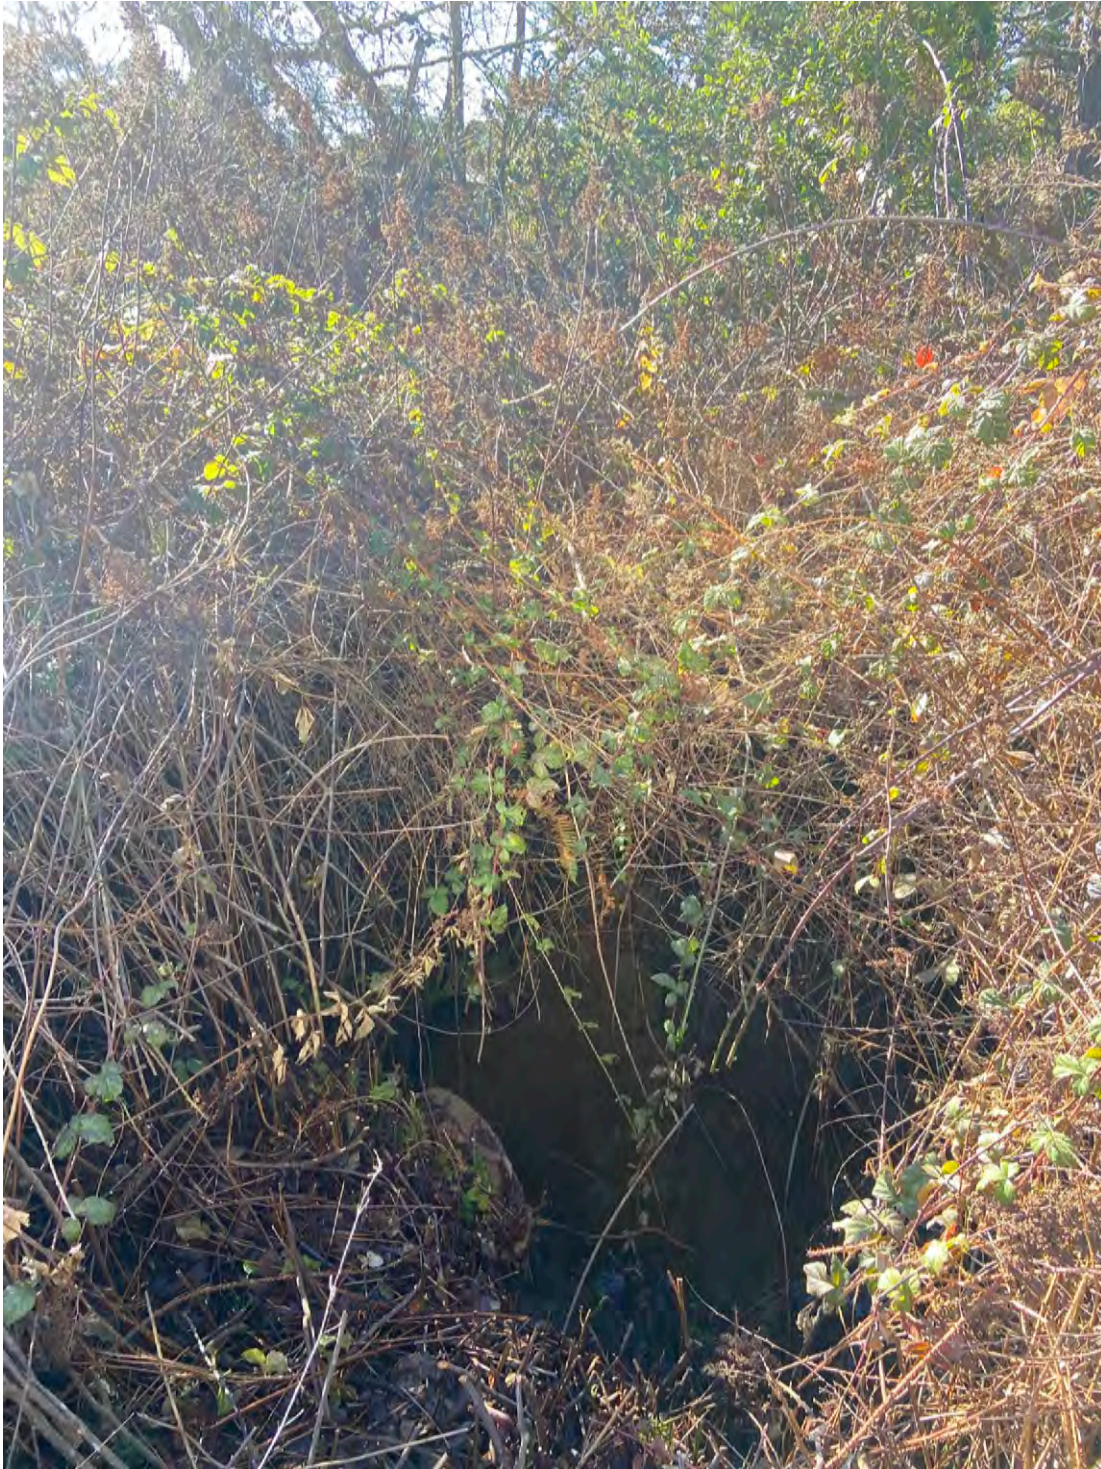
**Photo Point 3. View of culvert outlet and associated riparian vegetation, looking southwest.  
Date of Photo: February 4, 2021.**

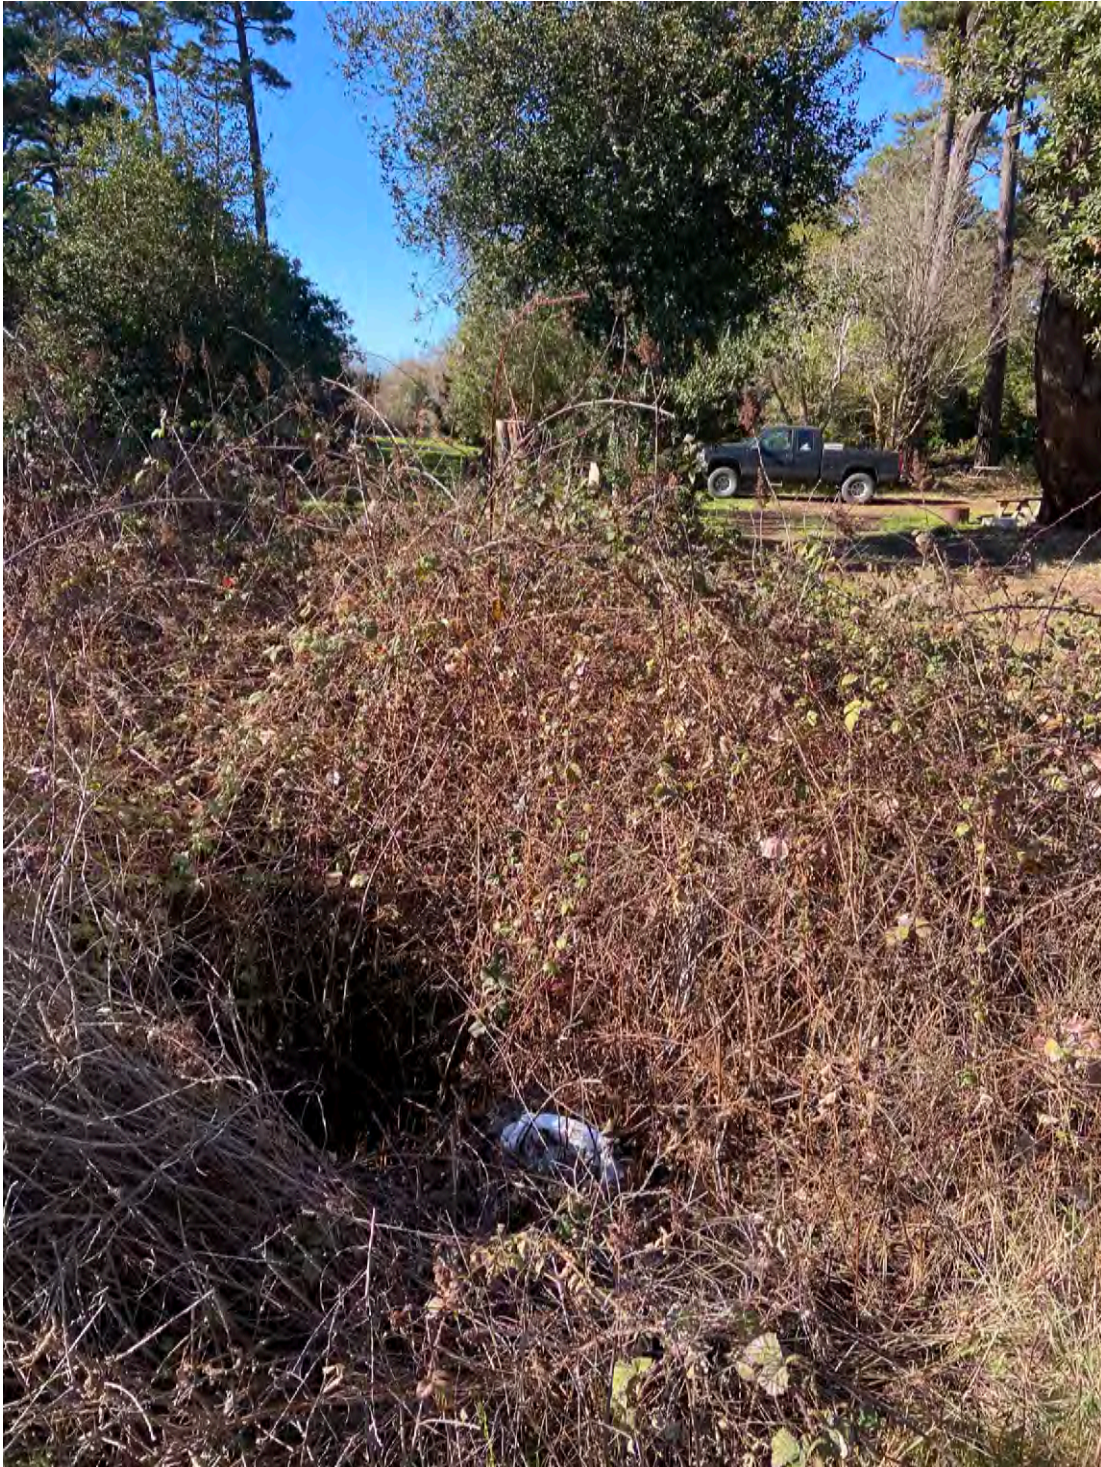
**Photo Point 4. View of riparian vegetation at culvert outlet, looking west.  
Date of Photo: February 4, 2021.**
