**PUBLIC HEARING NOTICE OF PENDING ACTION  
STANDARD COASTAL DEVELOPMENT PERMIT**

**CASE#:** CDP\_2020-0011

**REQUEST:** Standard Coastal Development Permit for an after-the-fact request to remove structures and restore riparian and Bishop Pine Forest ESHA, and requirement to monitor the restoration for three years or more.

**COASTAL PERMIT ADMINISTRATOR  
STAFF REPORT- STANDARD CDP**

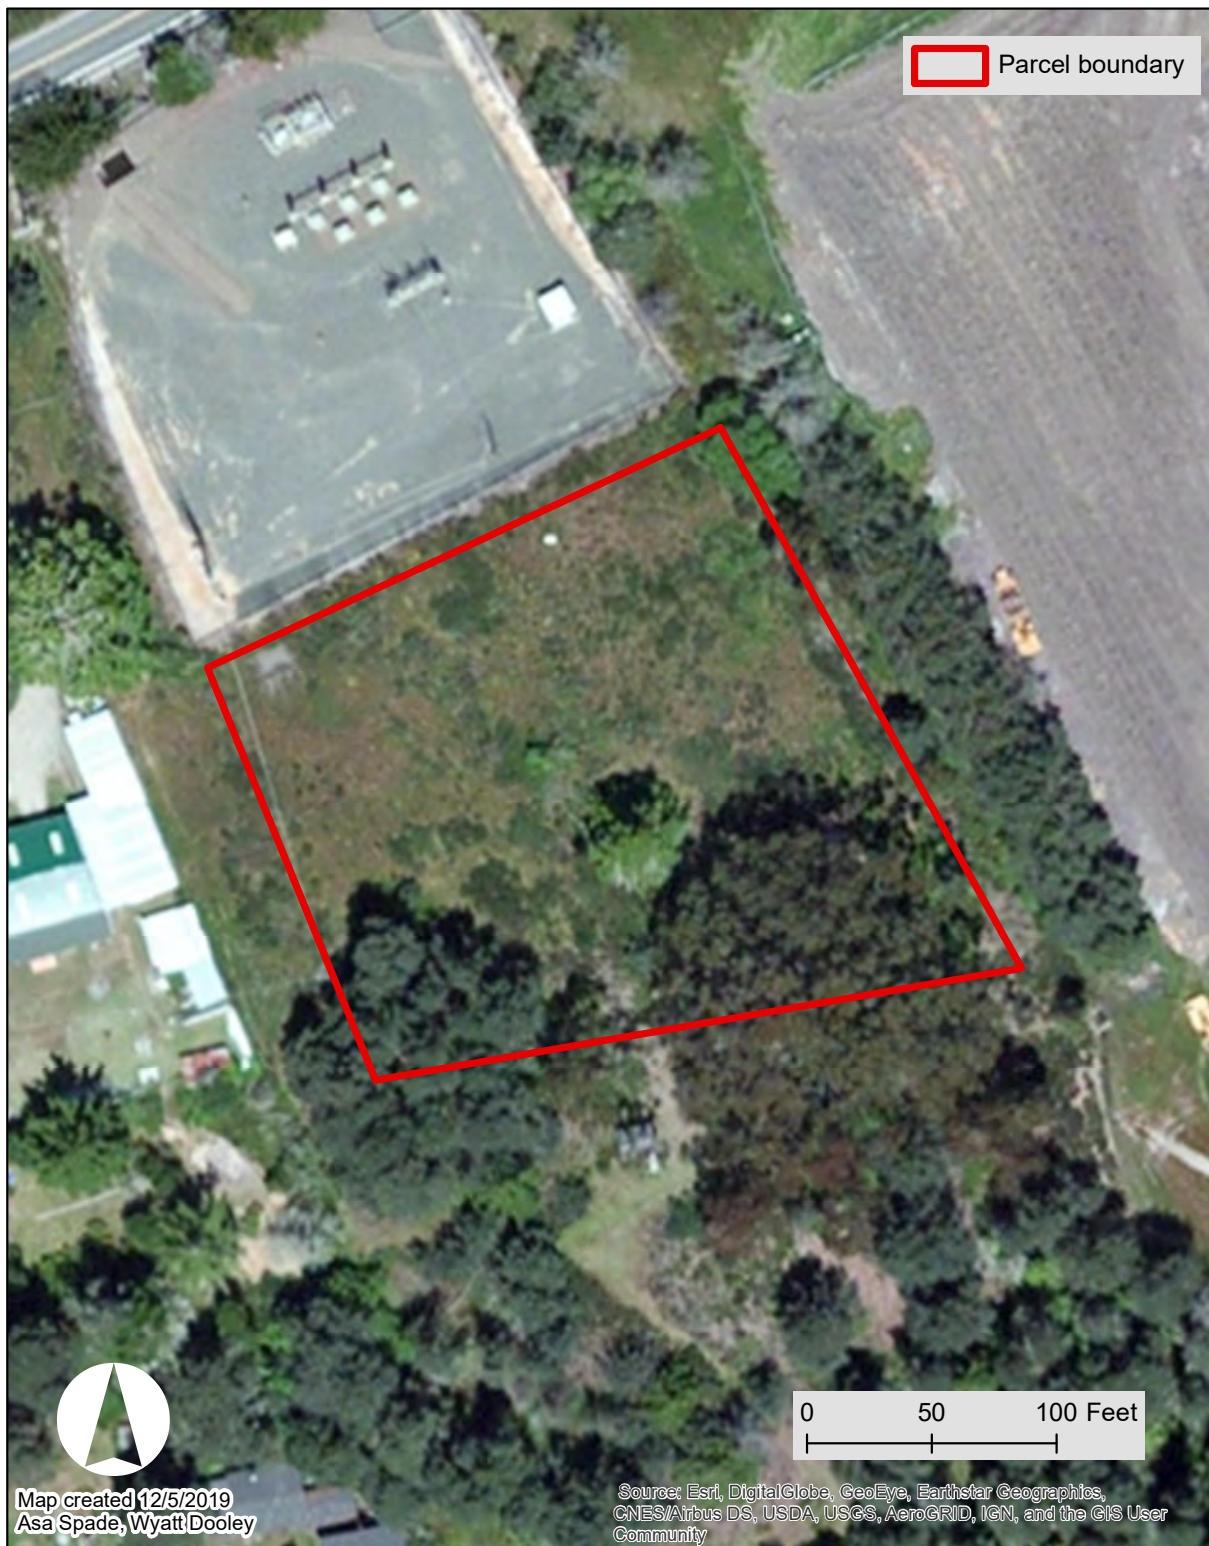
Figure 2. Aerial photo showing the extent of Bishop pine forest prior to the owner installing temporary structures.

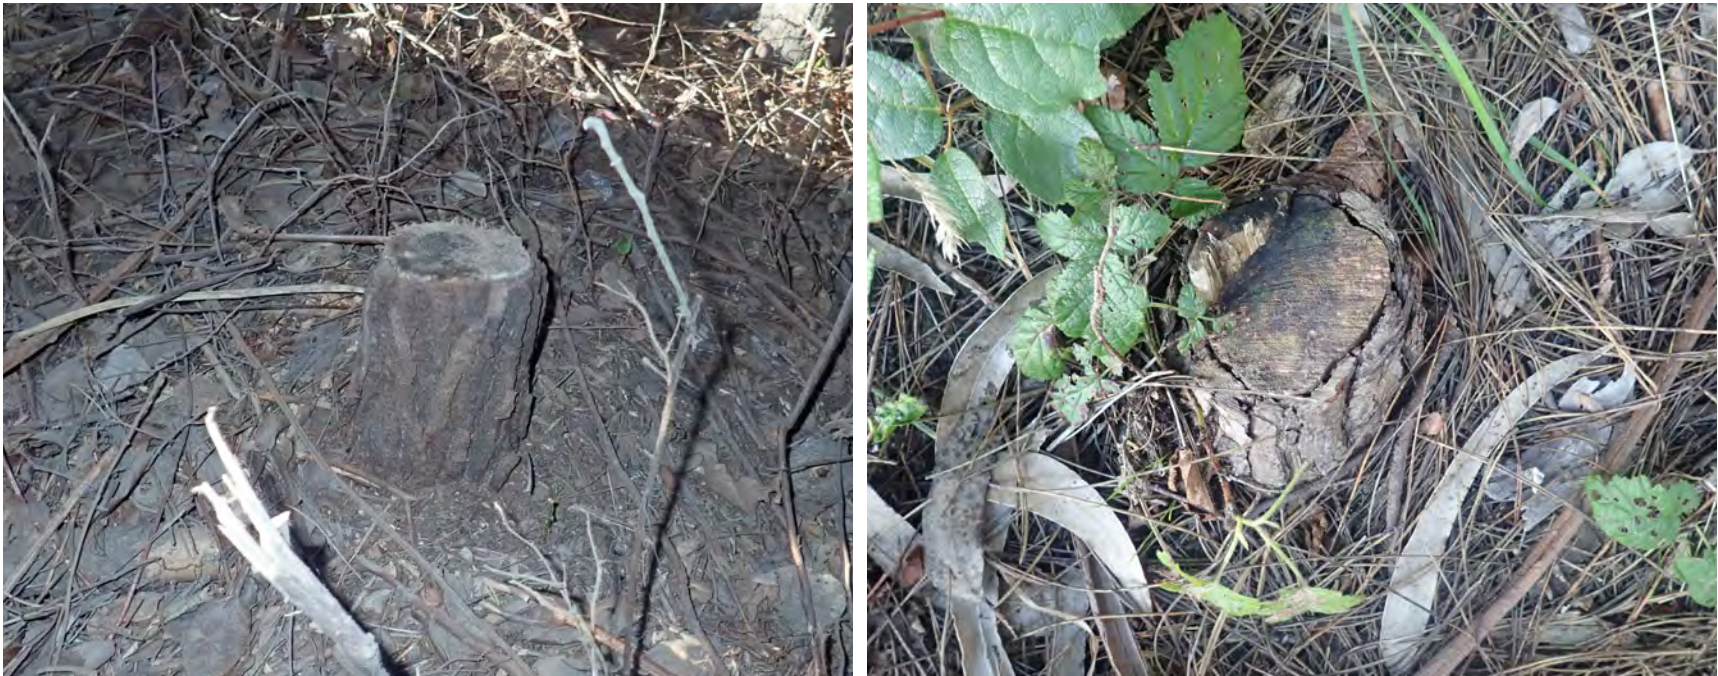
*Figure 4. Two small Bishop pine stumps observed beneath the temporary storage structures. These trees were less than 6-inches in diameter when cut.*

The development that was placed within the Bishop pine forest was a wood framed, metal sided temporary storage building build on concrete pier blocks as shown in **Figure 5** and **Figure 9**. Road base (**Figure 10**) was placed north of the temporary storage building for parking and access; this road base is spread on an area within 100ft of the Bishop pine forest. Some building materials and/or rental equipment were also placed within 50ft of the Bishop pine forest. A temporary event tent, which was used for additional storage, was erected in a location within 100ft, but further than 50ft, of Bishop pine forest and riparian area. It does not appear that any grading was conducted in the installation of the buildings; they are supported by concrete pier pads placed on top of the relatively flat ground and the remains of some vegetation, such as evergreen huckleberry were present and resprouting. Removal of the buildings should be relatively easy and is unlikely to have further impacts on the habitat present. Much of the understory vegetation is expected to become reestablished through resprouting since shrub crowns and root systems were not eliminated.

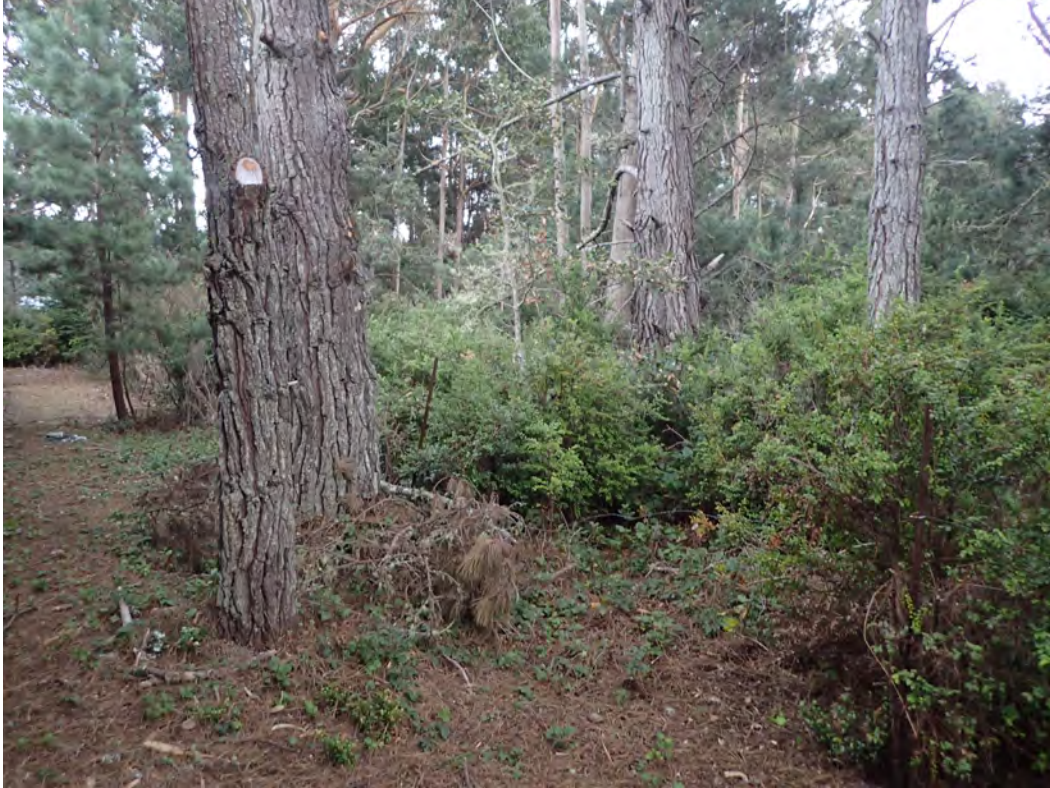
*Figure 6. Bishop pine forest understory on the parcel to the south of the temporary storage structures.*

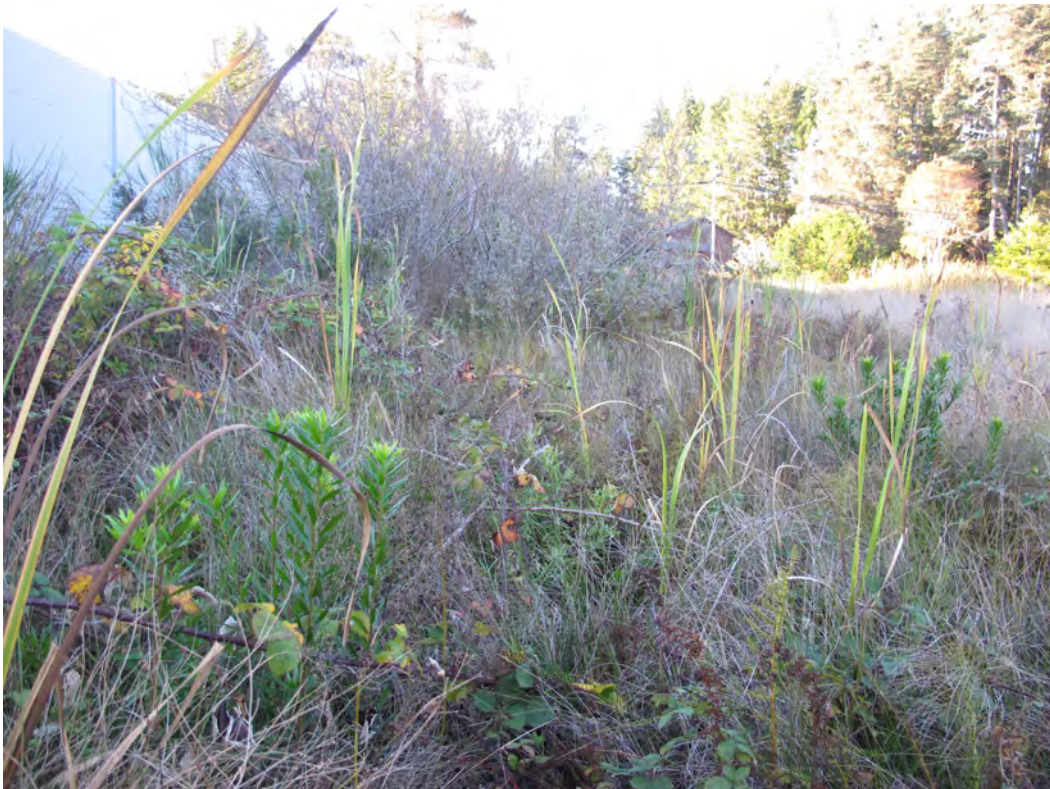
*Figure 7. Riparian area present on the adjacent parcel to the east. This habitat runs parallel to the subject parcel's eastern boundary.*

Wynn Coastal Planning & Biology conducted a site visit and documented two presumed ESHAs – **Bishop pine forest** (*Pinus muricata* forest alliance G3 S3.2) and a **riparian area** on the neighboring parcel to the east. These presumed ESHAs are mapped in **Figure 5**. Areas beneath the Bishop pine forest contained plants characteristic to the community such as huckleberry (*Vaccinium ovatum*), salal (*Gaultheria shallon*), and California blackberry (*Rubus ursinus*) (**Figure 6**). A riparian area was observed on the eastern property boundary. Species that characterized this area included willow (*Salix* sp.), wax myrtle (*Morella californica*), Himalayan blackberry (*Rubus armeniacus*), broad-leaved cattail (*Typha latifolia*), and Scotch broom

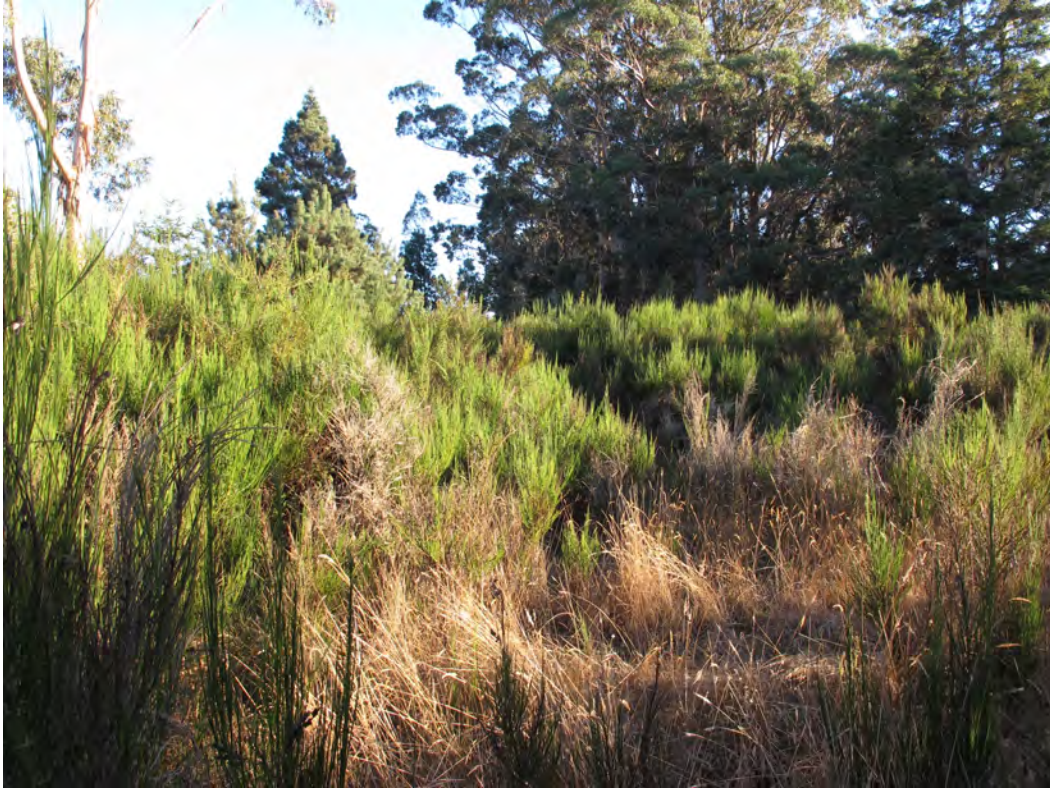
*Figure 8. Scotch broom that invaded the site prior to placement of temporary structures.*

(*Cytisus scoparius*). Blue gum eucalyptus trees (*Eucalyptus globulus*) formed a grove in the southeastern corner of the subject parcel and beyond. A single grand fir tree stands near the center of the parcel and a mature planted fruit tree grows near the fir. Outside of the other vegetation described above much of the parcel was vegetated with invasive Scotch broom (**Figure 8**).

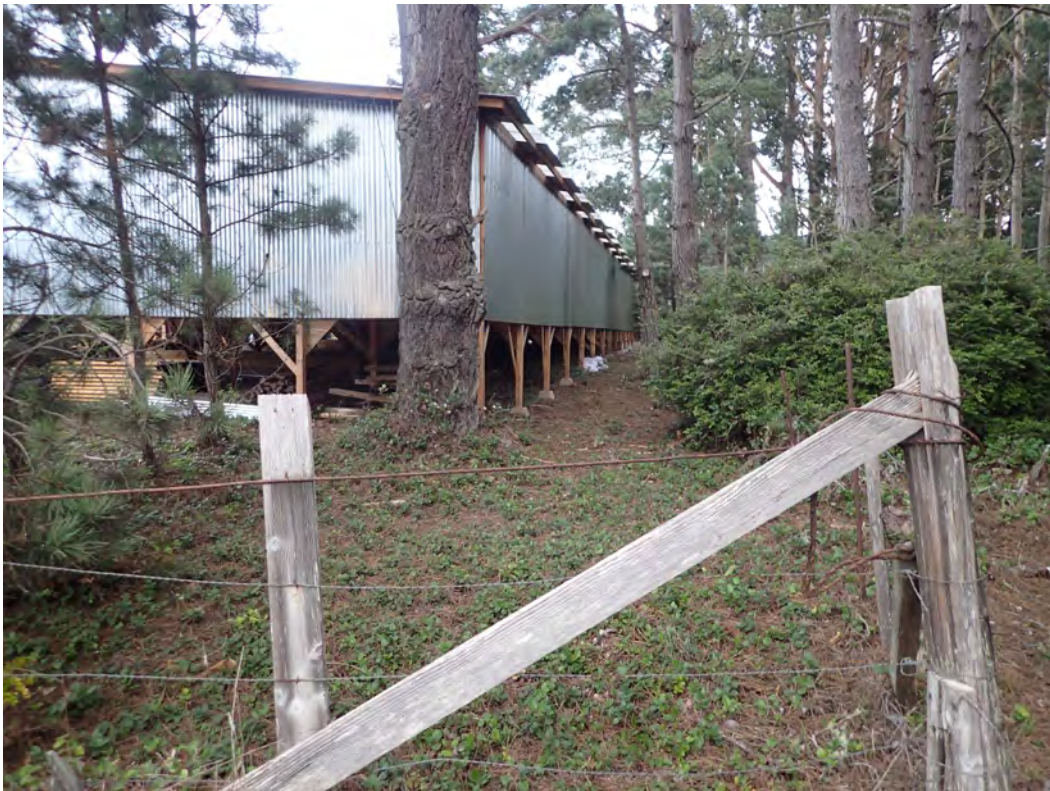
*Figure 9. Southwest corner of the parcel illustrating the storage structure in relation to Bishop pine forest.*

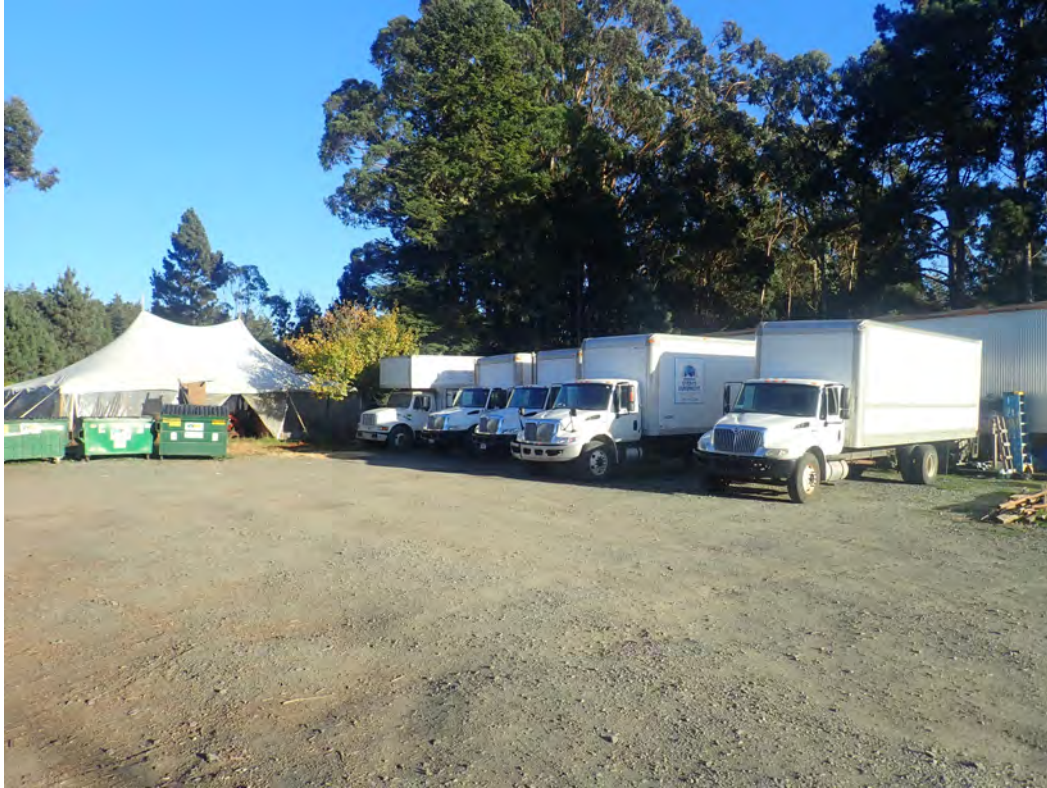
Figure 10. Road base that was placed north of the storage structure.
