Biological Assessment for Building Demolition at Lost Coast Redwoods

49551 HWY 1, Westport Mendocino County, California 95488 (APN-013-390-15)

Devilbiss Ranch Demolition Project Delineation of Waters of the United States

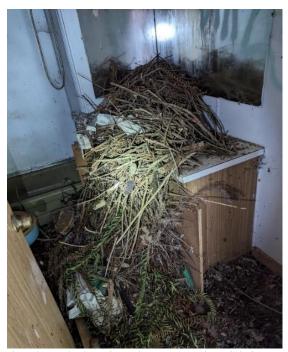
Photo 2. Dusky-footed wood rat nest inside mobile home.

A non-listed species, dusky-footed wood rat (*Neotoma fuscipes*), will possibly be affected by the proposed building removal as middens were found in three different structures (Photo 2). Prior to demolition, the nests will be inspected and removed to minimize impact.

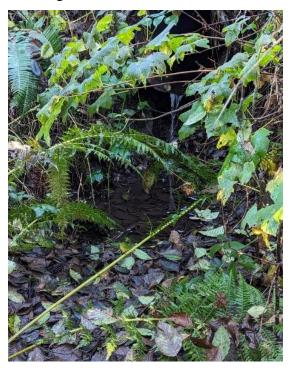
Photo 3. Pooling of water on west side of culvert in small Class II watercourse

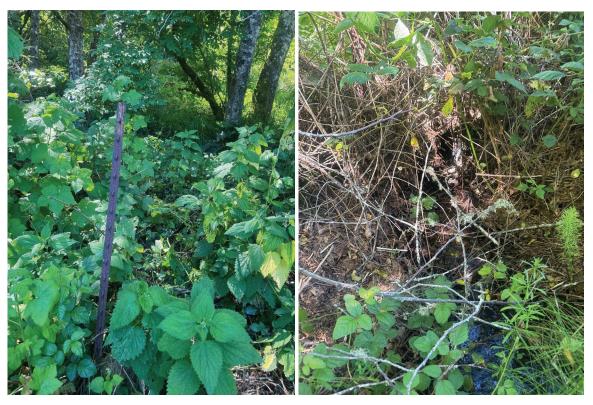
Photo #1 Photo#2

Photo #1: Photo taken looking south towards ephemeral creek, located approximately 15 feet from post. Sample Point #2 is near metal post.

Photo #2: Ephemeral creek channel. Location of Sample Point #1.

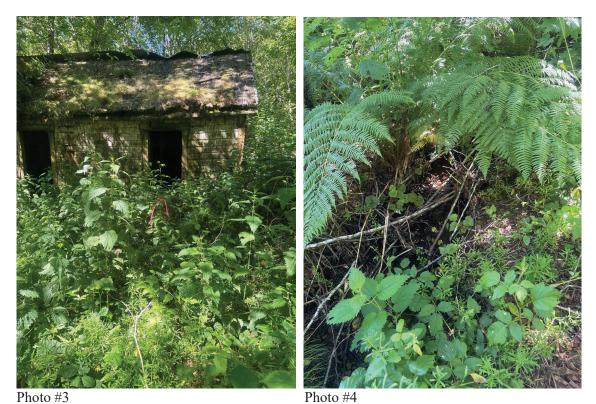
Photograph #3 - Sample Point #4 at flag. Photograph #4 - Location of Sample Point #3, in channel.

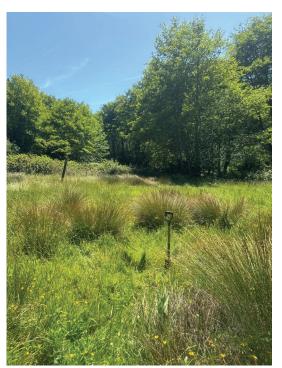
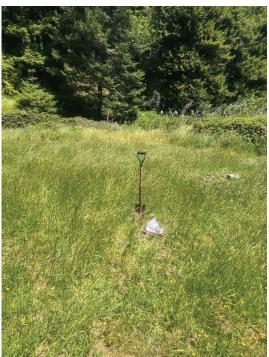
Photo #5 Photo #6

Photo #5 – Sample Point #5 looking South. Photo #6 – Sample Point #6 looking East.

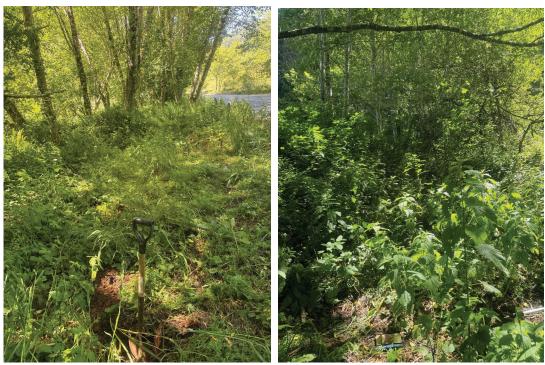
Photo #7 Photo #8

Photo #7 – Photograph of Sample Points #7 (channel) and #8 (upland), taken looking north towards ephemeral creek.
