Acceptance of Informational Report Regarding the Issuance of Emergency Coastal Development Permit EM\_2024-0003 (Balderston) to Install Drilled Piers, a Grade Beam Foundation System, and a Perimeter Foundation Drain, Located at 12700 N. Highway 1, Mendocino; APN: 118-320-05

BALDERSTON FOUNDATION IMPROVEMENTS  
12700 NORTH HIGHWAY 1  
MENDOCINO, CALIFORNIA

GEOTECHNICAL INVESTIGATION  
BALDERSTON FOUNDATION IMPROVEMENTS  
12700 NORTH HIGHWAY 1  
MENDOCINO, CALIFORNIA

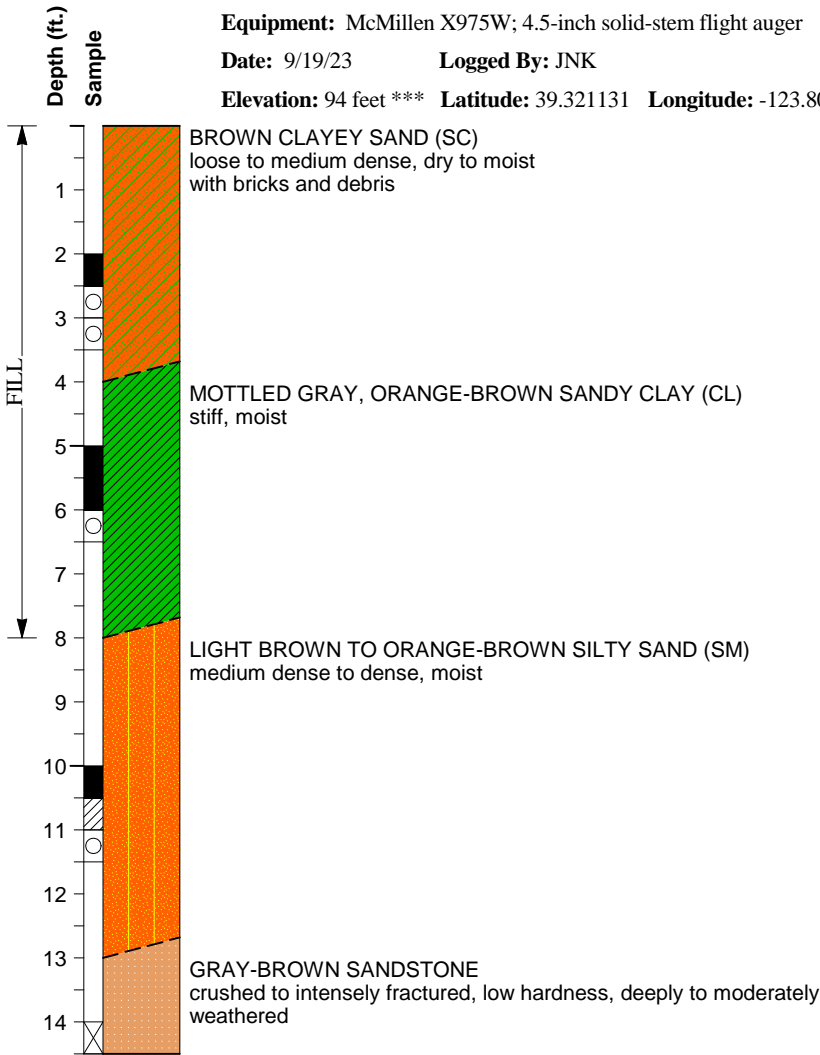
- Notes:
1. No free water encountered
  2. No caving
  3. Practical drilling refusal at 14.5 feet

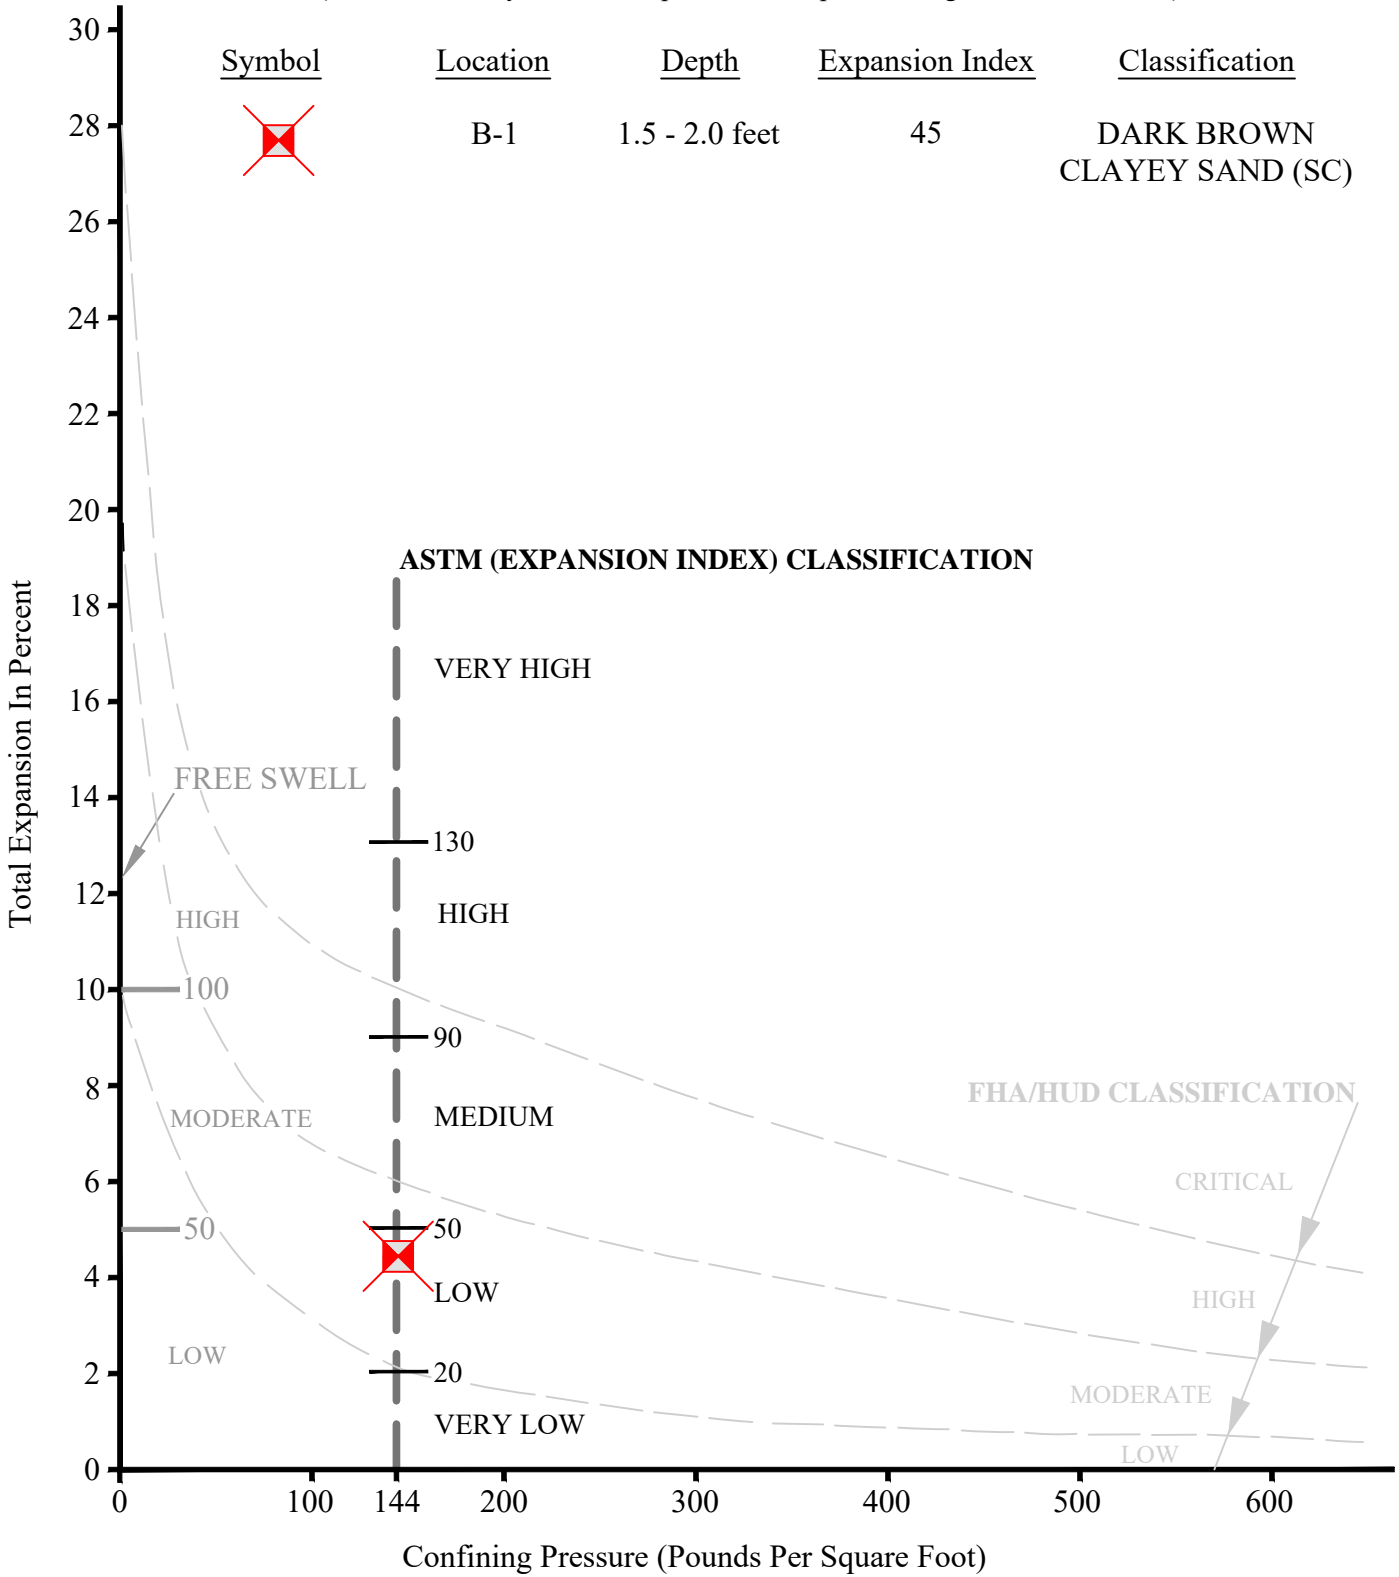
**PLATE**  
9

B-1	1.5 - 2.0 feet	45	DARK BROWN CLAYEY SAND (SC)

\*Free Swell test procedure per United States Bureau of Reclamation.  
 Results interpreted per "Pavements on Expansive Clays", 1969, by Kassif, Livneh, and Wiseman.

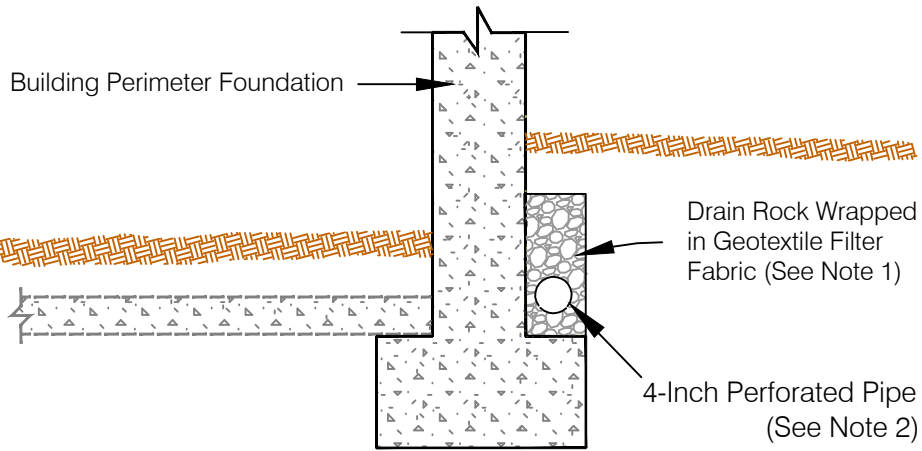
**PERIMETER FOUNDATION DRAINAGE DETAILS**

PERIMETER FOUNDATION DRAINAGE DETAIL  
(Not to Scale)

1. Drain rock should be clean, free-draining 3/4 inch crushed rock. Perimeter foundation drain rock should be wrapped in a non-woven geotextile filter fabric (Mirafi 140N or equivalent) or Class 2 permeable material, without filter fabric, per Caltrans standard specifications, latest edition.
2. Pipe should be SDR 35 or equivalent, placed with perforations down, sloped at least 1 percent to gravity outlet or sump with automatic pump.
3. A clean-out pipe with cap should be installed at the up-slope end of the pipe, pipe elbows should be 45 degrees or less (for "snake" access).

Because surface and/or subsurface water is often the cause of foundation or interior moisture problems, care should be taken to intercept and divert concentrated surface flows and subsurface seepage away from the building foundations. Drainage across the lot should be by sheet-flow. Surface grades should maintain a recommended five percent gradient away from building foundations. To minimize the chance for moisture inundation of the near surface soils, we recommend that a perimeter foundation drain be installed around the perimeter foundation elements, as shown on Plate 11
