Acceptance of Informational Report Regarding the Issuance of Emergency Coastal Development Permit EM_2024-0002 (Kopriva) to Inject Ultra-Fine Cement Grout into the Terrace Sands and Bedrock to Harden Cut Slope Soils and Reduce their Erosion Potential which Currently Threatens an Existing Residence, Located at 6170 S. Highway 1, Elk, APN: 127-200-06.

The purpose of our investigation was to evaluate the site soil and bedrock conditions and the geologic hazards at the site in order to provide recommendations for erosion mitigation to protect the existing property. Our approach to providing the geotechnical guidelines for the design of the project utilized our knowledge of the soil, bedrock and geologic conditions in the site vicinity and experience with similar projects. Field exploration for this investigation was directed toward confirming anticipated soil, bedrock, and geologic conditions, in order to provide the basis for our conclusions and recommendations.

KOPRIVA SLOPE STABILIZATION
 6170 South Highway 1
 Elk, California

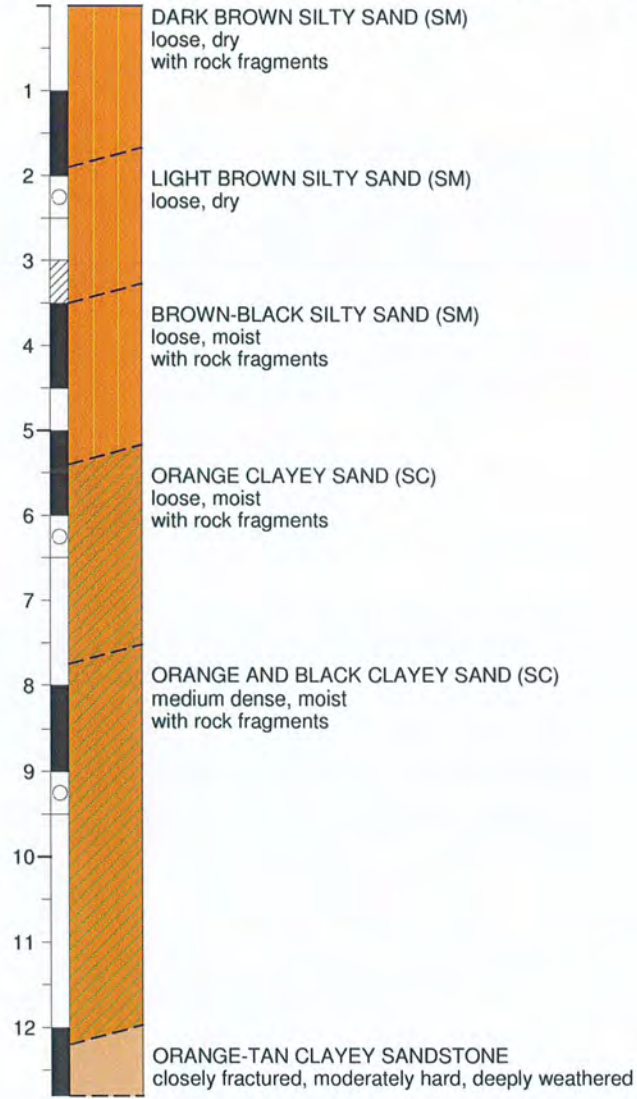
BORING LOG, 1 PER PAGE, 13487.03 GINT.GPJ, 9/8/24

11.6	67	
	CM			8 **
Tx 960 (576)		17.1	101	
	CM			9 **
	CM			8 **
Tx 1263 (1008)		21.7	94	
	CM			11 **
	CM			11/3" **

- Notes:**
1. No water encountered
 2. No caving
 3. Backfilled with cuttings

The site bedrock consists of sedimentary bedrock of the Cretaceous-Tertiary Franciscan Complex coastal belt, comprised of orange-tan clayey sandstone. The bedrock is closely fractured, moderate in hardness, and deeply weathered. The orange-tan clayey/silty sandstone was encountered at between five and 12 feet below the ground surface. Practical drilling refusal for the light, portable drill rig was encountered in the moderately hard sandstone in boring B-2 at 6.5 feet, B-3 at 10.1 feet and B-4 at 6.1 feet.

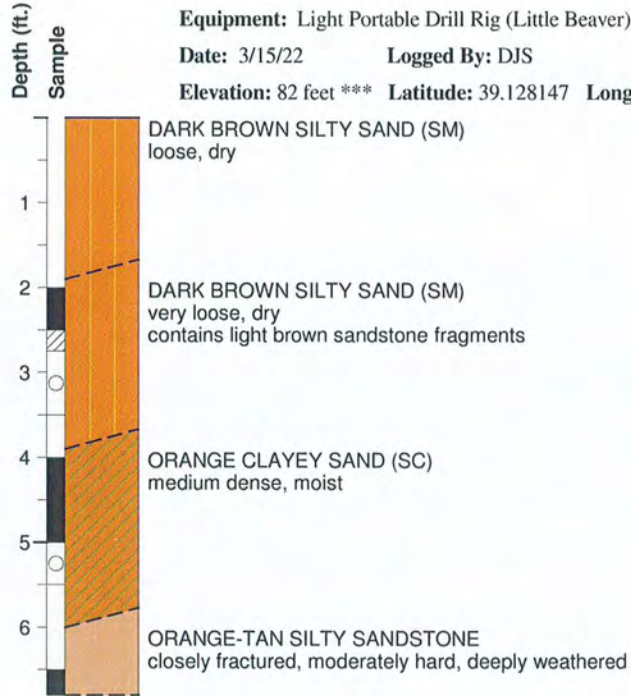
BORING LOG 1 PER PAGE. 13487.03 GINT.GPJ, 8/8/24

Laboratory Tests	Sampler Type*	Moisture Content (%)	Dry Density (pcf)	Blows/foot
		20.6	84	
	CM			4 **
Tx 2240 (576)		16.9	103	
	CM			10 **
	CM			20/3" **

- Notes:**
1. No water encountered
 2. No caving
 3. Practical drilling refusal at 6.5 feet

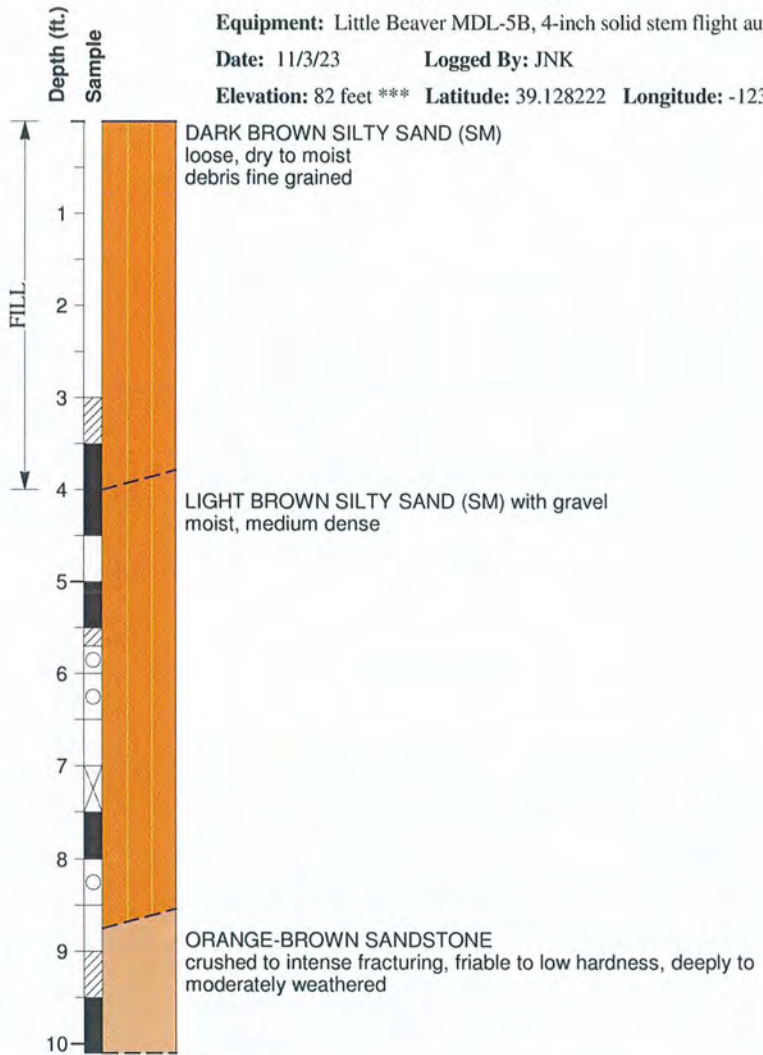
BORING LOG 1 PER PAGE 13487.03 GINT GRJ 8/8/24

Sampler Type*	Moisture Content (%)	Dry Density (pcf)	Blows/foot
CA	11.9	97	11 **
CA	16.8	96	6 **
CA	20.4	100	16 **
CA			16/5" **
SPT			25/2"

- Notes:**
1. No free water encountered
 2. No caving
 3. Practical drilling refusal at 10.1 feet

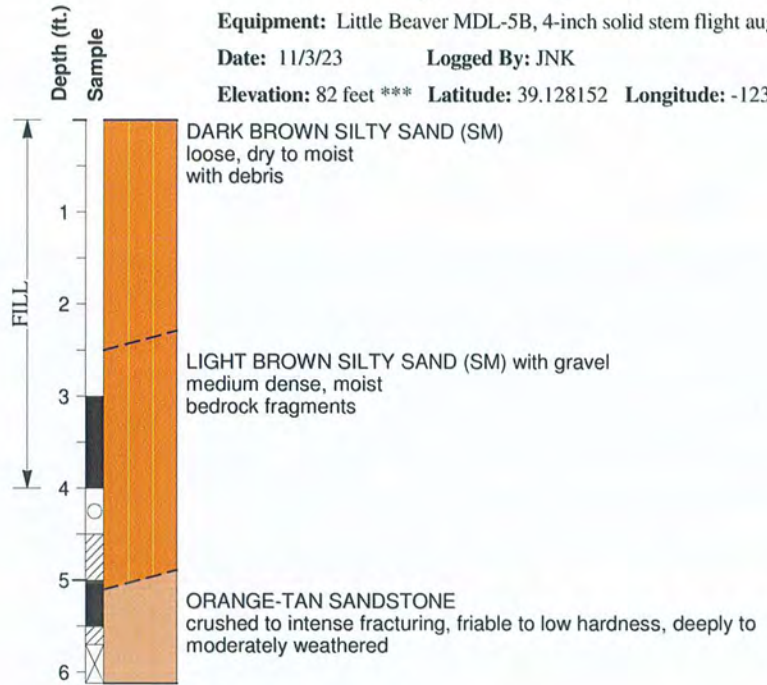
Laboratory Tests	Sampler Type*	Moisture Content (%)	Dry Density (pcf)	Blows/foot
21% Passing #200 75% Passing #4	CA	11.4	96	8 **
	CA SPT			22/8" ** 25/5"

1. No free water encountered
2. No caving
3. Practical drilling refusal at 6.1 feet

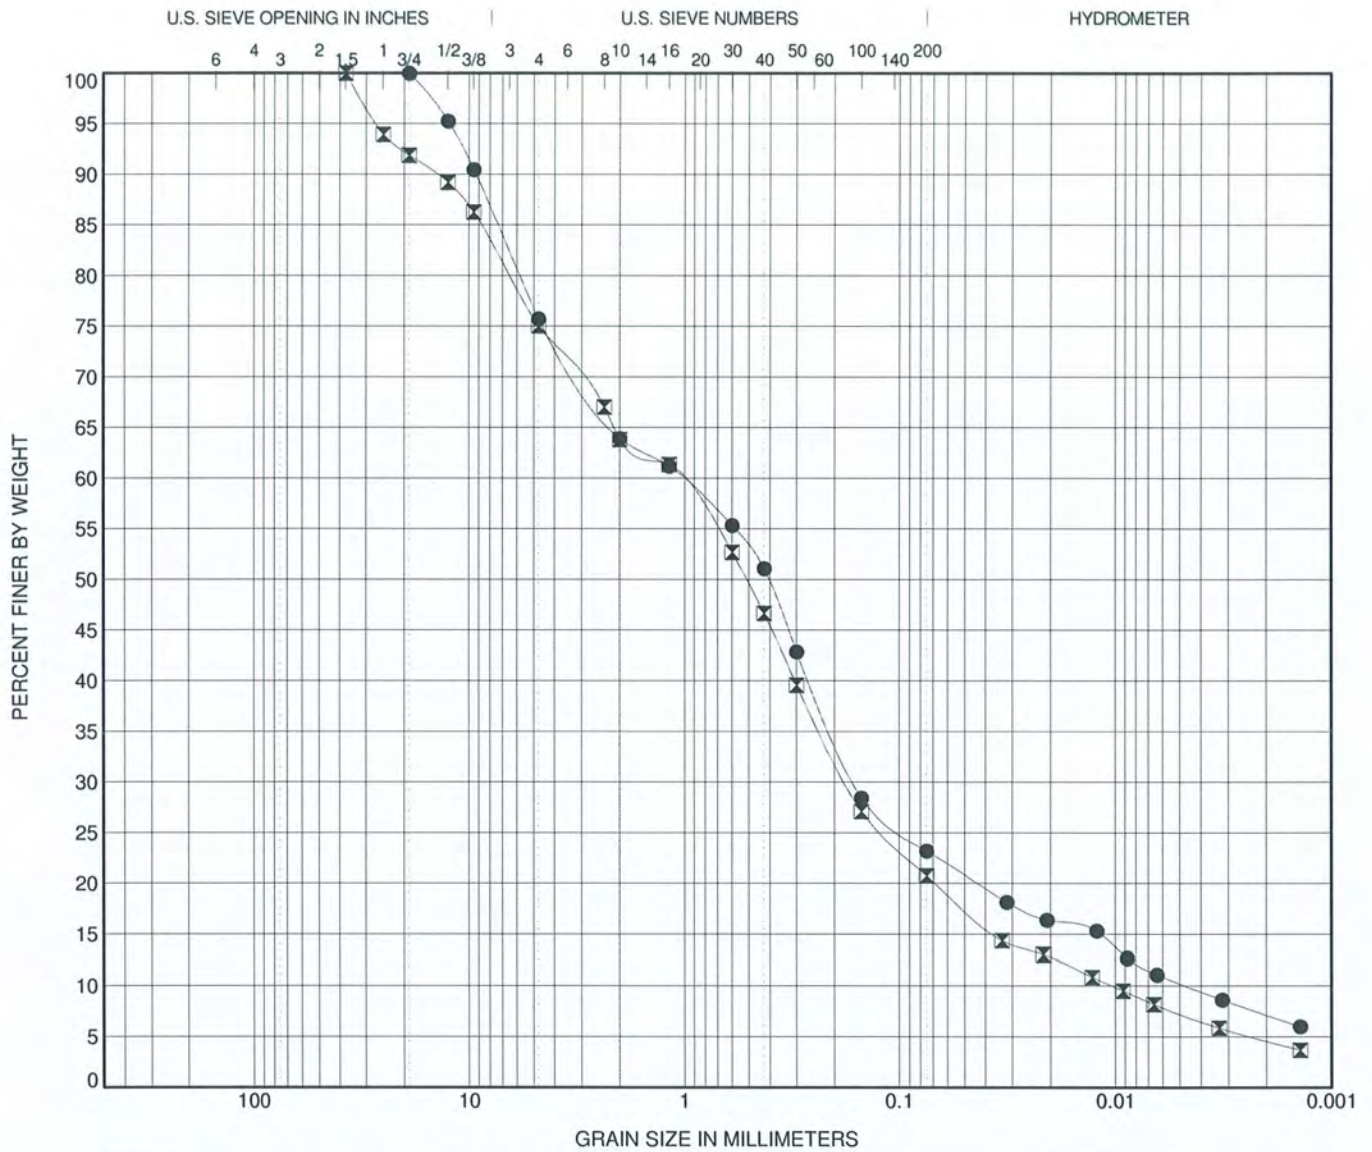
PLATE
10

COBBLES	GRAVEL		SAND			SILT OR CLAY
	coarse	fine	coarse	medium	fine

Specimen Identification		Classification				LL	PL	PI	Cc	Cu
●	B-3 6.0 ft	LIGHT BROWN SILTY SAND (SM) with gravel							5.42	218.23
⊠	B-4 4.0 ft	LIGHT BROWN SILTY SAND (SM) with gravel							2.82	102.27
Specimen Identification		D100	D60	D30	D10	%Gravel	%Sand	%Silt	%Clay	
●	B-3 6.0 ft	19	1.027	0.162	0.005	24.3	52.5	13.0	10.2	
⊠	B-4 4.0 ft	37.5	1.06	0.176	0.01	24.9	54.3	13.5	7.2

GRAIN SIZE DISTRIBUTION
KOPRIVA SLOPE STABILIZATION
 6170 South Highway 1
 Elk, California

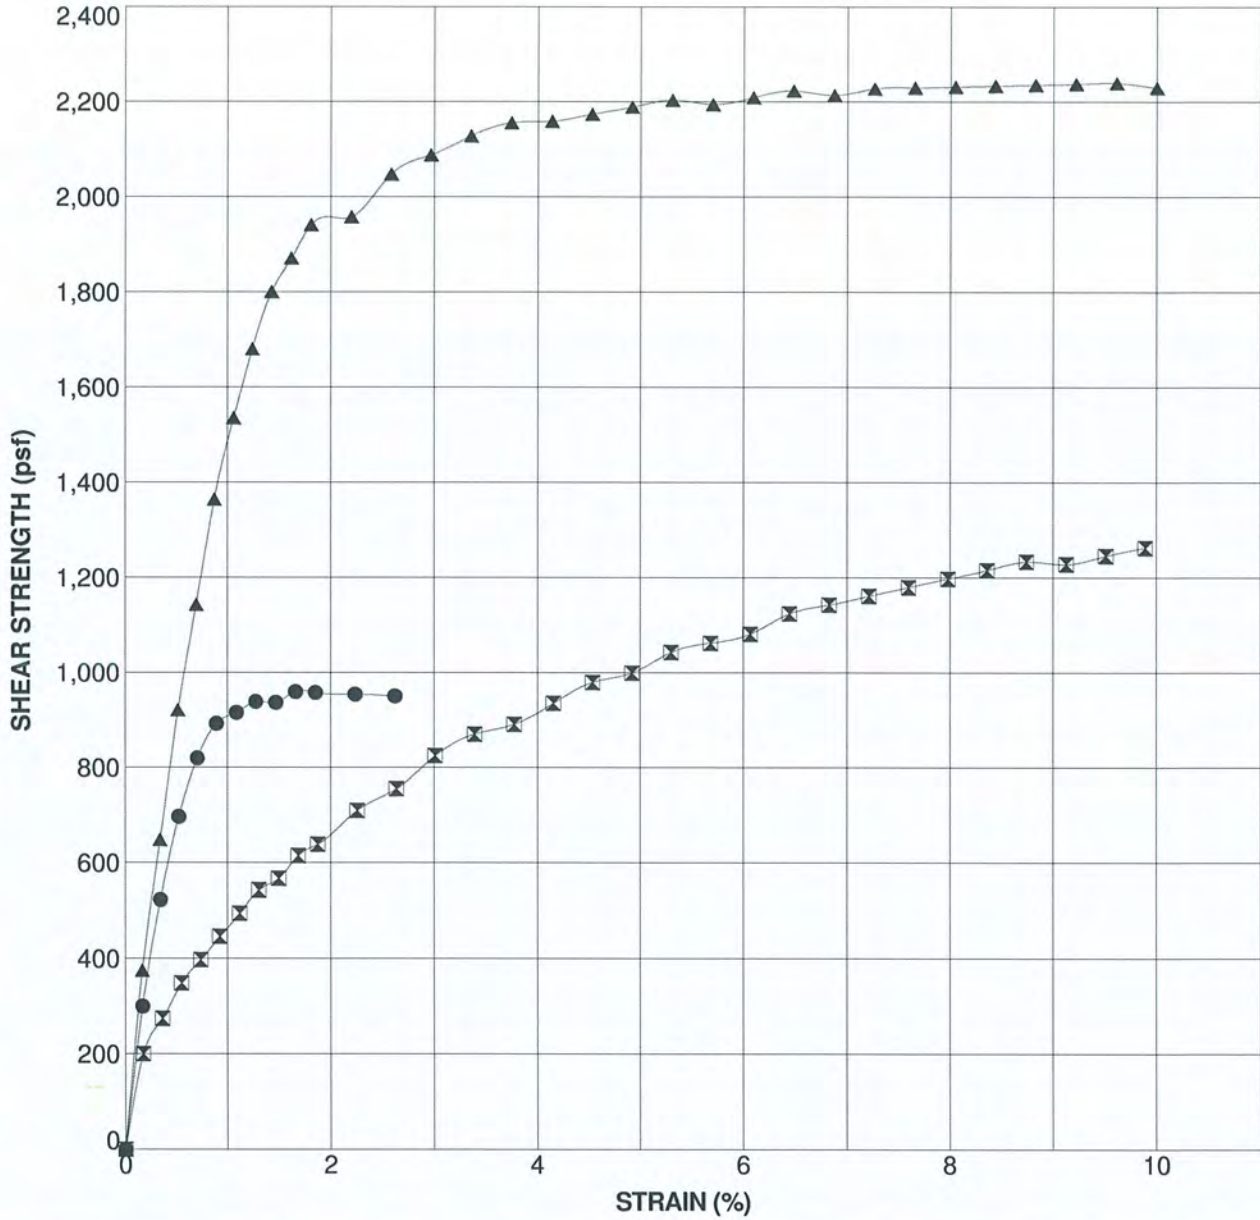
**PLATE
 11**

Sample Source	Classification	Confining Pressure (psf)	Ultimate Strength (psf)	Strain (%)	Dry Density (pcf)	Moisture Content (%)
● B-1 at 3.5 ft	BROWN-BLACK SILTY SAND (SM)	576	960	1.7	101	17.1
☒ B-1 at 8 ft	ORANGE AND BLACK CLAYEY SAND (SC)	1008	1263	9.9	94	21.7
▲ B-2 at 4.5 ft	ORANGE CLAYEY SAND (SC)	576	2240	9.6	103	16.9

UNCONSOLIDATED TRIAXIAL (ULTIMATE), 13487.03 GINT.GPJ, 8/8/24

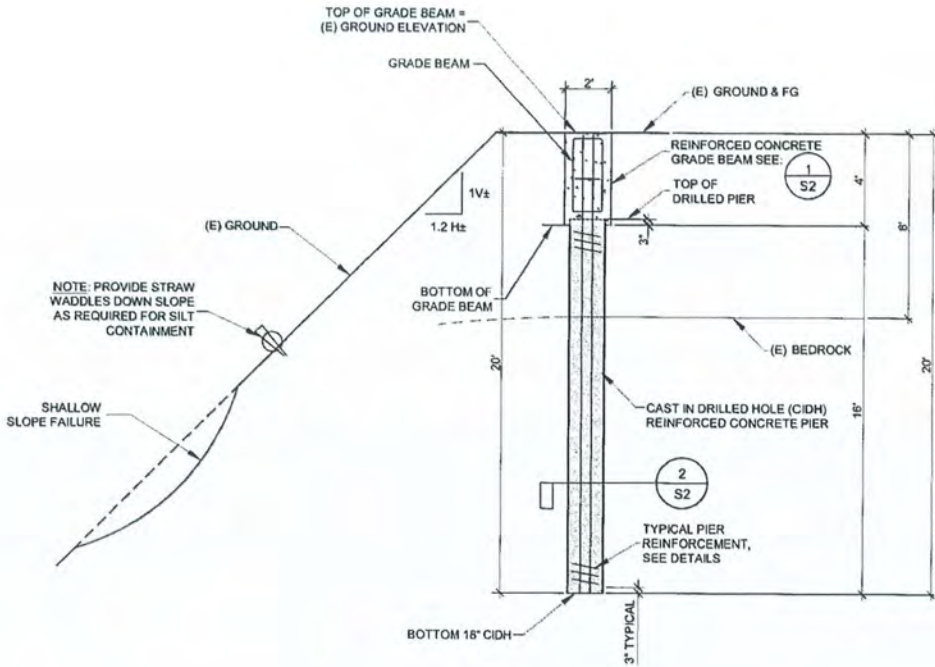
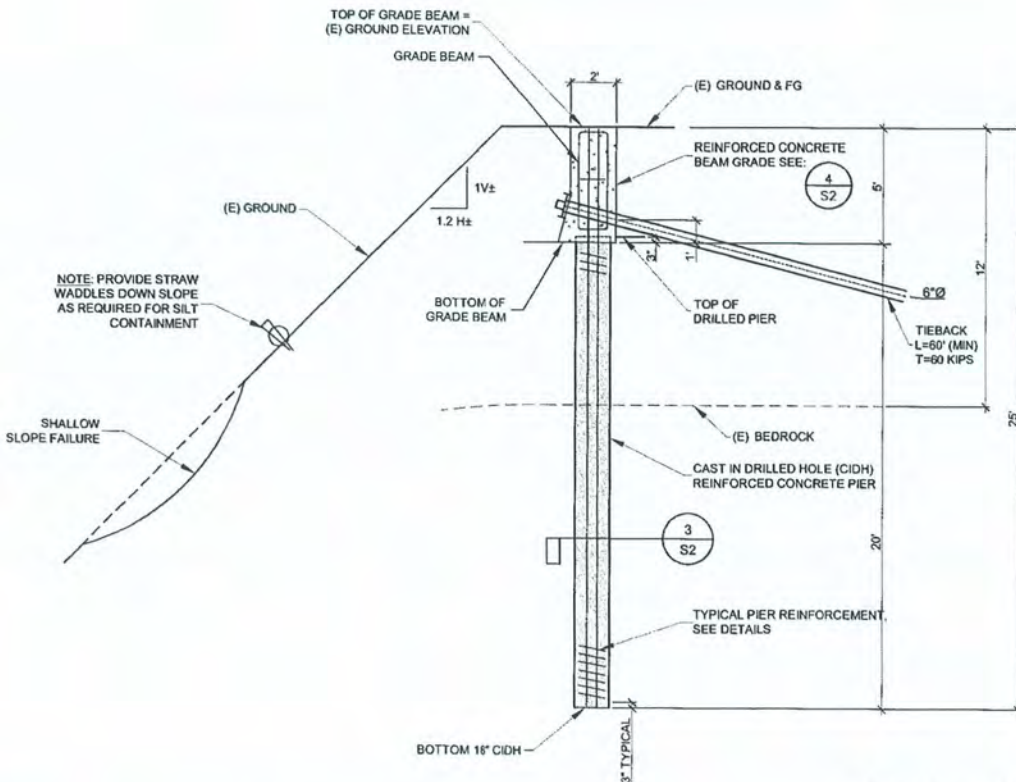
PLATE
13

Elevation, Plan & Cross Sections, sheet S1, prepared by Duncan Engineering, Inc. dated 09/14/2022

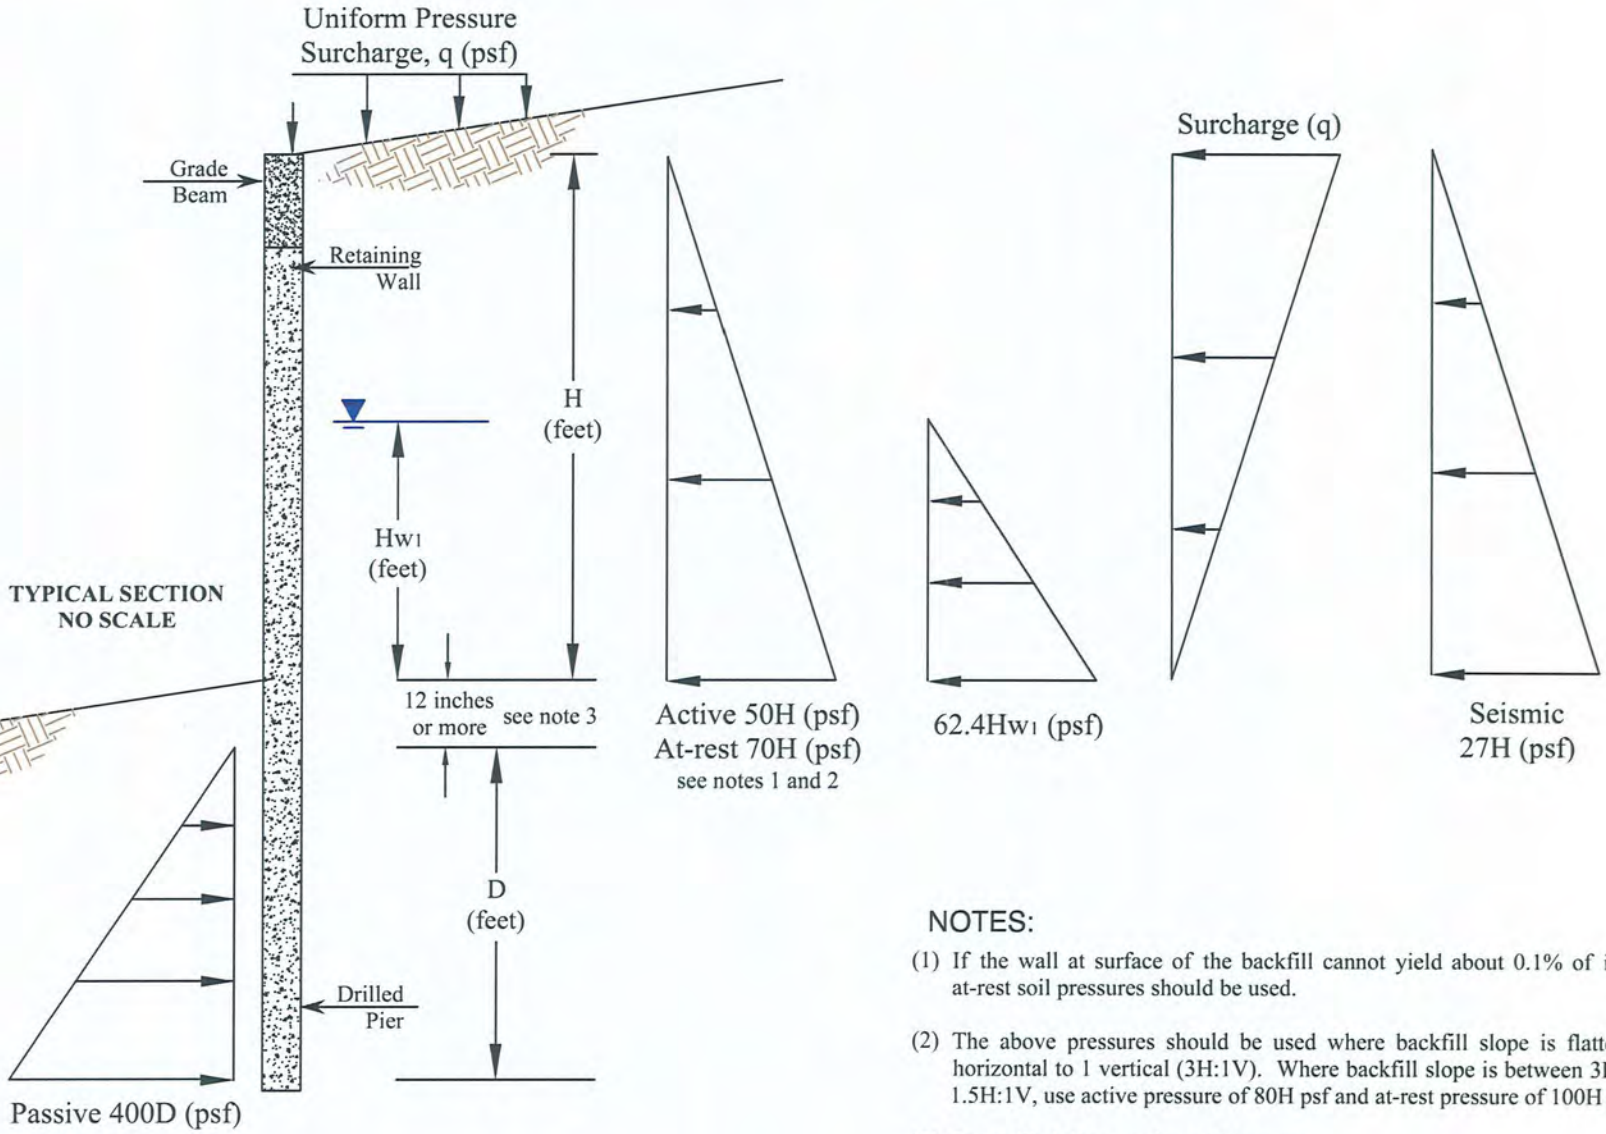
- (1) If the wall at surface of the backfill cannot yield about 0.1% of its' height, at-rest soil pressures should be used.
- (2) The above pressures should be used where backfill slope is flatter than 3 horizontal to 1 vertical (3H:1V). Where backfill slope is between 3H:1V and 1.5H:1V, use active pressure of 80H psf and at-rest pressure of 100H psf.
- (3) See Drilled Piers section of this report.

In addition to static loads, the retaining structure should also be designed to resist potential seismic loads, in accordance with California Building Code requirements. For seismic loads, a pressure increment equivalent to a triangular distribution is recommended, varying from 0 (zero) pounds per square foot (psf) at the top of the wall to 27H psf at the bottom of the retaining portion, where "H" is the height of the retaining portion of the structure (resultant dynamic thrust act at 0.33H above the bottom of the retaining portion of the structure).
