Mendocino County Museum  
Building Condition Assessment Report  
Prepared by: Stephen Farneth FAIA  
Final Report September 16, 2022

## **1. Introduction:**

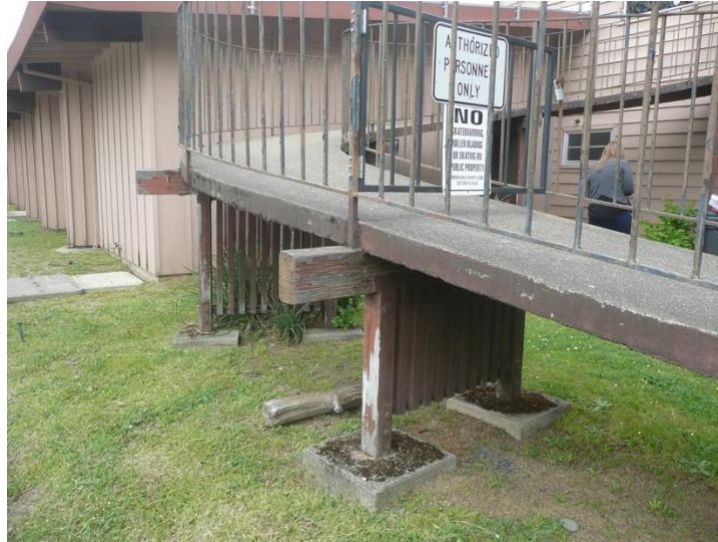
Figure 5. Curved Ramp to Second Floor

The buildings of the Mendocino County Museum appear to be structurally sound. The structural settlement observed along the west wall of the Exhibits Building is almost certainly due to roof drainage water retained adjacent to the building foundation wall. The free-standing curved sloped walkway to the second floor is in poor structural condition, and should be removed rather than repaired. See further discussion later in this report for both of these issues.

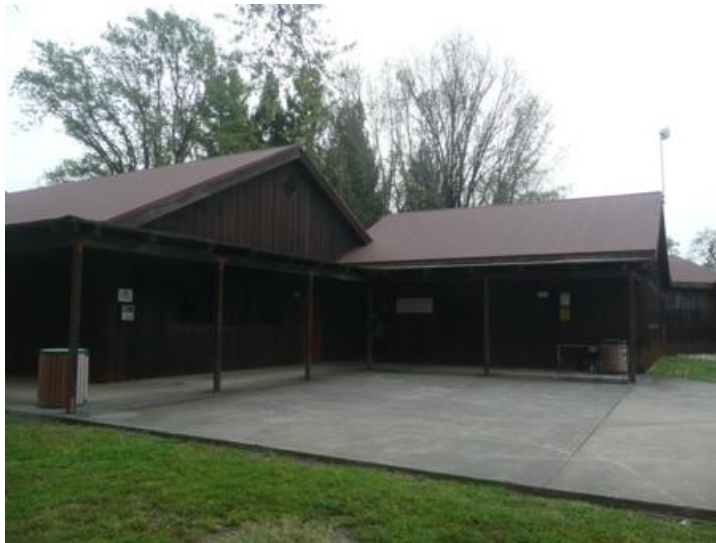
*Figure 10. North Elevation, Rear entry to Classroom Building*

- c) Northern site: The north side of the building also has opportunities for outdoor activities, especially related to the three classrooms. The long path of travel for Mendocino College students using the classroom, runs all along the north side of the building from the Library parking lot. It is a long, not particularly attractive walk, with limited signage, lighting, and security. Relocating the classrooms' main entry to a shared entrance on the south side (discussed later in this report), would provide better, direct, and more attractive, accessible environment for arrival.

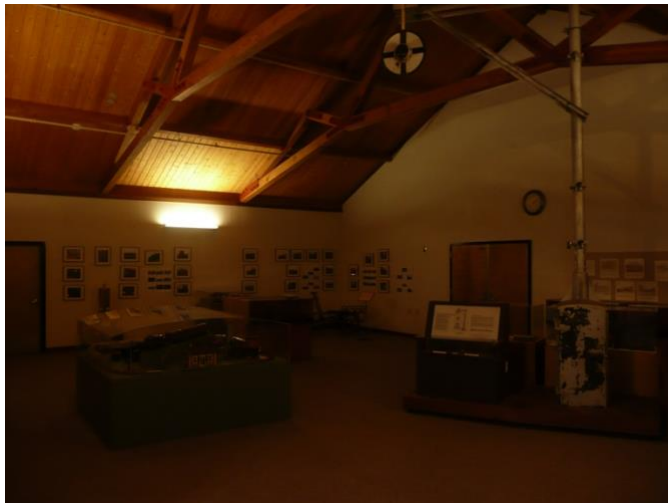
*Figure 22. Tall Gallery at Classroom Building*

- b) The Tall and Long Gallery spaces of the Classroom Building are very nice spaces, but without any daylight. They would both benefit from skylighting and/or installation of a few windows. If the proposed south entry is developed, consideration should be given to additional daylight into these spaces.

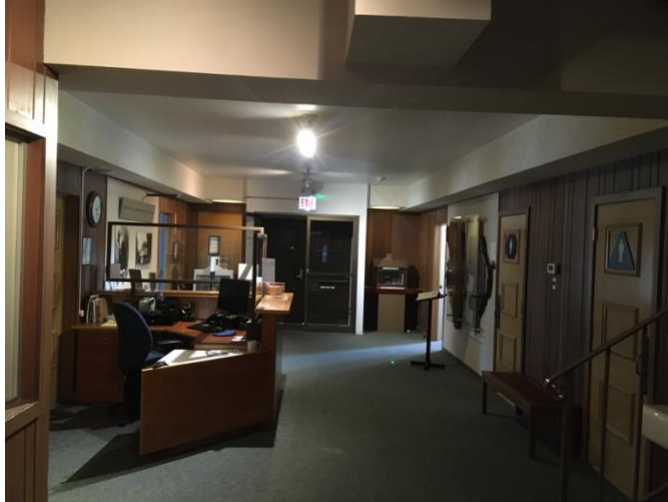
*Figure 25. Lobby*

- **Administration Building:** The entry, arrival lobby and support spaces of the first floor seem to function adequately, but would benefit from some minor alterations. When the restrooms are remodeled to bring them up to CBC accessibility standards, the lobby might be refreshed with improved lighting and orientation information.

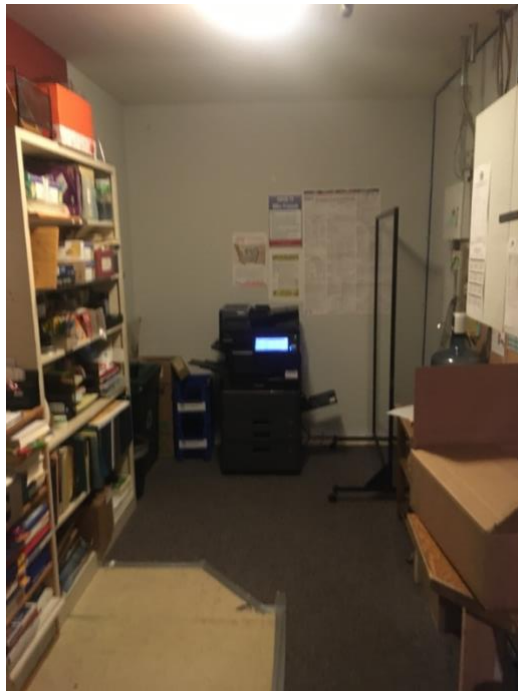
Figure 27. Copy Room, proposed elevator area

Providing disabled accessibility to the second floor administrative level of the building requires that an elevator be installed. The existing copy room at the rear wall of the Administration Building first floor has adequate space for a limited use/limited access elevator and small lobby area to serve the elevator. The shaft would project up through the roof of the Exhibits Building and connect through the north exterior wall into the second floor of the Administration Building. In this way no space is lost from the second floor. A small copy area can be provided in the upstairs office area.
