Acceptance of Informational Report Regarding the Issuance of Emergency Coastal Development Permit EM_2023-0003 (McLellan) to Relocate the Single-Family Residence, Located at 34301 Pacific Reefs Road, Albion, APN: 123-340-19

NATURE OF EMERGENCY: Approximately twenty-two (22) feet of the ocean bluff collapsed in early March 2023, extending to the foundation of the existing single-family residence.

BRUNSG ASSOCIATES, INC.
5468 Skylane Blvd. Suite 201
Santa Rosa, CA 95403
(707) 528-6108

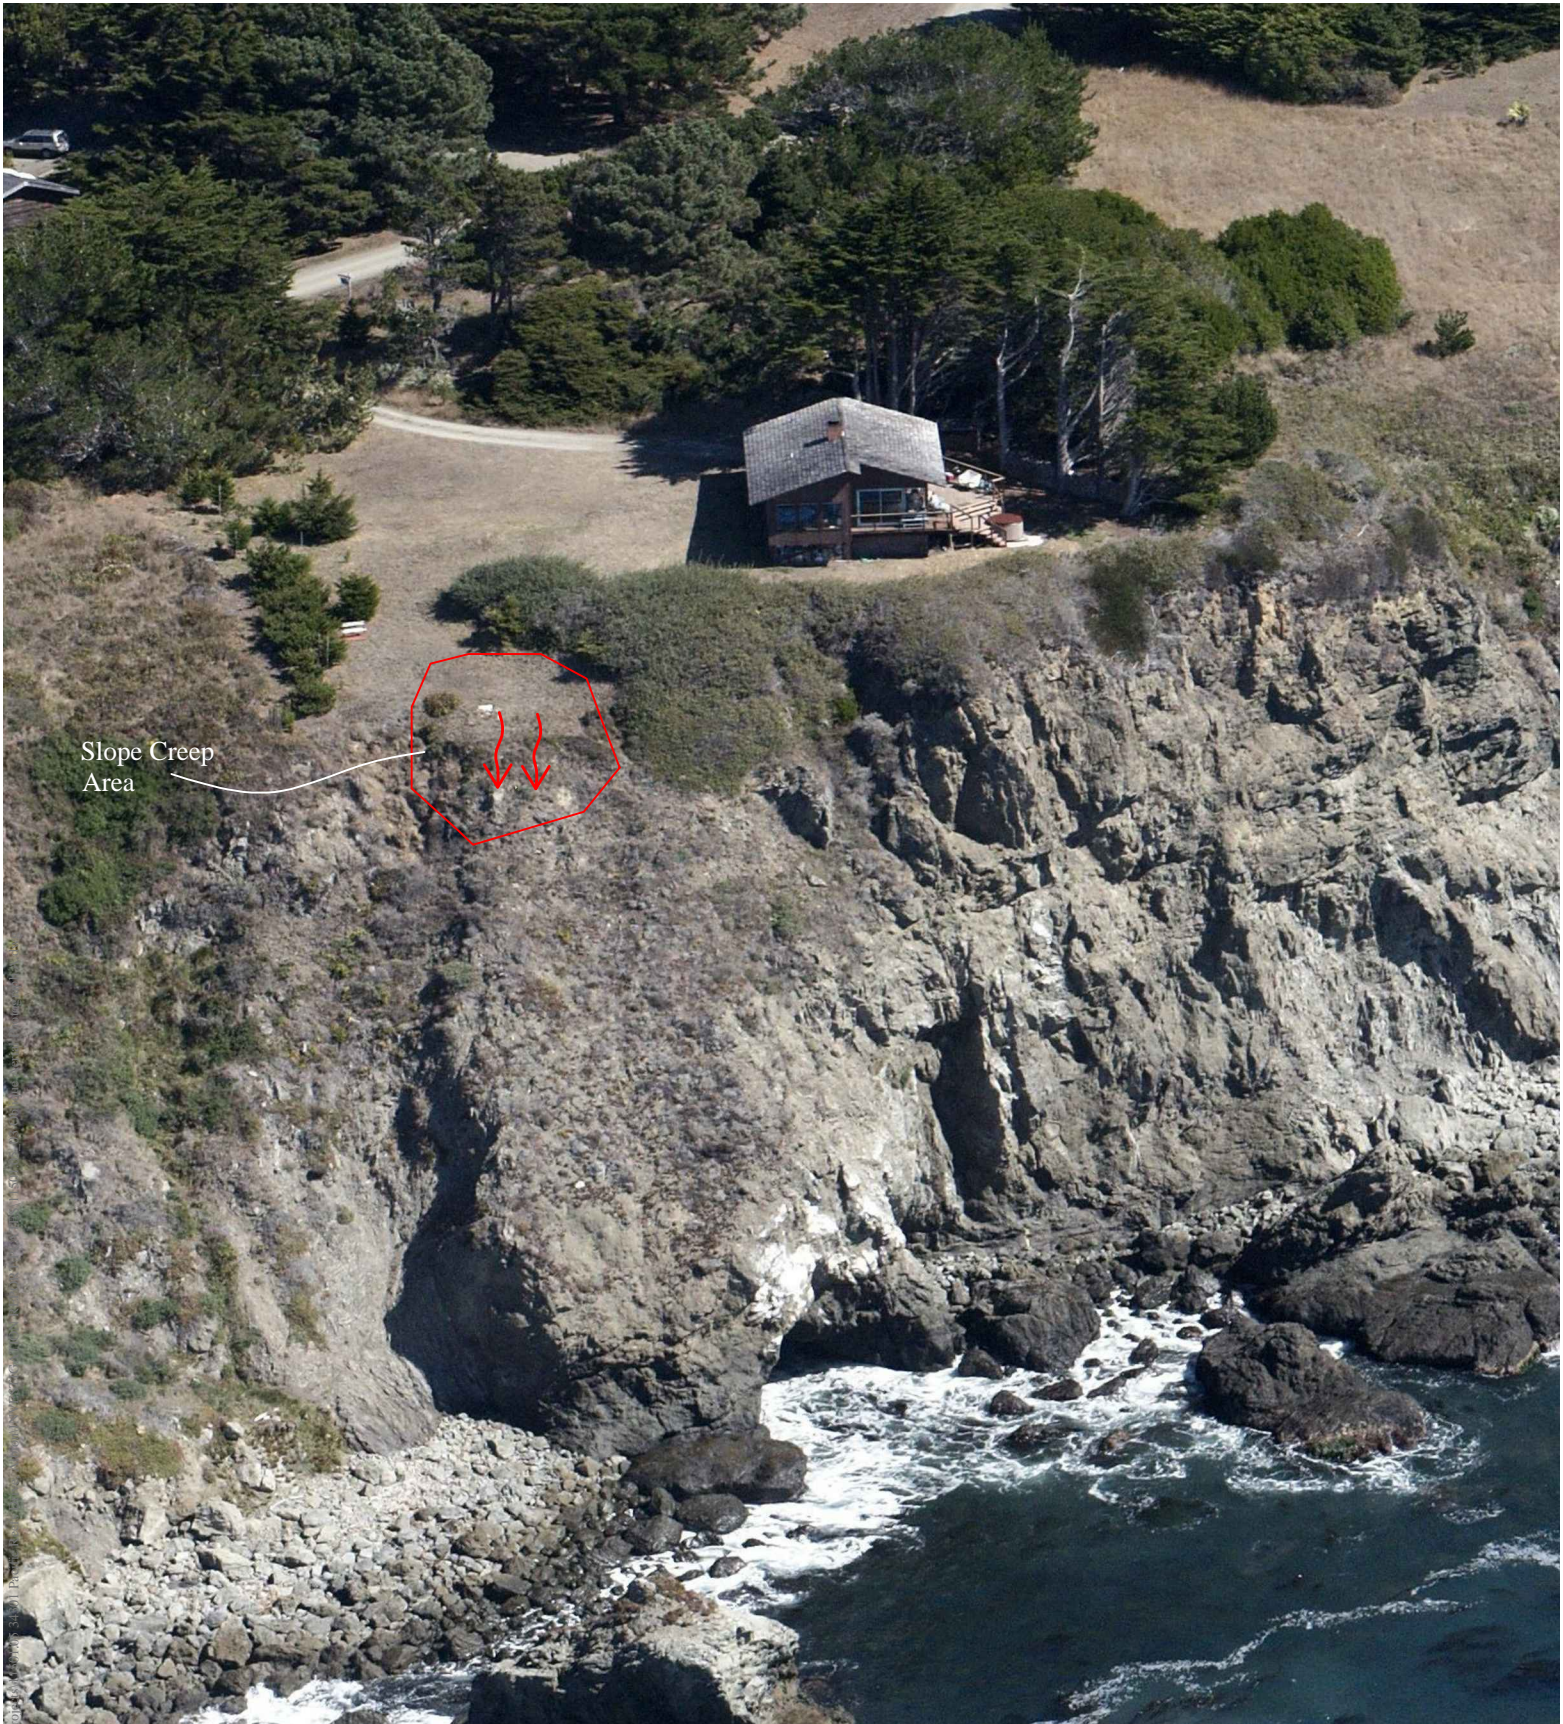
PLATE
2

The ocean bluff next to the residence collapsed in early March 2023. The bluff landslide headscarp extended to the residence foundations. Since a landslide “repair” is extremely difficult to nearly impossible to be permitted by coastal agency standards or performed economically, the house needs to be abandoned or moved back, away from the landslide, as recommended below. The intent of this investigation is to evaluate the site geologic conditions in order to determine the feasibility of moving the house away from the bluff landslide to a new, stable building site on the property. The proposed, new building site is shown on the Site Aerial Photograph, Plate 2.

The initial field exploration consisted of drilling and logging two test borings on June 6, 2000 at the approximate locations shown on Plate 2. Boring B-1 was drilled near a planned building addition area, and boring B-2 was drilled within a planned lap pool area on the west side of the driveway. The test borings ranged from about 15.5 to 20 feet below the ground surface.

Our subsequent field exploration consisted of drilling and logging three test borings (borings B-3 through B-5) on May 10, 2001, at the approximate locations shown on Plate 2. Boring B-3 was drilled near the southeast corner of the existing residence, boring B-4 was drilled near a planned addition at the southwest corner of the existing residence, and boring B-5 was drilled near the northwest corner of the existing residence. The test borings ranged from about 11.75 to 15 feet below the ground surface.

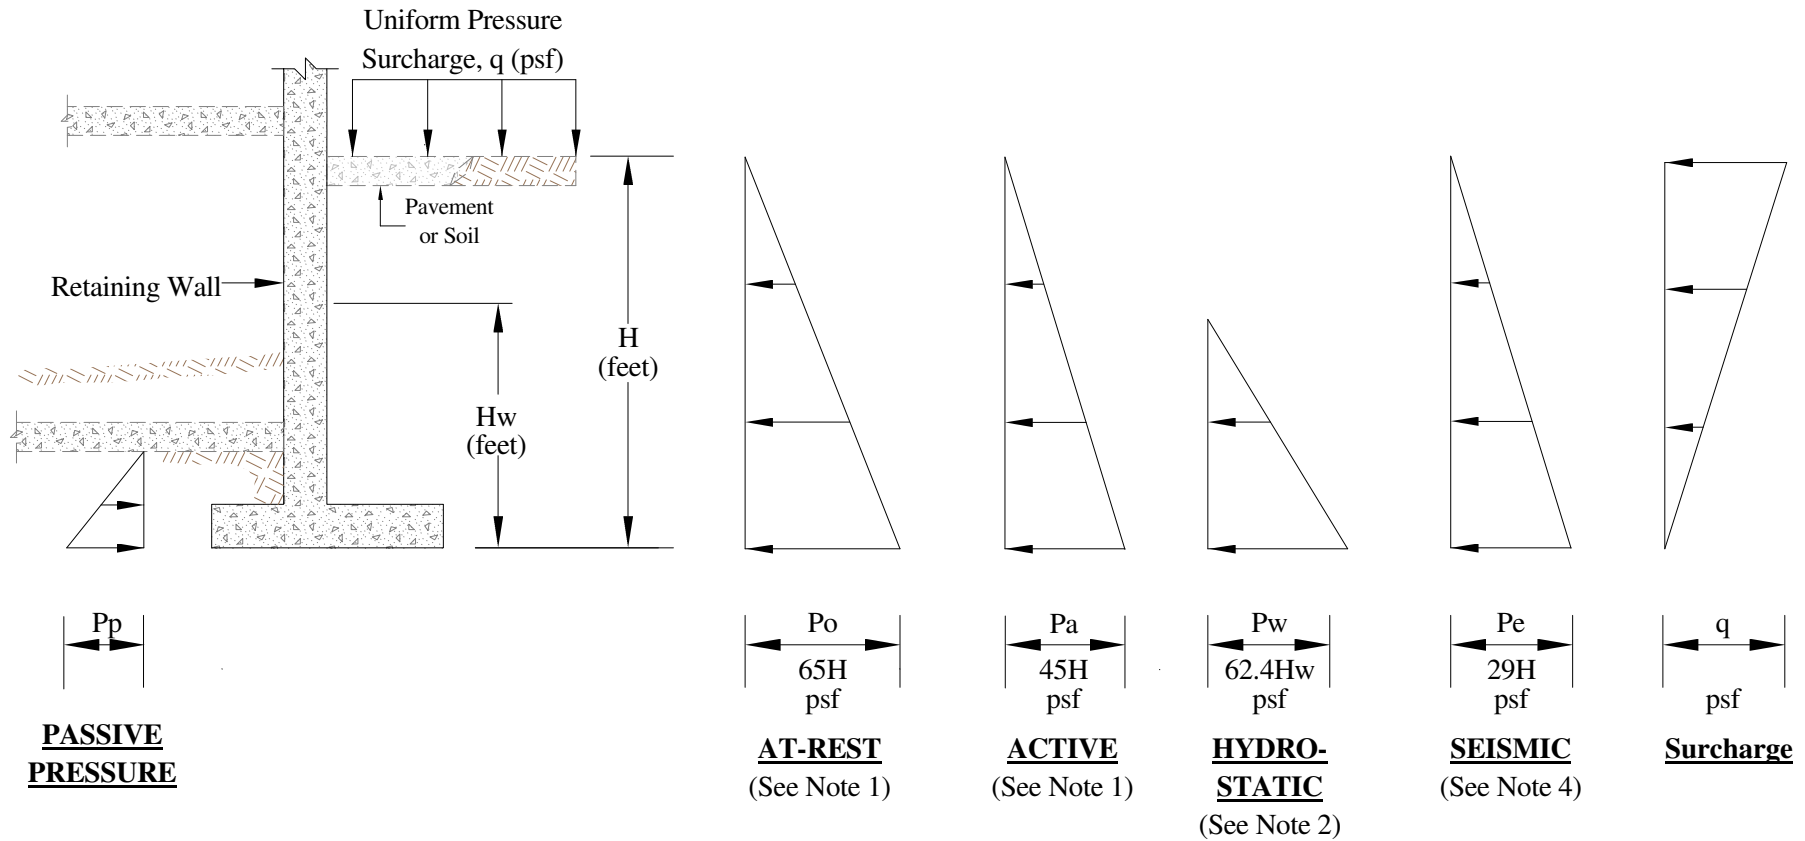
- (1) If the wall at the surface of the backfill cannot move more than about 0.1 percent of its' height, at-rest soil pressures should be used.
- (2) If the wall is drained the above hydrostatic pressure does not have to be used. See Plate 10 for drainage and backfill details.
- (3) The above pressures should be used where backfill slope is flatter than 3 horizontal to 1 vertical (3H:1V). Where backfill slope is between 3H:1V and 1.5H:1V, use active pressure of 55H psf and at-rest pressure of 87H psf, respectively.
- (4) For additional design seismic pressures see the Retaining Walls section of this report.

presented on Plate 10. In areas where movement of moisture vapor through the wall would be detrimental to its intended use, installation of a vapor retarder membrane should be considered. Construction of vapor retarders does not guarantee the prevention of moisture moving through concrete walls. Quality, placement, and compaction requirements for backfill behind subsurface walls are the same as previously presented for fill. Light compaction equipment should be used near the wall to avoid overstressing the walls. Retaining walls should be designed to resist the lateral earth pressures presented on Plate 11.
