To: Mendocino Historical Review Board

From: Ann Zollinger, 33975 Albion River South Side Road, Albion CA

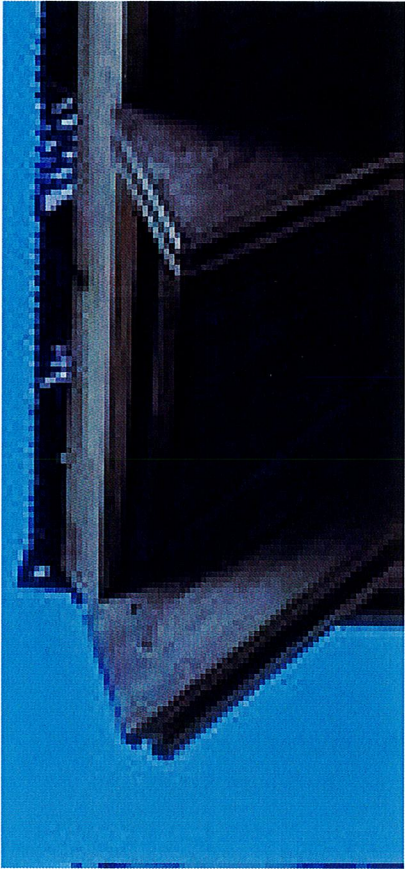
10-year-old steel roof (yes, that is holes in the steel)

I purchased a home with a 10-year-old weathered steel roof 2 ½ years ago in July. Six months later, it became apparent the roof was failing and needed to be replaced. My home is located under the village of Albion approximately 1500 feet from the ocean. Located on the south (north facing) side of the river, even on a clear day, most surfaces are continuously damp.

A steel roof should not be on the coastline. Properties near the ocean, especially those within **one mile from the ocean**, are surrounded by a **high amount of salt particles in the atmosphere**. When salt spray is continuously deposited onto a steel surface, it prevents the development of the inner protective oxide layer from forming.

The rust will not stabilize but may continue to corrode, inevitably resulting in holes in the material. Properties that are waterfront, or close to water, should not use a steel roof to avoid future roofing issues.
